NAPA RIVER LEFT BANK TULOCAY TO IMOLA LEVEE SYSTEM

**NAPA RIVER/NAPA CREEK FLOOD PROTECTION PROJECT
NAPA, CALIFORNIA
NLD SYSTEM ID NO. 5305000100; SEGMENT ID NO. 5304000090**

**PERIODIC INSPECTION REPORT NO. 1
SEPTEMBER 2020**

**US Army Corps
of Engineers®
San Francisco District**

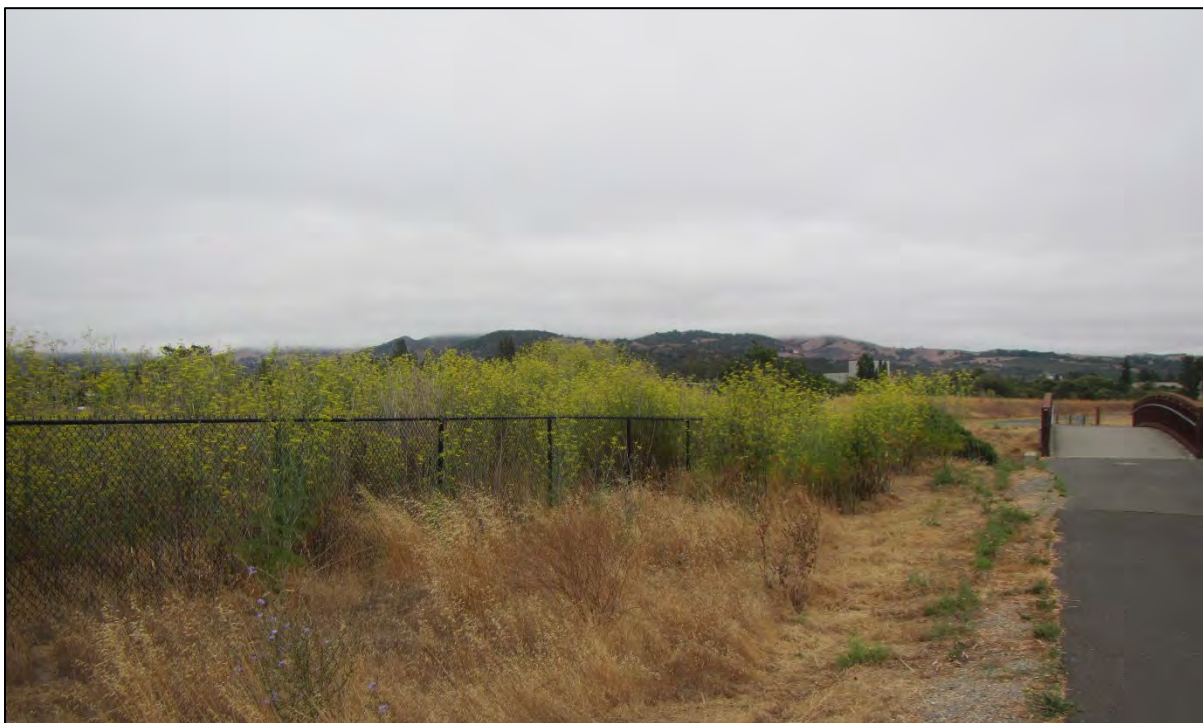
This item was rated “acceptable”. A fence along the levee toe was noted along with some gates. Access through the gates is maintained and these items were rated acceptable.

Figure 5-1: Inspection Point NLT3_2020_0012: Fence along the levee toe.

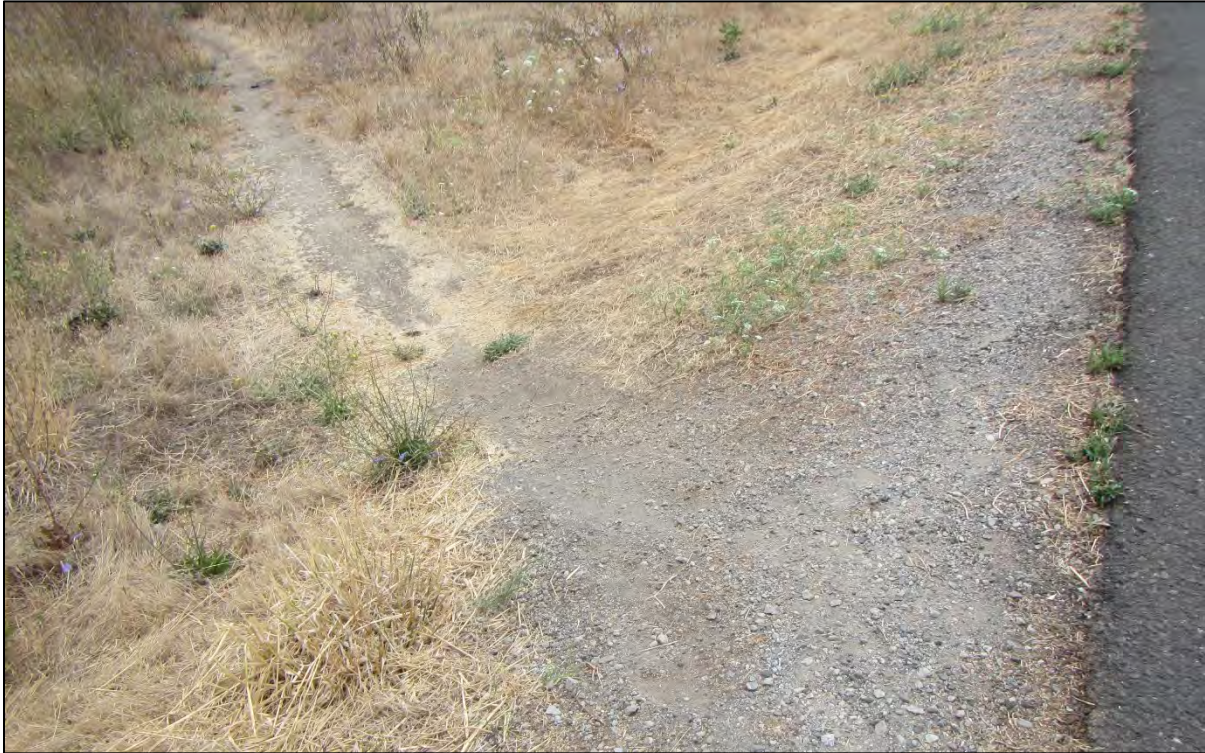
This item was rated “minimally acceptable”. Several footpaths have been established on the levee slopes. These should be filled and compacted to reestablish the levee cross section.

Figure 5-2: Inspection Point NLT3_2020_a_0011: Rutting along the levee slope

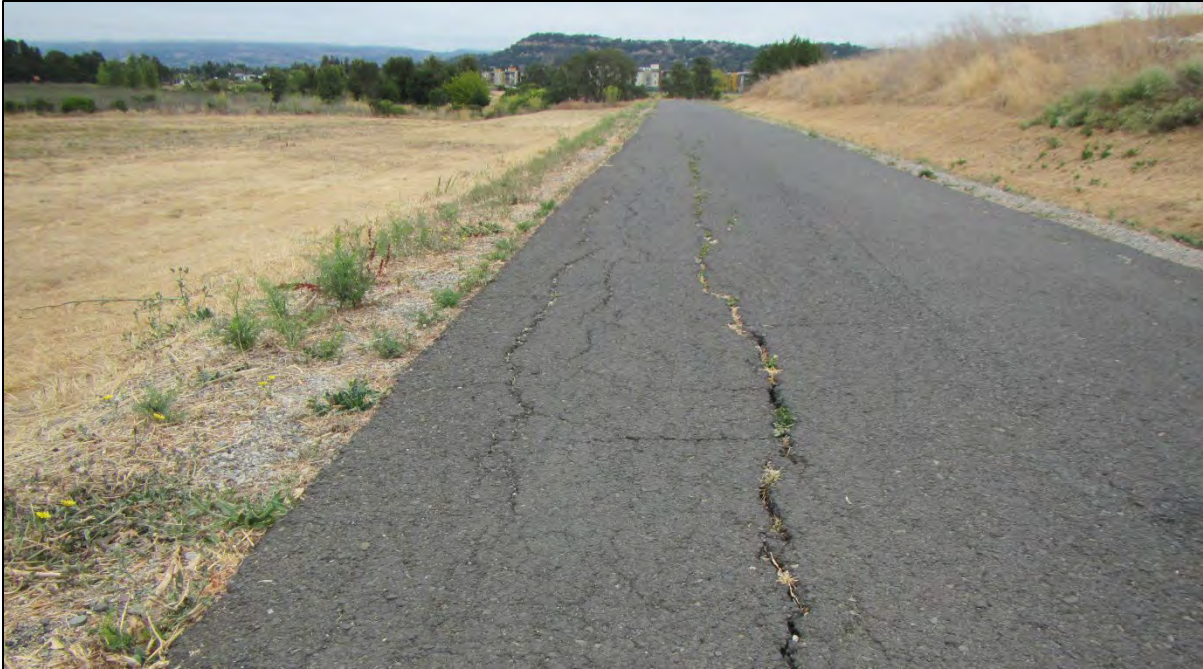
This item was rated “minimally acceptable”. Longitudinal cracks were observed in asphalt along the NSD Levee crest between station 16+00 and 18+00 in the general area where additional fill material was placed on the landside of the levee. These may be from drying of the embankment or may be from the fill material adding stress to the embankment. However, the cracks may be just in the asphalt pavement and not in the levee embankment. The area should be monitored for additional cracking or moving of the embankment.

Figure 5-3: Inspection Point NLT3_2020_a_0020: Cracking observed in asphalt

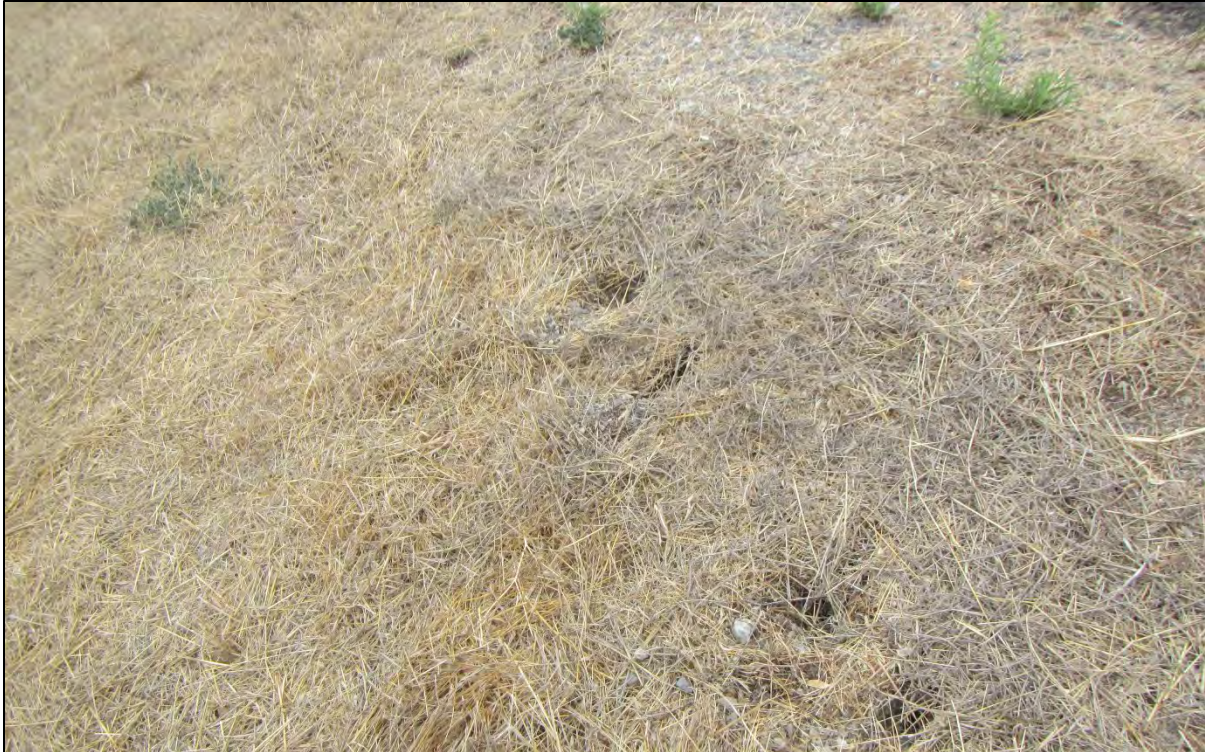
This item was rated “acceptable”.

Figure 5-4: Inspection Point NLT3_2015_a_0020: Animal burrows on the downstream slope of the levee.

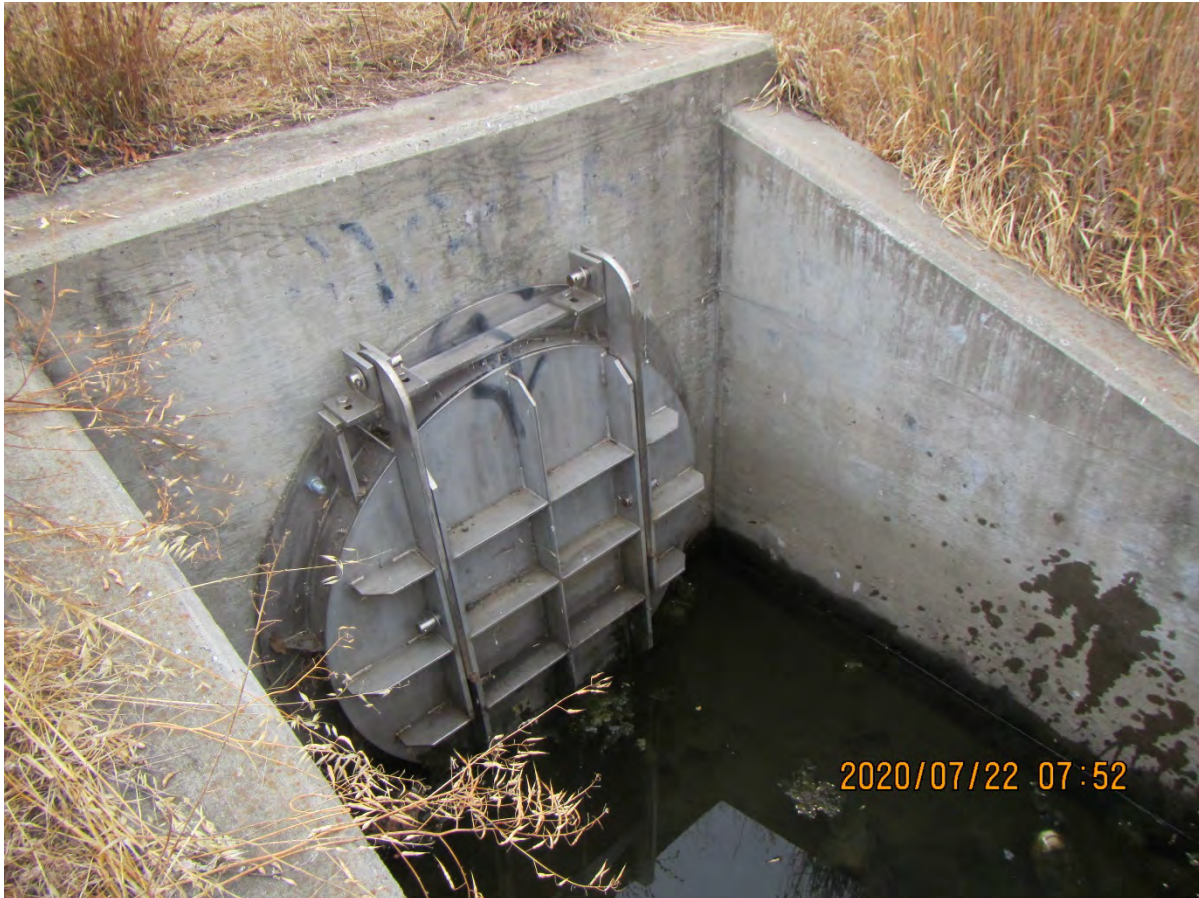
This item was rated “acceptable”. The only flap gate noted is on the Caltrans culvert through the Imola Levee near the downstream end. The gate is in good condition and exercised annually.

Figure 5-5: Inspection Point NLT3_2015_a_0008: Headwall structure and flap gate on the Caltrans Drainage Structure

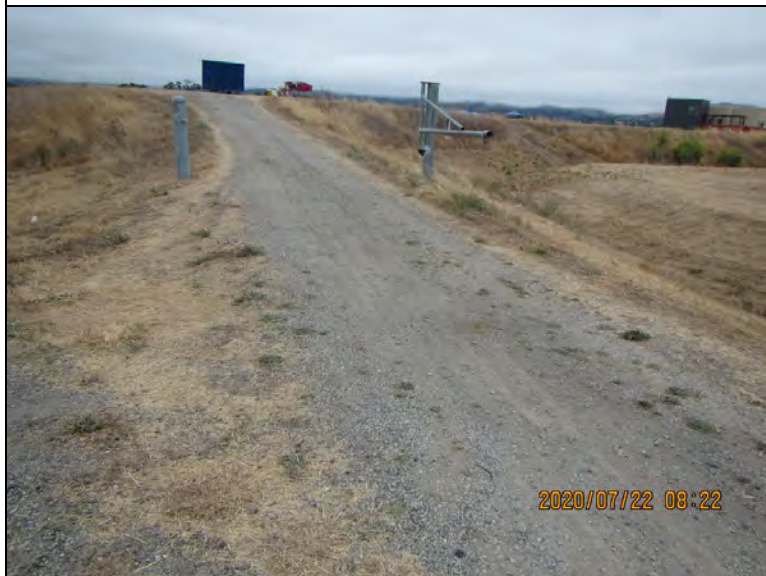
Inspect ID: NLT3_2020_a_0018 **Title:** USACE_CESPN_NLT3_2020_a_0018_1.jpg
Rated Item: 3. Encroachments **Caption:** Rating: Acceptable; Remarks: Access ramp observed on landside slope.; Action: No action required at this time.

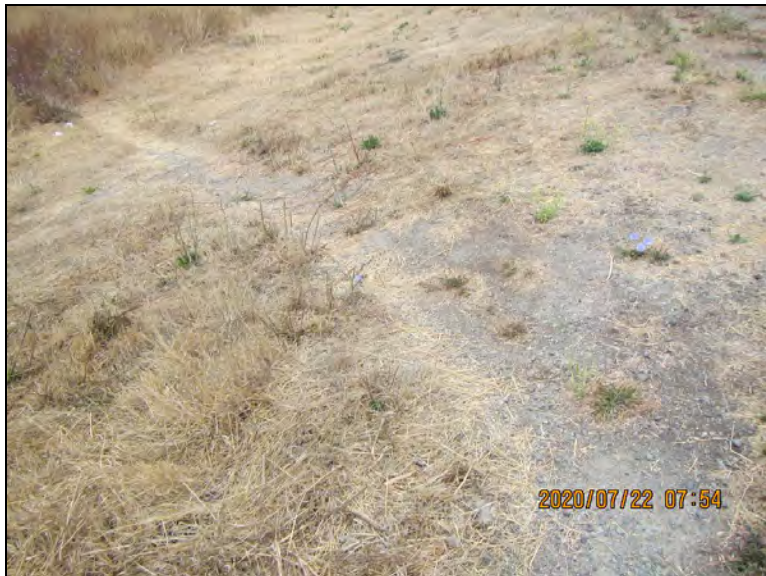
Inspect ID: NLT3_2020_a_0011 **Title:** USACE_CESPN_NLT3_2020_a_0011_1.jpg
Rated Item: 6. Erosion/ Bank Caving **Caption:** Rating: Minimally Acceptable;
Remarks: Foot path observed on riverside slope.; **Action:** Fill and compact to reestablish levee cross section.

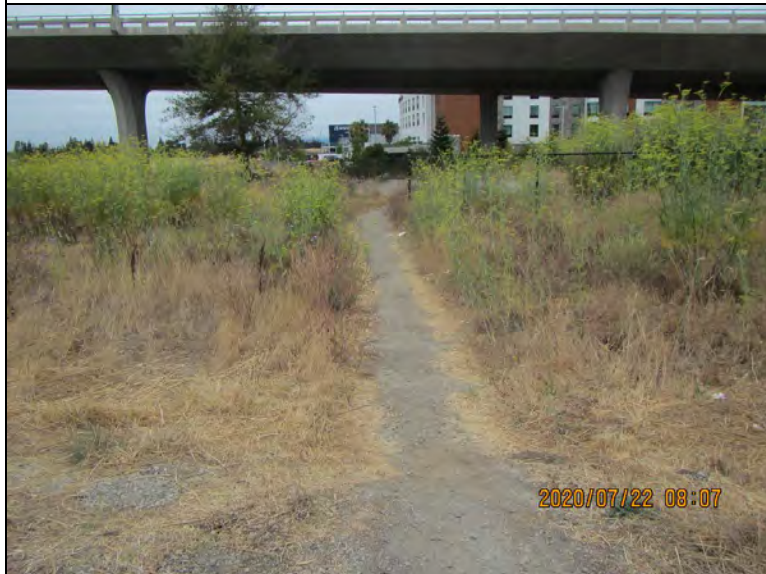
Inspect ID: NLT3_2020_a_0014 **Title:** USACE_CESPN_NLT3_2020_a_0014_1.jpg
Rated Item: 8. Depressions/ Rutting **Caption:** Rating: Acceptable; **Remarks:** Footpath observed on landside slope.; **Action:** Fill and compact to reestablish levee cross section.

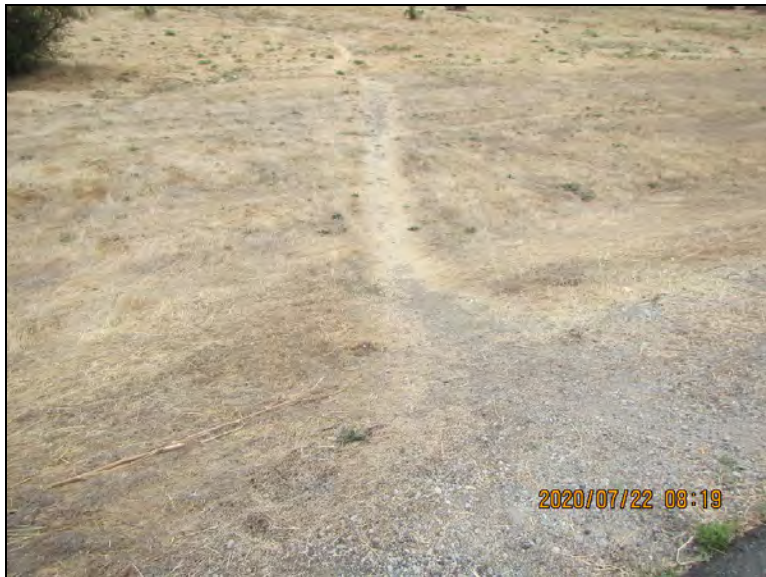
Inspect ID: NLT3_2020_a_0017 **Title:** USACE_CESPN_NLT3_2020_a_0017_1.jpg
Rated Item: 8. Depressions/ Rutting **Caption:** Rating: Minimally Acceptable; Remarks: Foot path observed on riverside slope.; Action: Fill and compact to reestablish levee cross section.

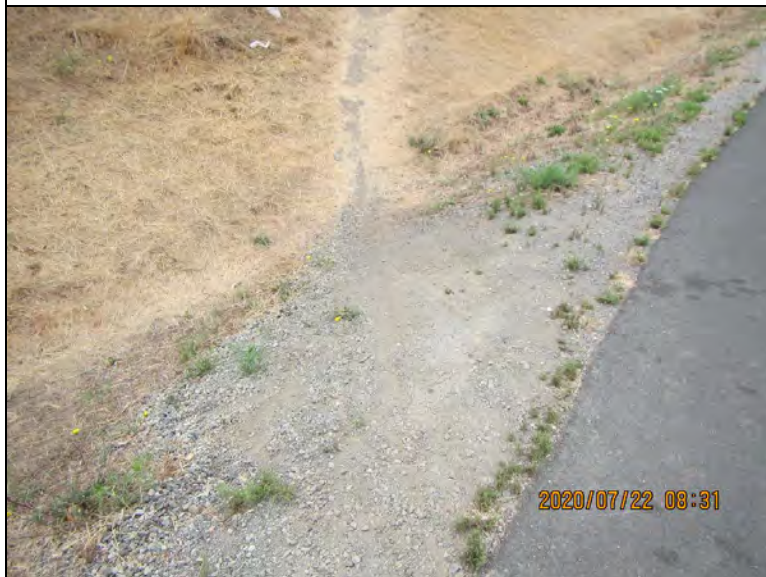
Inspect ID: NLT3_2020_a_0021 **Title:** USACE_CESPN_NLT3_2020_a_0021_1.jpg
Rated Item: 8. Depressions/ Rutting **Caption:** Rating: Minimally Acceptable; Remarks: Foot path observed on landside slope.; Action: Fill and compact to reestablish levee cross section.

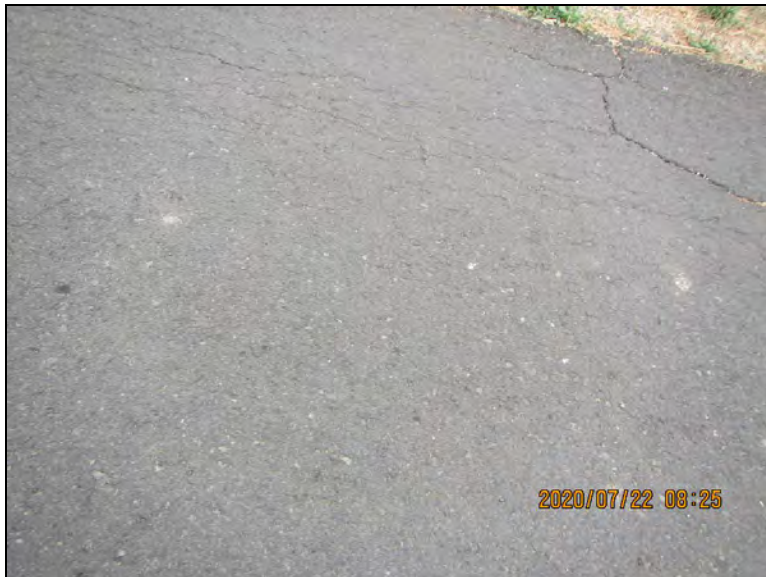
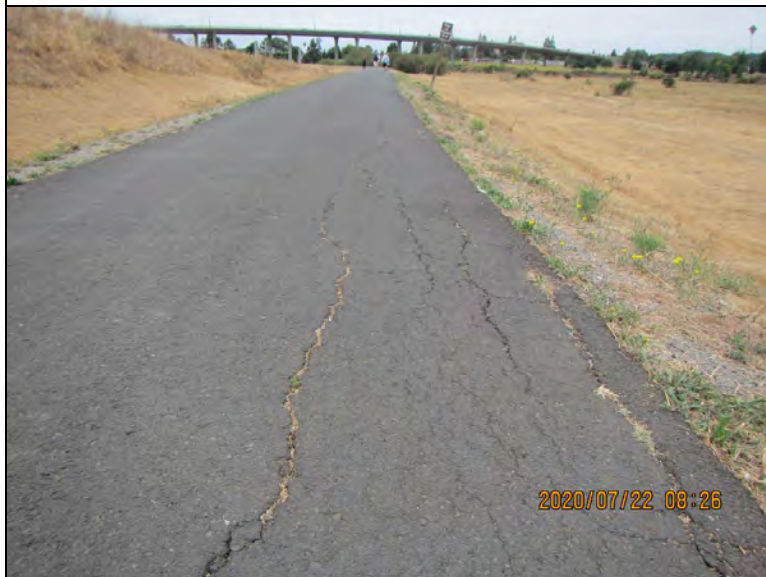
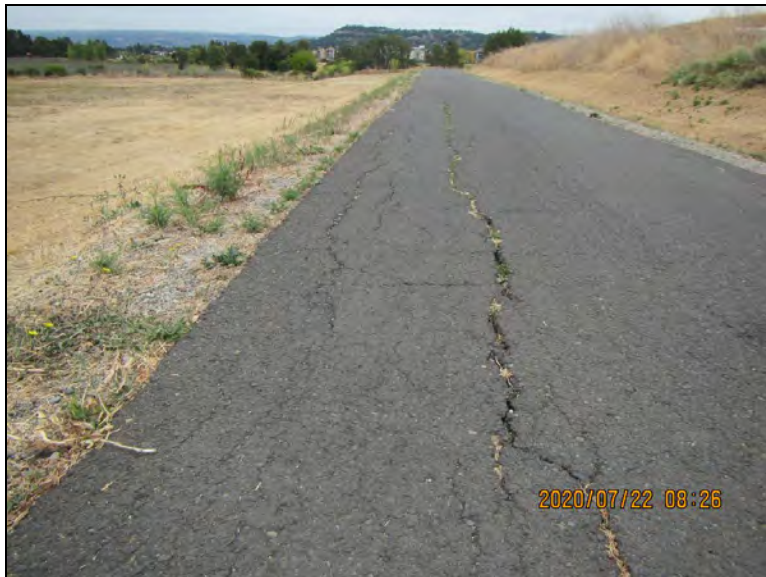
Inspect ID: NLT3_2020_a_0020 **Title:** USACE_CESPN_NLT3_2020_a_0020_1.jpg
Rated Item: 9. Cracking **Caption:** Rating: Minimally Acceptable; Remarks: Cracking observed in asphalt along this section.; Action: Repair as needed.

Inspect ID: NLT3_2020_a_0020 **Title:** USACE_CESPN_NLT3_2020_a_0020_2.jpg
Rated Item: 9. Cracking **Caption:** Rating: Minimally Acceptable; Remarks: Cracking observed in asphalt along this section.; Action: Repair as needed.

Inspect ID: NLT3_2020_a_0020 **Title:** USACE_CESPN_NLT3_2020_a_0020_3.jpg
Rated Item: 9. Cracking **Caption:** Rating: Minimally Acceptable; Remarks: Cracking observed in asphalt along this section.; Action: Repair as needed.

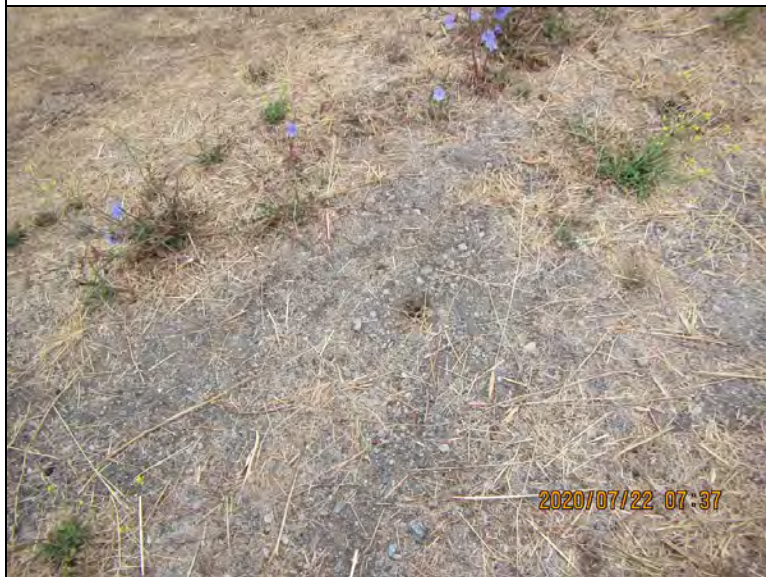
Inspect ID: NLT3_2020_a_0002 **Title:** USACE_CESPN_NLT3_2020_a_0002_1.jpg
Rated Item: 10. Animal Control **Caption:** Rating: Minimally Acceptable; Remarks: Animal burrows where observed. Sponsor provided photos of animal control measure conducted. ; Action: Continue animal control measures; ; ;

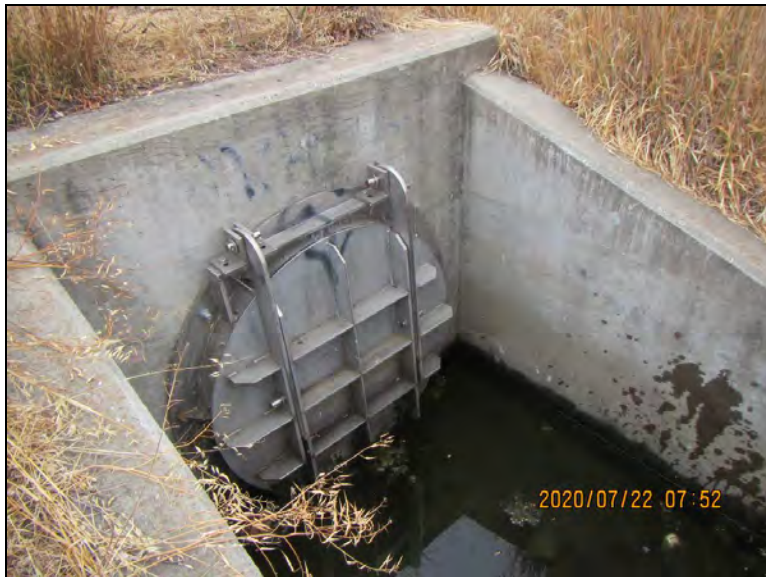
Inspect ID: NLT3_2020_a_0009 **Title:** USACE_CESPN_NLT3_2020_a_0009_1.jpg
Rated Item: 5. Concrete Surfaces (Such as gate wells, outfalls, intakes, or culverts)
Caption: Rating: Acceptable; Remarks: Concrete headwall in good condition.; Action: No action required at this time.

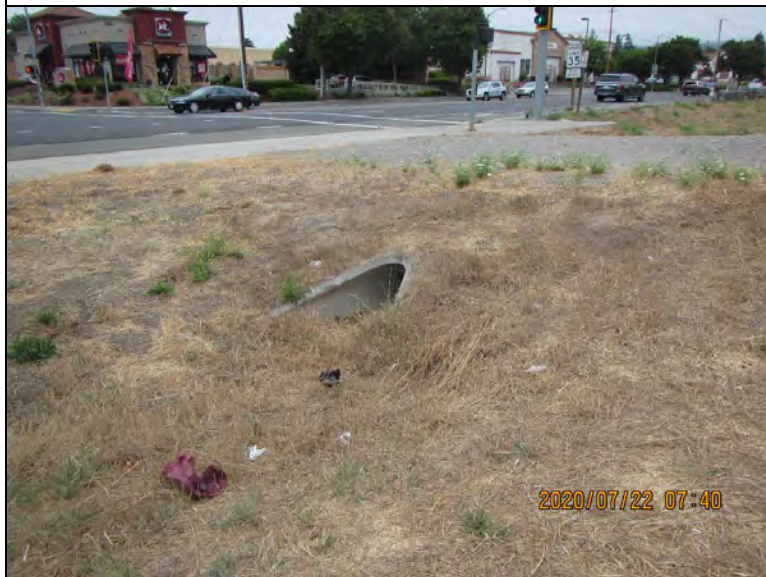
Inspect ID: NLT3_2020_a_0004 **Title:** USACE_CESPN_NLT3_2020_a_0004_1.jpg
Rated Item: 9. Culverts/ Discharge Pipes **Caption:** Rating: Acceptable; Remarks: Concrete culvert through access ramp; Action: No action required at this time.

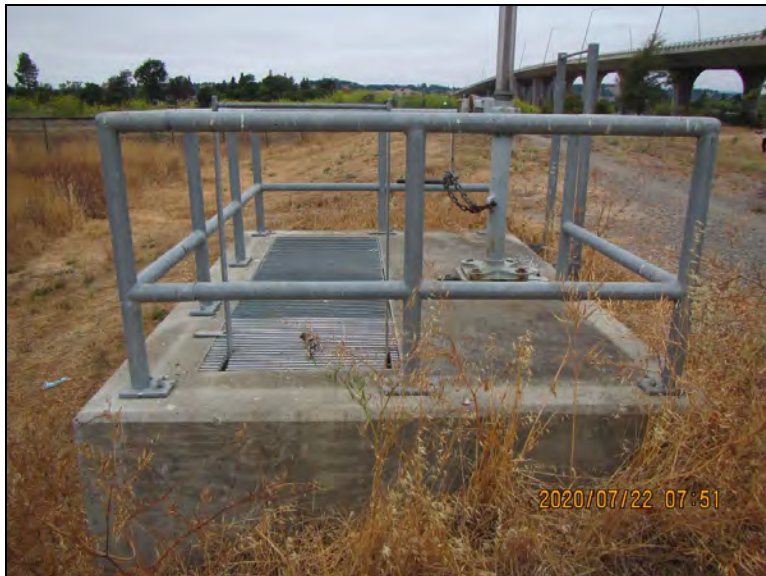
Inspect ID: NLT3_2020_a_0007 **Title:** USACE_CESPN_NLT3_2020_a_0007_1.jpg
Rated Item: 9. Culverts/ Discharge Pipes **Caption:** Rating: Acceptable; Remarks: Culvert is in good condition. Slide gate is exercised annually.; Action: Culvert is due for 5-year inspection by inspection season 2021.

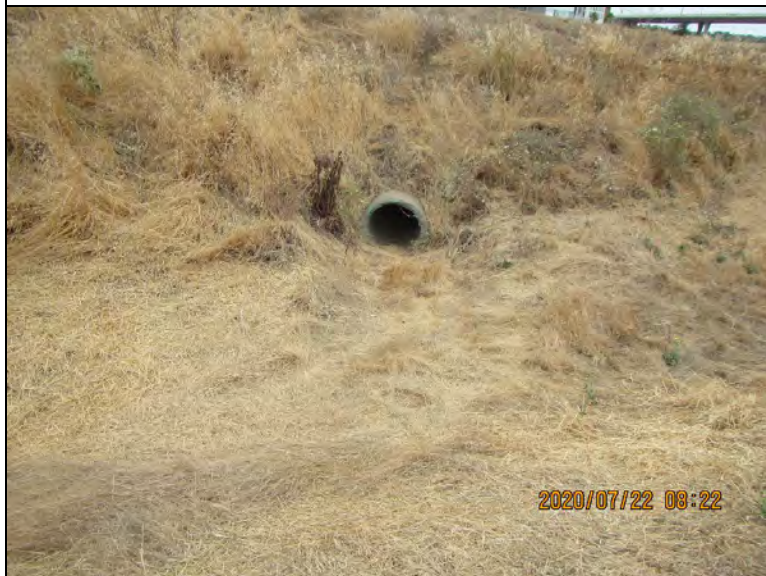
Inspect ID: NLT3_2020_a_0019 **Title:** USACE_CESPN_NLT3_2020_a_0019_1.jpg
Rated Item: 9. Culverts/ Discharge Pipes **Caption:** Rating: Acceptable; Remarks: Concrete culvert passing through access ramp.; Action: Monitor.

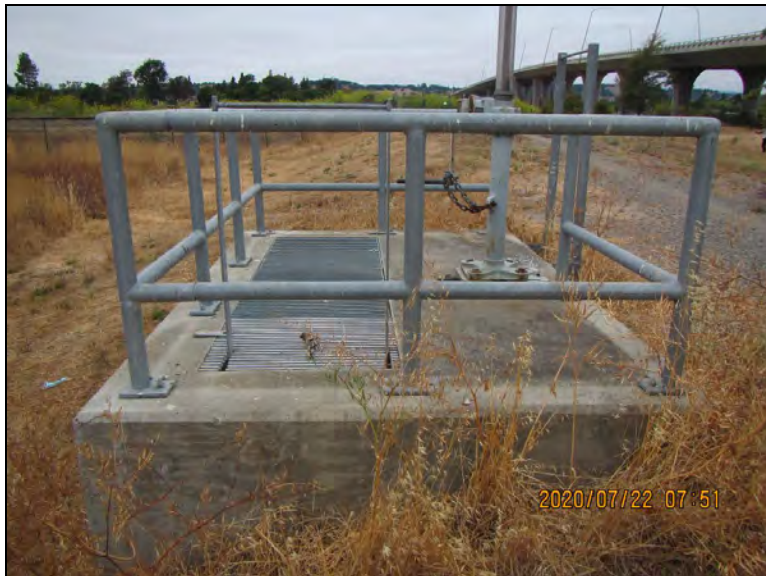
Inspect ID: NLT3_2020_a_0010 **Title:** USACE_CESPN_NLT3_2020_a_0010_1.jpg
Rated Item: 10. Sluice/ Slide Gates **Caption:** Rating: Acceptable; Remarks: Slide gate is in good condition and functional. Sponsor exercises gate annually.; Action: No action required at this time.

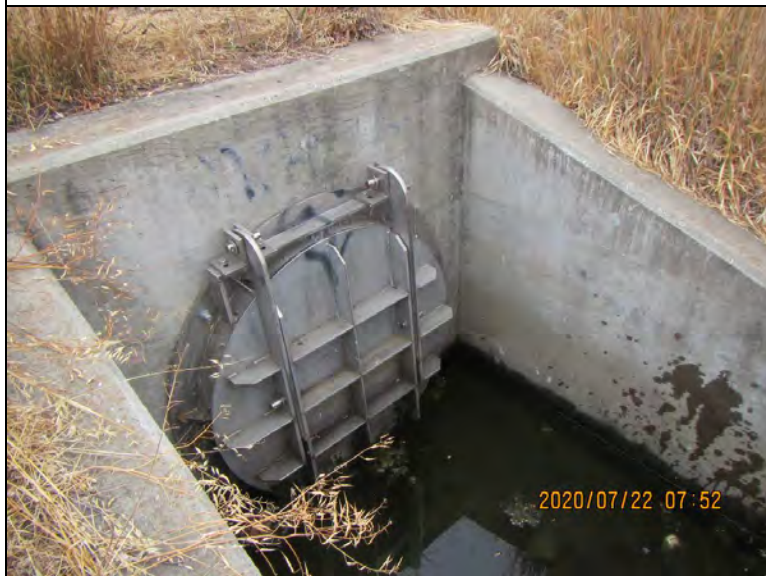
Inspect ID: NLT3_2020_a_0008 **Title:** USACE_CESPN_NLT3_2020_a_0008_1.jpg
Rated Item: 11. Flap Gates/ Flap Valves/ Pinch Valves **Caption:** Rating: Acceptable; Remarks: Flap gate is functional and in good condition, exercised annually.; Action: No action required at this time.
