CORTE MADERA CREEK PROJECT TOWN OF ROSS, CALIFORNIA

Background, Site, and Geotechnical Investigation for the Lagunitas Road Bridge Corte Madera Creek

**U.S. Army Corps of Engineers
San Francisco District**

100% Submittal

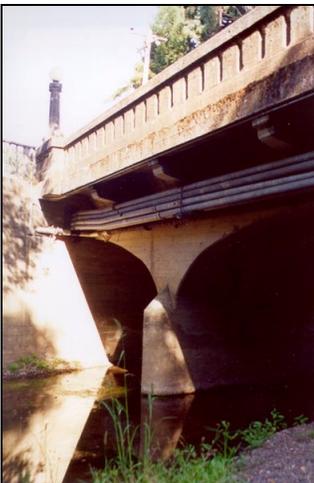
The west abutment is in generally good condition with minor spalling. Some scour is evident at the upstream side of the west pier. Minor patching is evident throughout the structure. The west abutment and wingwall are offset approximately 1-1/2 to 2".

West Pier Prior to Maintenance Excavation

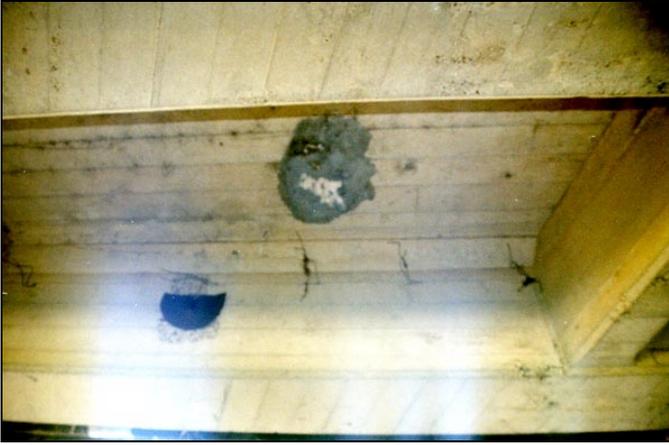
Patch in Underside of Deck – Looking South

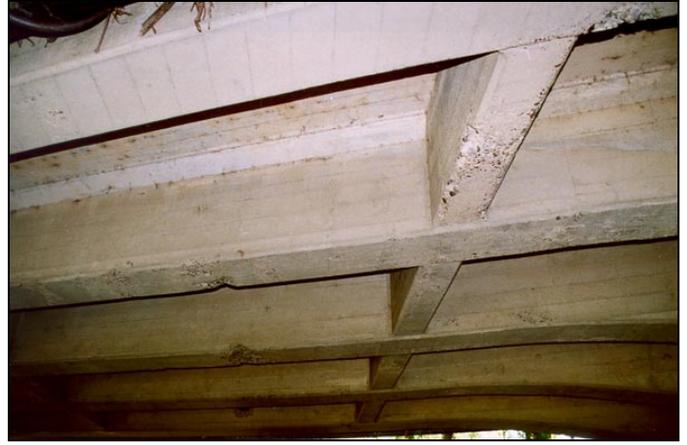
Spalled Concrete – Diaphragm

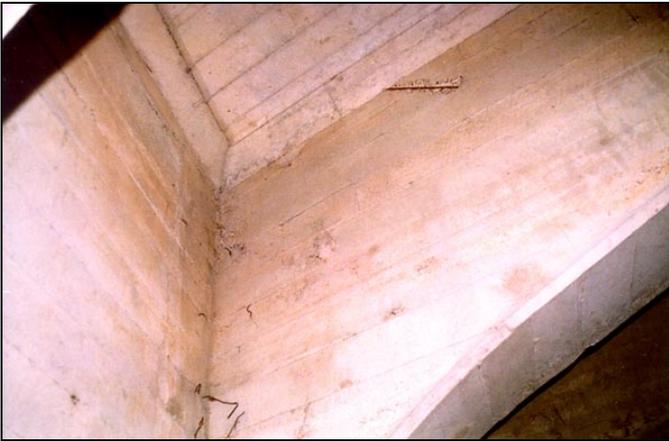
Visible Reinforcing Steel – End of Girder

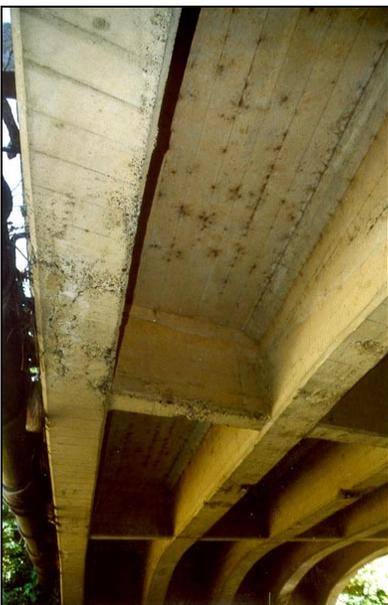
Concrete Girder Spalled from Debris – Looking East

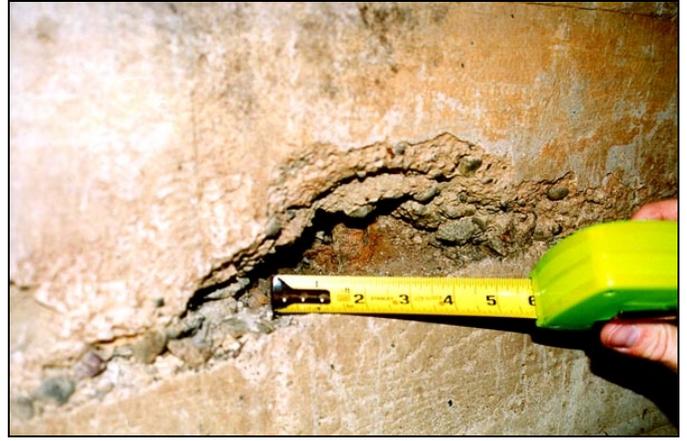
Void at Base of Girder in East Pier

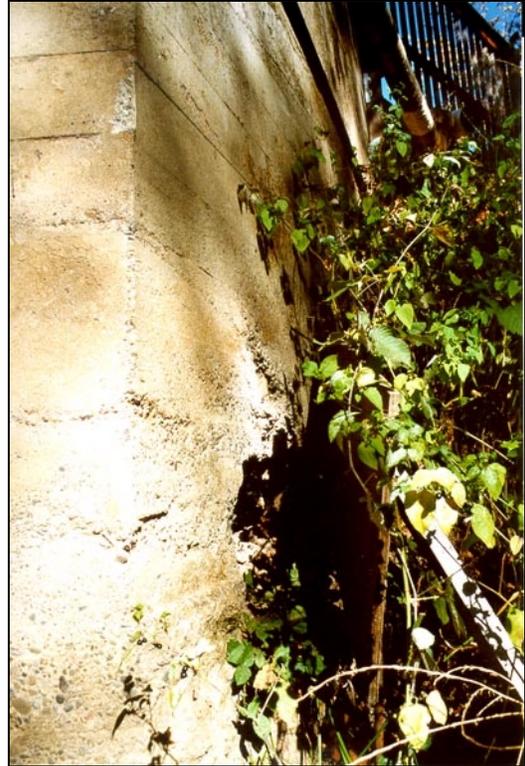
A cursory visual inspection of the bridge was performed. Minor spalling and deterioration of the concrete has occurred over the years, as evidenced in the photographs of Appendix D. Some scour action has occurred at the east abutment and wingwall interface, forming a 3' x 1'-6" scour pocket in the 17-inch thick wall. Evidence exists on the face of the upstream girders that debris has collided with the bridge girders during high flows in the past. Some reinforcing steel is exposed and minor cracks are in evidence at various locations on the structure. Various pipes are suspended from the bridge, including an active natural gas line on the south side and numerous steel conduits, as well.

Scour Damage to South Side of East Wingwall

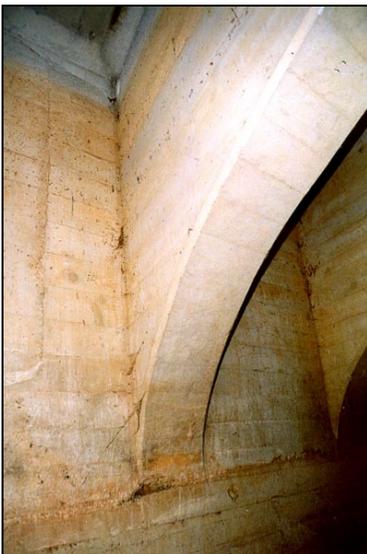
Small Void in East Face of East Pier at Base of Girder

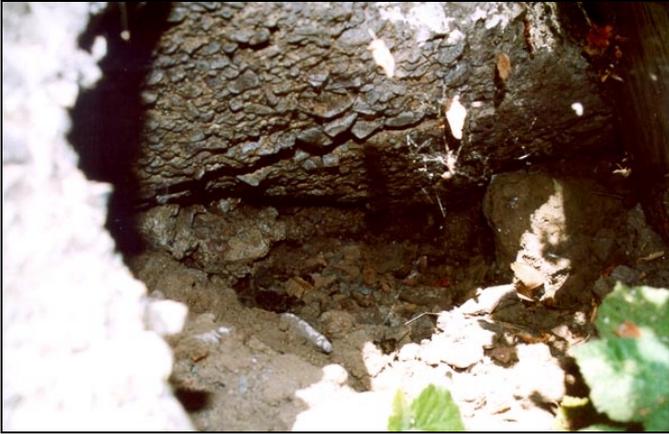
Closeup of Scour Damage to South Side of East Wingwall

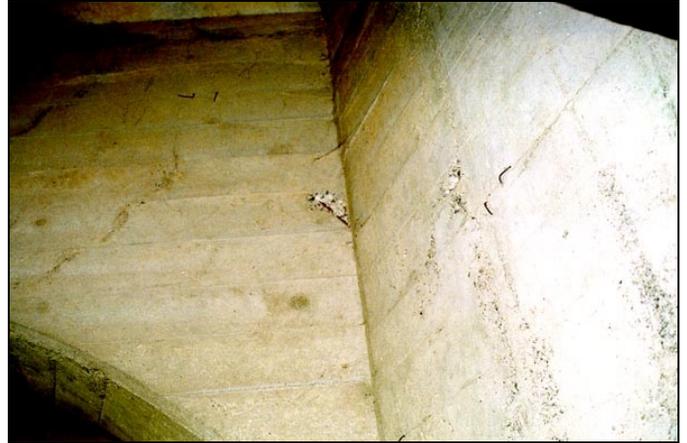
Exposed Reinforcing Steel – North Girder Connection to West Pier Looking South

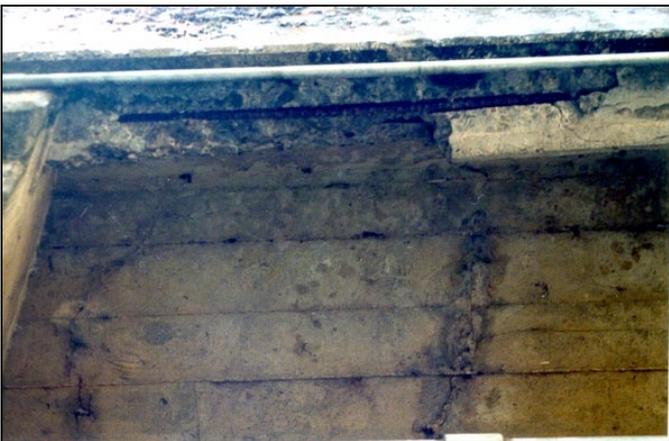
Exposed Reinforcing Steel Under South Sidewalk Support Beam

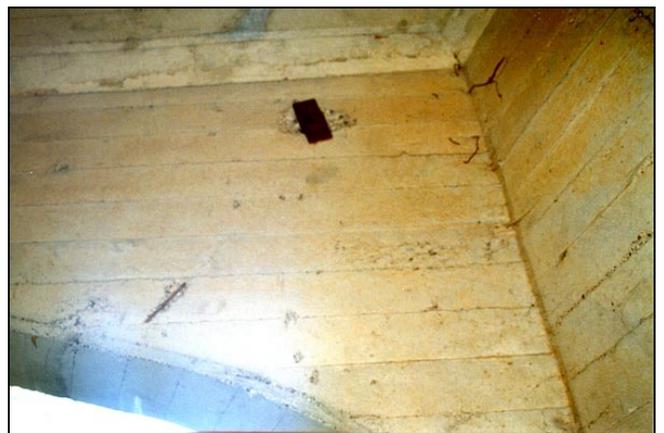
Exposed Reinforcing Steel – North Girder Connection to West Pier Looking North

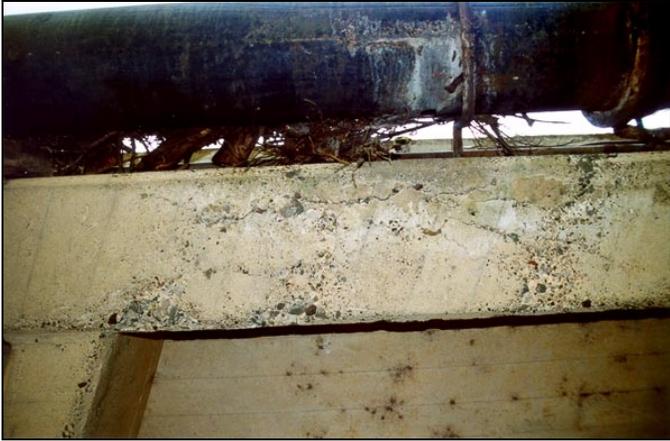
Looking Up at North Girder – Spalling / Abrasion from Debris During High Flow

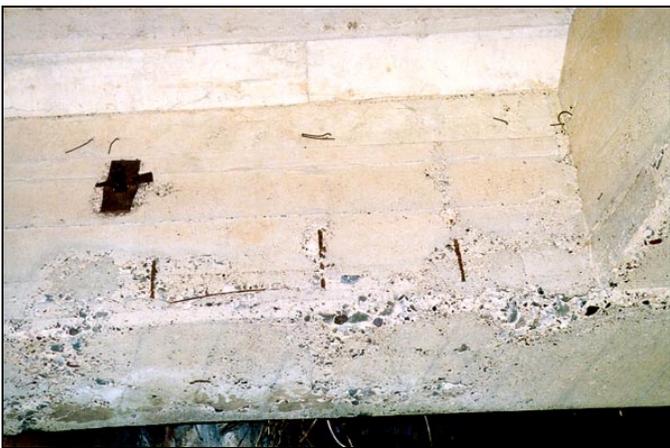
Closeup of Visible Reinforcing Steel in North Girder Looking North
