Flood Damage Reduction Segment / System Inspection Report

Name of Segment / System: Alameda Creek FFCP Left Bank ALLB

Location: Fremont, CA
 Year/cycle: 2018 a
 Inspection type: Routine
 Inspected by: Anthony Galvan, Rachael Marzion
 Inspection date(s): 06/19/2018
 Observation ID prefix: USACE_CESPN_ALLB_2018_a
 Map created: 24 September 2020

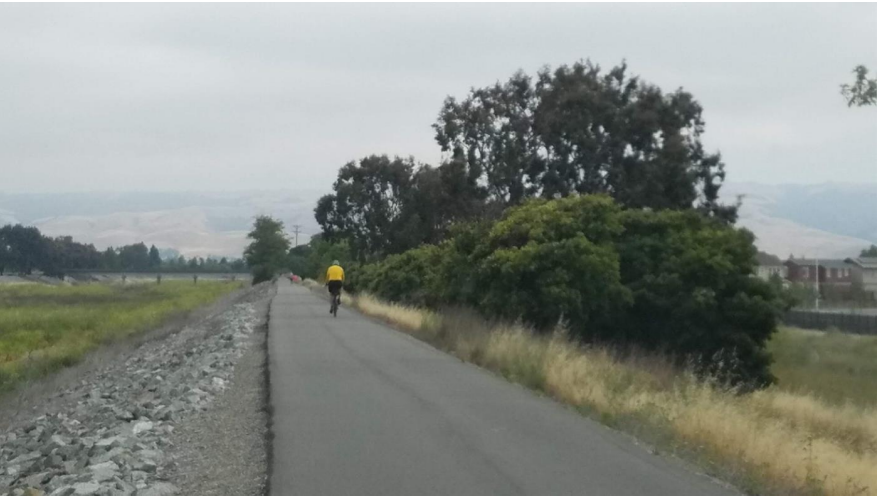
<p>Inspect ID: ALLB_2018_a_0006 Title: USACE_CESPN_ALLB_2018_a_0006_1.jpg Rated Item: 1. Unwanted Vegetation Growth Caption: Rating: Acceptable; Remarks: Trees more than 10 ft tall were observed within the 15 ft vegetation-free zone. Typical condition.; Action: The trees should be managed in accordance with ETL 1110-2-583 or a vegetation variance should be obtained.; Station_1: 208+00</p>

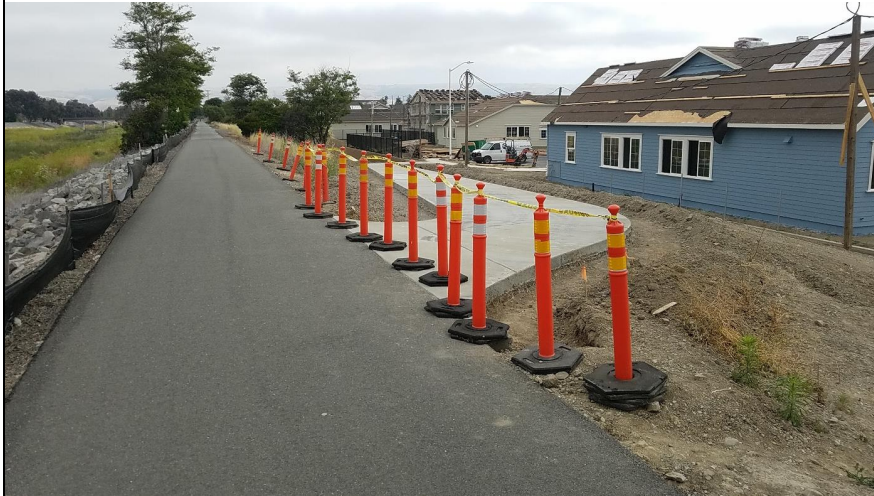
<p>Inspect ID: ALLB_2018_a_0008 Title: USACE_CESPN_ALLB_2018_a_0008_1.jpg Rated Item: 1. Unwanted Vegetation Growth Caption: Rating: Minimally Acceptable; Remarks: Trees more than 10 feet tall and with trunk diameters greater than 12 inches were observed on the landside slope.; Action: The trees should be managed in accordance with ETL 1110-2-583 or a vegetation variance should be obtained.; Station_1: 230+00; View looking upstream along the crest of the levee prism.</p>

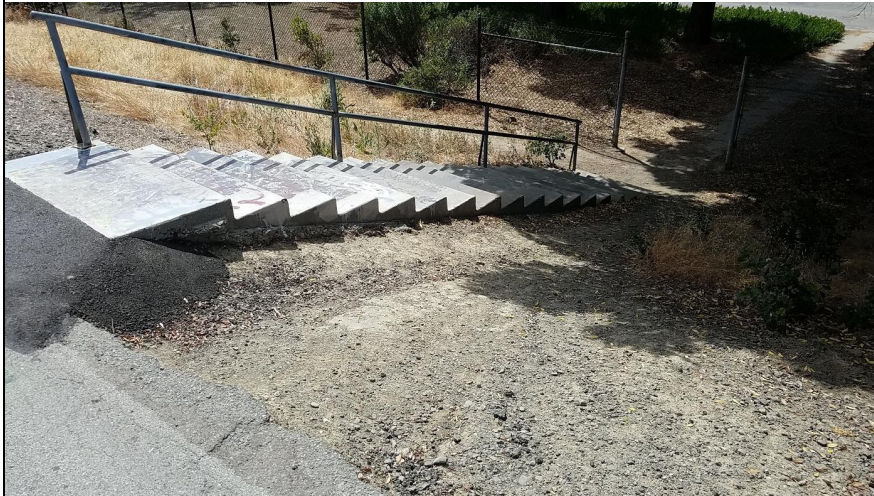
6. Erosion/ Bank Caving	M	A	No erosion or bank caving is observed on the landward or riverward sides of the levee that might endanger its stability.	ALLB_2018_a_0017: Station_1 325+00: Pioneer trails observed on both sides of the concrete stairs. Path on the north side of the staircase is a possible remnant of an erosion rill.: NA (M) ALLB_2018_a_0029: Station_1 478+00: Left bank under the bridge.: NA (M)
		M	There are areas where minor erosion is occurring or has occurred on or near the levee embankment, but levee integrity is not threatened.	
		U	Erosion or caving is occurring or has occurred that threatens the stability and integrity of the levee. The erosion or caving has progressed into the levee section or into the extended footprint of the levee foundation and has compromised the levee foundation stability.

Inspect ID: ALLB_2018_a_0017 **Title:** USACE_CESPN_ALLB_2018_a_0017_1.jpg **Rated Item:** 6. Erosion/ Bank Caving
Caption: Rating: Minimally Acceptable; Remarks: Pioneer trails observed on both sides of the concrete stairs. Path on the north side of the staircase is a possible remnant of an erosion rill. ; Action: NA; Station_1: 325+00

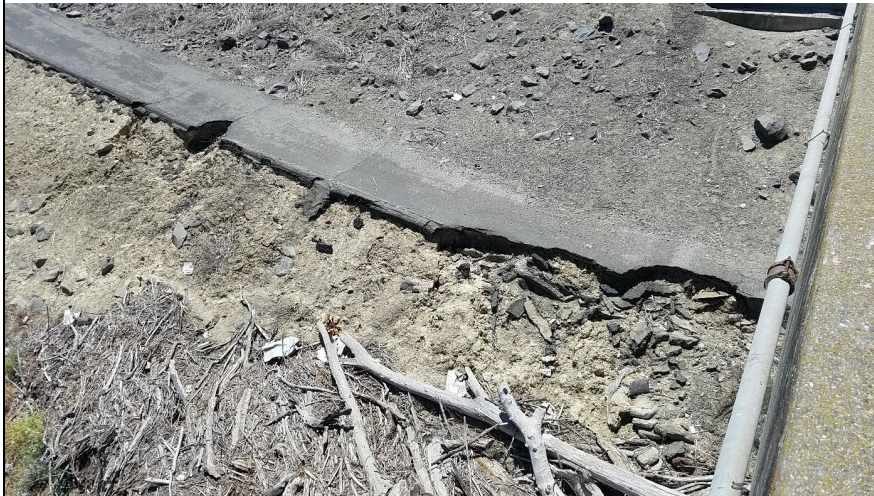
Inspect ID: ALLB_2018_a_0017 **Title:** USACE_CESPN_ALLB_2018_a_0017_2.jpg **Rated Item:** 6. Erosion/ Bank Caving
Caption: Rating: Minimally Acceptable; Remarks: Pioneer trails observed on both sides of the concrete stairs. Path on the north side of the staircase is a possible remnant of an erosion rill. ; Action: NA; Station_1: 325+00

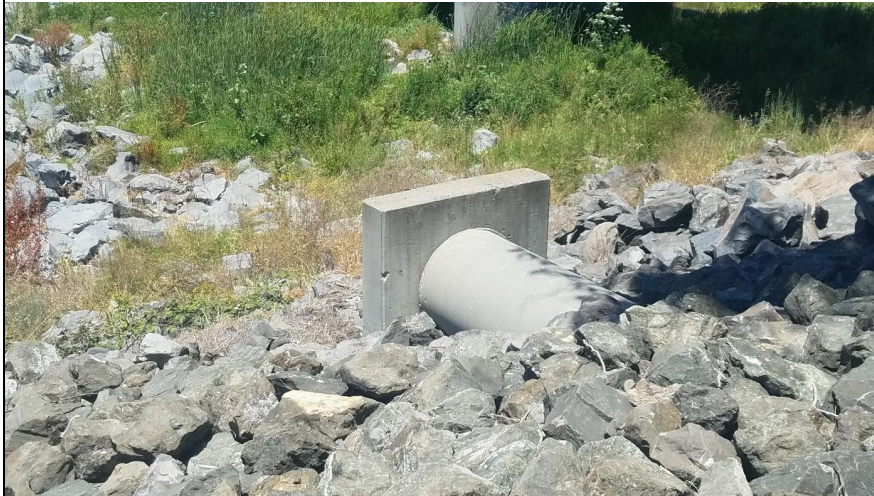
Inspect ID: ALLB_2018_a_0035 **Title:** USACE_CESPN_ALLB_2018_a_0035_1.jpg
Rated Item: 11. Culverts/ Discharge Pipes (This item includes both concrete and corrugated metal pipes.) **Caption:** Rating: Acceptable; Remarks: Concrete outlet structure in good condition.; Action: NA; Station_1: 518+00

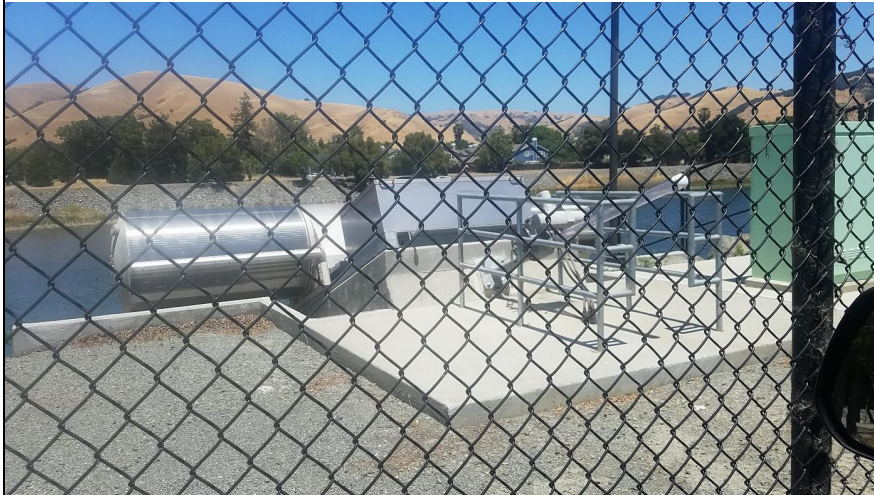
Inspect ID: ALLB_2018_a_0036 **Title:** USACE_CESPN_ALLB_2018_a_0036_1.jpg
Rated Item: 11. Culverts/ Discharge Pipes (This item includes both concrete and corrugated metal pipes.) **Caption:** Rating: Acceptable; Remarks: Fish screen on the waterside slope.; Action: NA; Station_1: 547+00

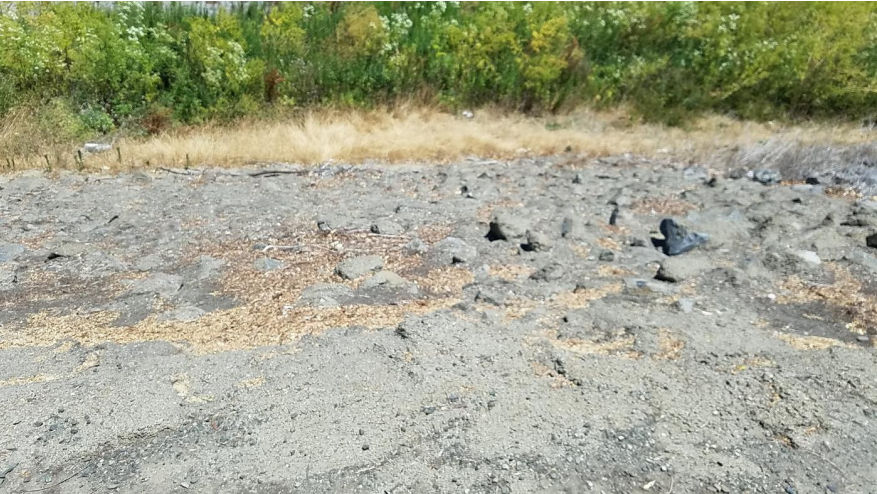
<p>Inspect ID: ALLB_2018_a_0023 Title: USACE_CESPN_ALLB_2018_a_0023_1.jpg Rated Item: 13. Revetments other than Riprap Caption: Rating: Acceptable; Remarks: Grouted stone slope protection was in good condition. ; Action: NA; Station_1: 412+00</p>

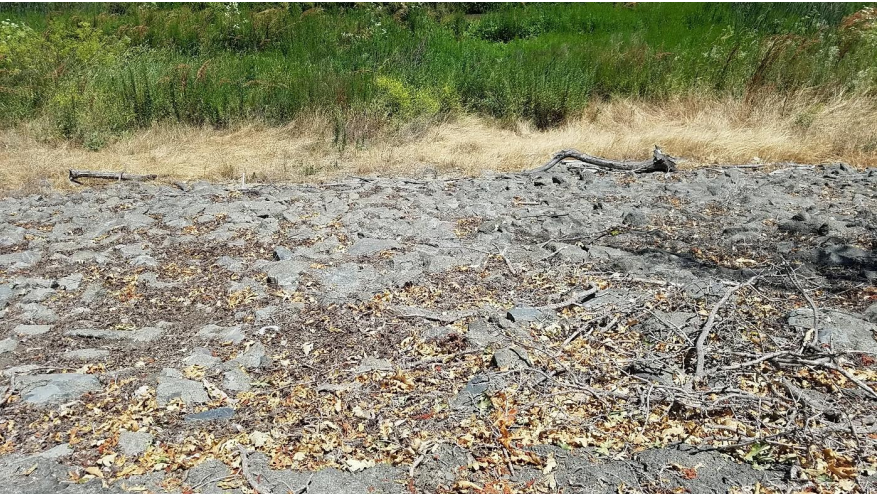
<p>Inspect ID: ALLB_2018_a_0024 Title: USACE_CESPN_ALLB_2018_a_0024_1.jpg Rated Item: 13. Revetments other than Riprap Caption: Rating: Acceptable; Remarks: Grouted stone slope protection was in good condition. ; Action: NA; Station_1: 432+00</p>

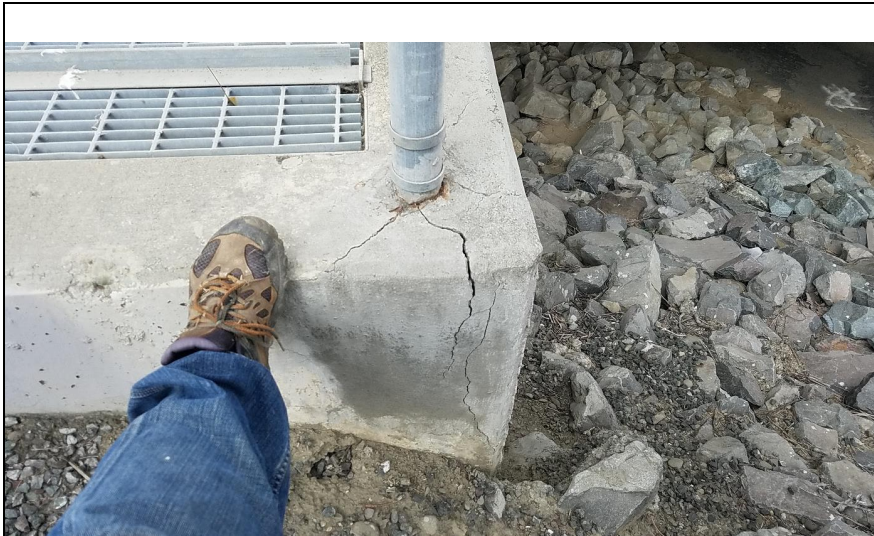
Inspect ID: ALLB_2018_a_0014 **Title:** USACE_CESPN_ALLB_2018_a_0014_1.jpg
Rated Item: 5. Concrete Surfaces (Such as gate wells, outfalls, intakes, or culverts)
Caption: Rating: Acceptable; Remarks: Cracking observed on the corner of the slide gate's concrete base approximately 1/4 inch wide.; Action: NA; Station_1: 304+00

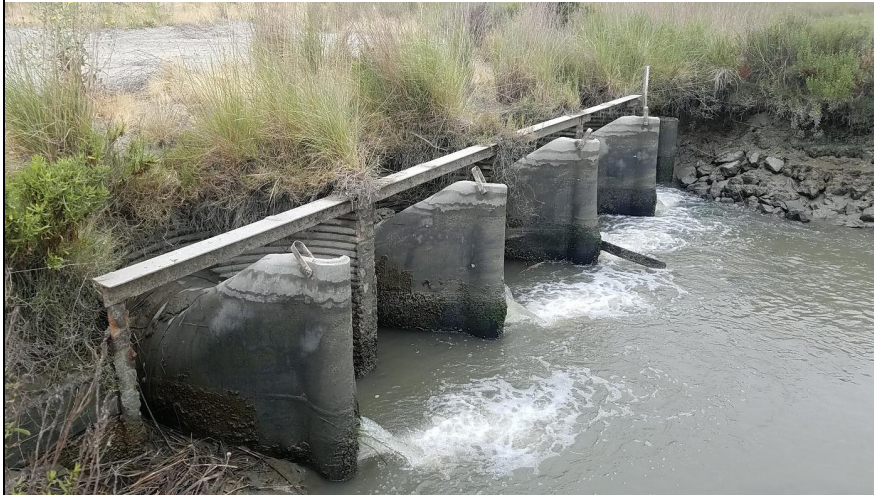
Inspect ID: ALLB_2018_a_0001 **Title:** USACE_CESPN_ALLB_2018_a_0001_1.jpg
Rated Item: 10. Sluice/ Slide Gates **Caption:** Rating: Acceptable; Remarks: The four 48-inch slide gates were in good condition and clear of debris. The duckbill valves on the channel side appeared to be in good condition.; Action: NA; Station_1: 148+00

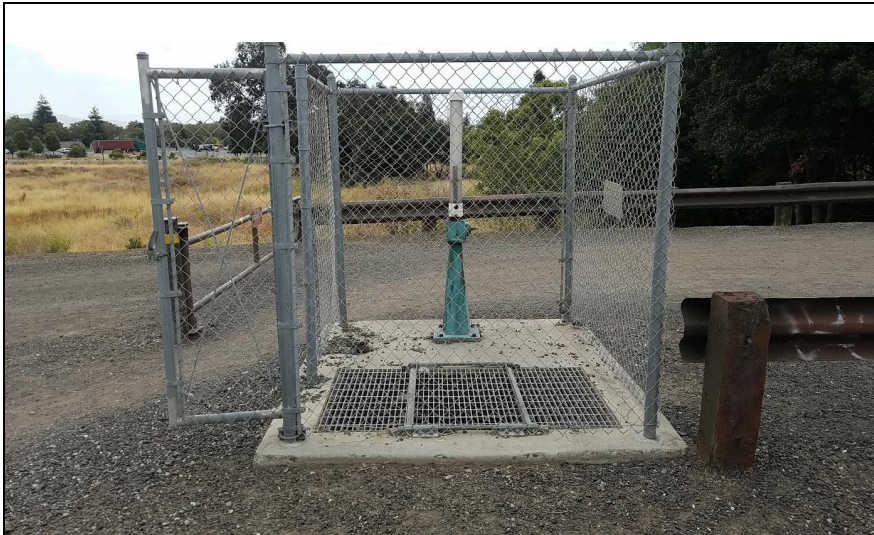
Inspect ID: ALLB_2018_a_0011 **Title:** USACE_CESPN_ALLB_2018_a_0011_1.jpg
Rated Item: 10. Sluice/ Slide Gates **Caption:** Rating: Acceptable; Remarks: NA;
Action: NA; Station_1: 292+00

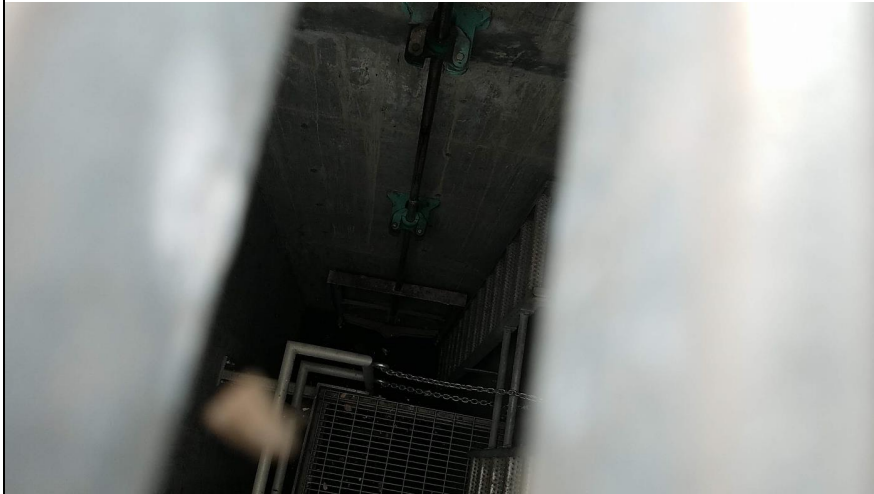
Inspect ID: ALLB_2018_a_0011 **Title:** USACE_CESPN_ALLB_2018_a_0011_2.jpg
Rated Item: 10. Sluice/ Slide Gates **Caption:** Rating: Acceptable; Remarks: NA;
Action: NA; Station_1: 292+00

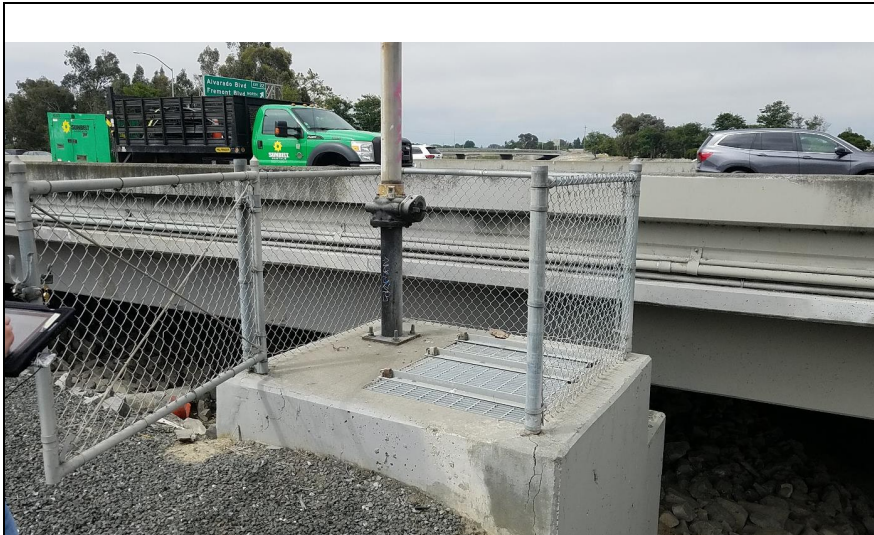
Inspect ID: ALLB_2018_a_0013 **Title:** USACE_CESPN_ALLB_2018_a_0013_1.jpg
Rated Item: 10. Sluice/ Slide Gates **Caption:** Rating: Acceptable; Remarks: Slide gate in good condition. Minor debris observed in the well.; Action: Clear debris from the well.; Station_1: 304+00

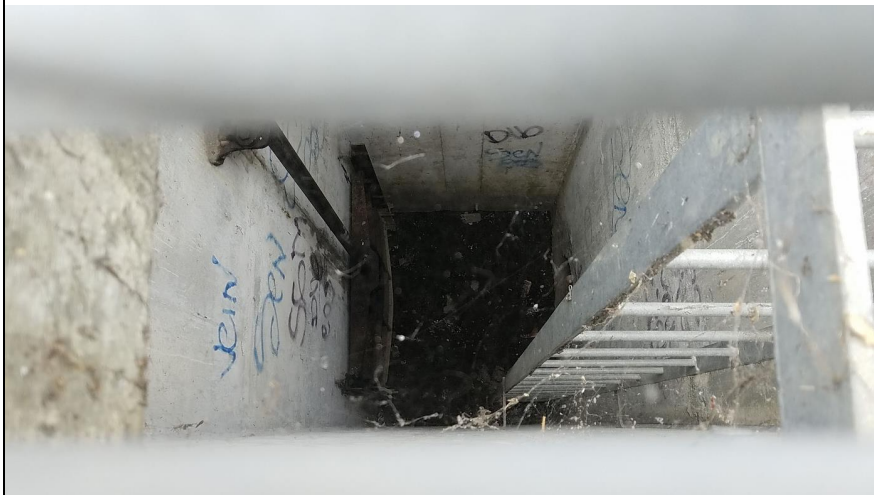
Inspect ID: ALLB_2018_a_0013 **Title:** USACE_CESPN_ALLB_2018_a_0013_2.jpg
Rated Item: 10. Sluice/ Slide Gates **Caption:** Rating: Acceptable; Remarks: Slide gate in good condition. Minor debris observed in the well.; Action: Clear debris from the well.; Station_1: 304+00

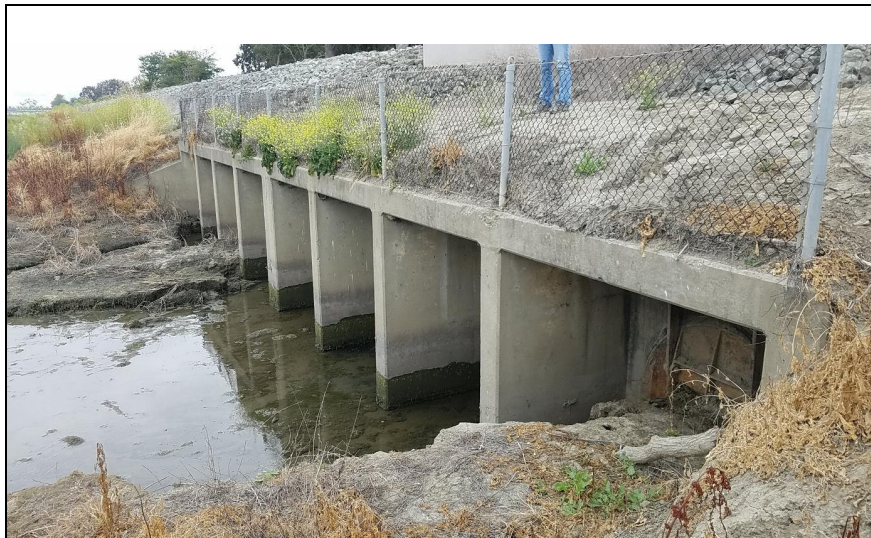
Inspect ID: ALLB_2018_a_0007 **Title:** USACE_CESPN_ALLB_2018_a_0007_1.jpg
Rated Item: 11. Flap Gates/ Flap Valves/ Pinch Valves **Caption:** Rated Item: 10. Sluice/ Slide Gates; Rating: Acceptable; Remarks: Sediment buildup in front of 2 of the 8 flap gate outlets. Joint separation observed in the concrete apron. Minor corrosion observed on the flap gates. Outlets are clear of debris.; Action: Monitor sediment accumulation around the outlets and repair joint material.; Station_1: 221+00

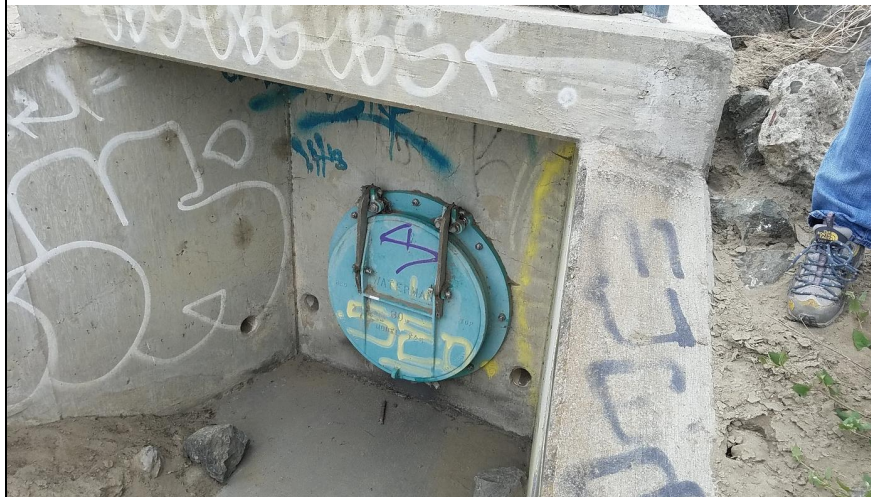
Inspect ID: ALLB_2018_a_0012 **Title:** USACE_CESPN_ALLB_2018_a_0012_1.jpg
Rated Item: 11. Flap Gates/ Flap Valves/ Pinch Valves **Caption:** Rating: Acceptable; Remarks: 30-inch flap gate and surrounding concrete apron in good condition.; Action: NA; Station_1: 291+00

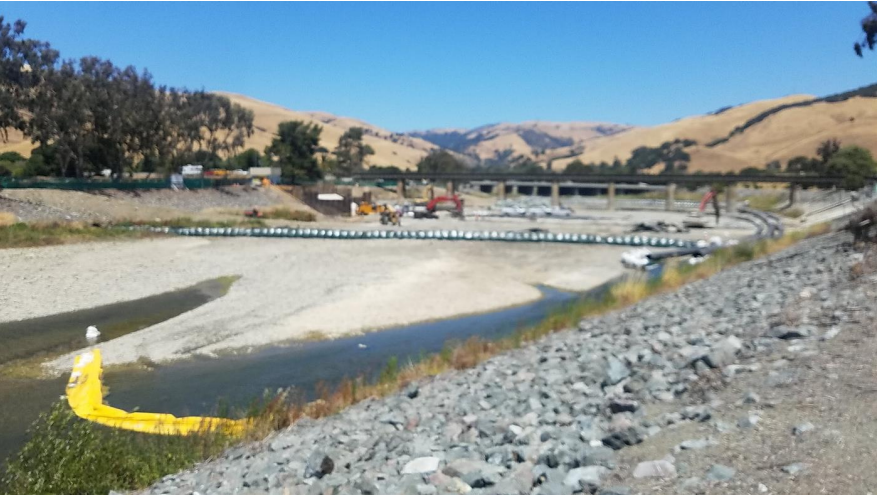
<p>Inspect ID: ALLB_2018_a_0038 Title: USACE_CESPN_ALLB_2018_a_0038_1.jpg Rated Item: 1. Vegetation and Obstructions Caption: Rating: Acceptable; Remarks: Active construction in the channel of the project segment.; Action: NA; Station_1: 577+00</p>

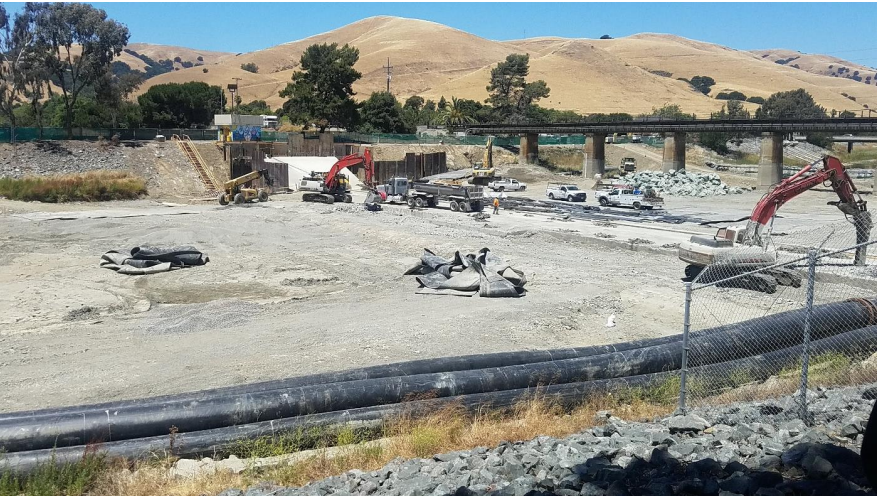
<p>Inspect ID: ALLB_2018_a_0038 Title: USACE_CESPN_ALLB_2018_a_0038_2.jpg Rated Item: 1. Vegetation and Obstructions Caption: Rating: Acceptable; Remarks: Active construction in the channel of the project segment.; Action: NA; Station_1: 577+00</p>

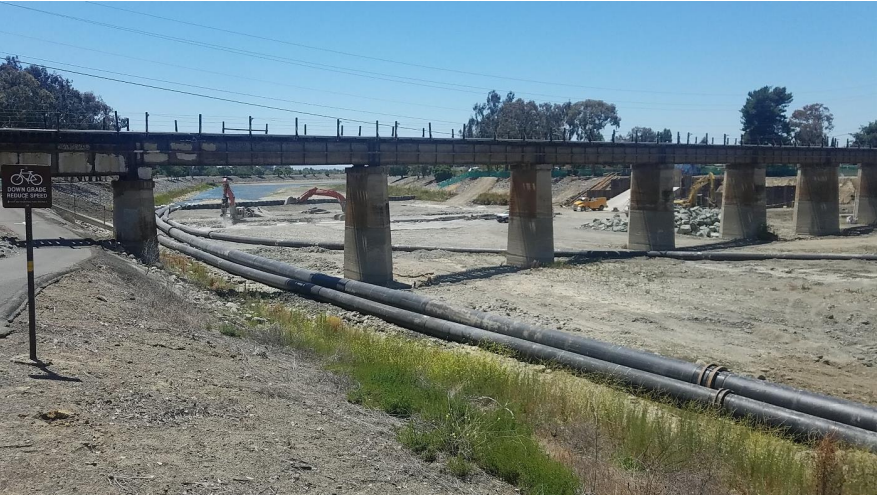
<p>Inspect ID: ALLB_2018_a_0038 Title: USACE_CESPN_ALLB_2018_a_0038_3.jpg Rated Item: 1. Vegetation and Obstructions Caption: Rating: Acceptable; Remarks: Active construction in the channel of the project segment.; Action: NA; Station_1: 577+00</p>

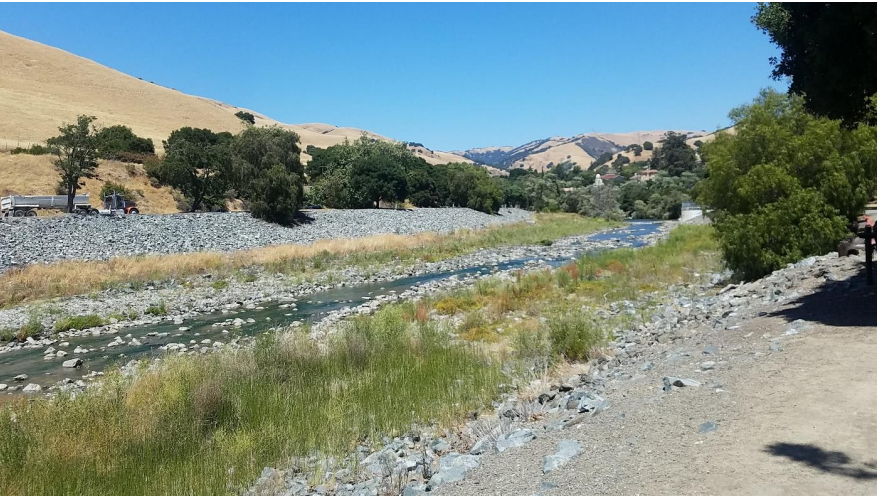
<p>Inspect ID: ALLB_2018_a_0040 Title: USACE_CESPN_ALLB_2018_a_0040_1.jpg Rated Item: 1. Vegetation and Obstructions Caption: Rating: Acceptable; Remarks: Upstream end of the project segment.; Action: NA; Station_1: 606+00</p>

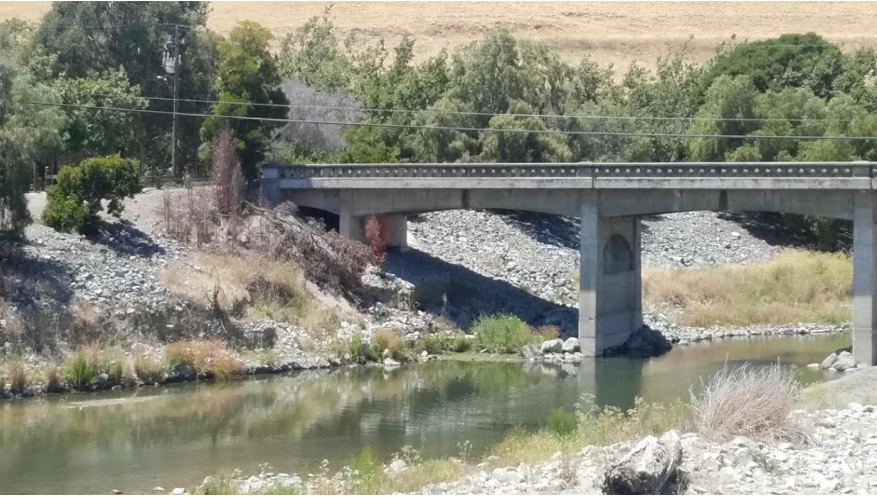
<p>Inspect ID: ALLB_2018_a_0039 Title: USACE_CESPN_ALLB_2018_a_0039_2.jpg Rated Item: 4. Erosion Caption: Rating: Acceptable; Remarks: Old Canyon Bridge.; Action: NA; Station_1: 594+00</p>

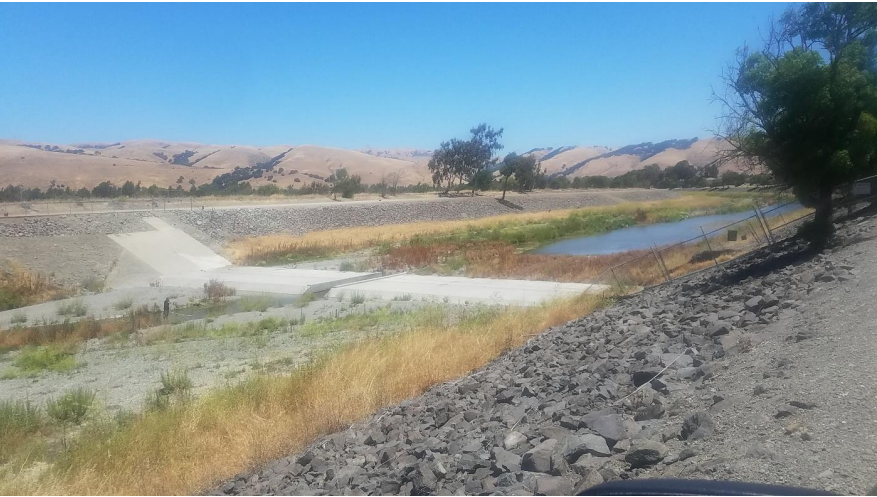
<p>Inspect ID: ALLB_2018_a_0031 Title: USACE_CESPN_ALLB_2018_a_0031_1.jpg Rated Item: 5. Concrete Surfaces Caption: Rating: Acceptable; Remarks: The grade control structure was in good condition.; Action: NA; Station_1: 491+00</p>
