Levee Inspection Report

Name of System: Alameda Zone 03A, Line B - Ward Creek (wDCR)
 Name of Segment: Alameda Zone 03A, Line B - Ward Creek (wDCR)
 NLD System ID: 5305001100 NLD Segment ID: 5304001100

Segment Type: Non-Federally Constructed, local O&M
 Levee Sponsor (Name and Organization): Alameda County Flood Control and Conservation District
 Inspection Report Prepared by: Patrick Sing, PE Date(s) of Inspection: 09/03/2020 - 09/03/2020

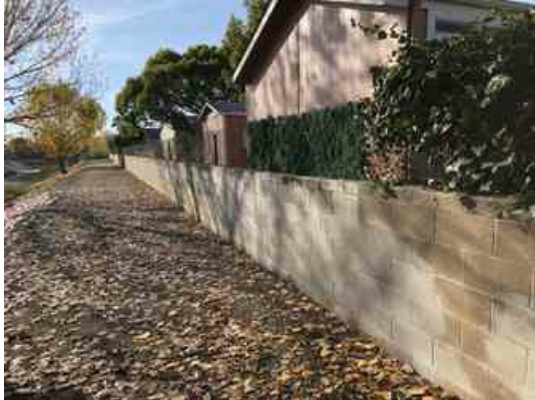
<p>Inspect ID: 2020-0030 Title: 5304001100_CESPN_2020_A_0030_1_20201218T212257.jpg Rated Item: 2. Encroachments Caption: Minimally Acceptable - Units of the mobile home park and an electricity pole are within 15 ft of the land side of the flood wall. Looking upstream in the photo. (O&M Manual Station 36+00)</p>

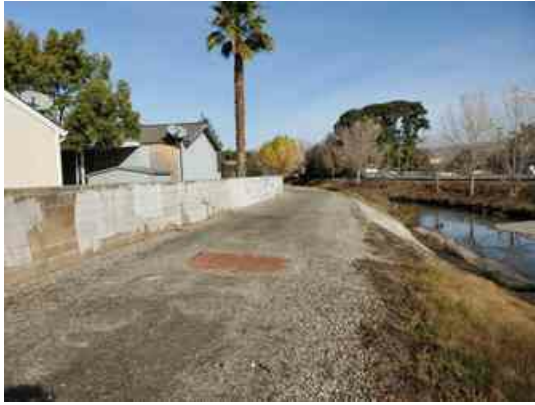
<p>Inspect ID: 2020-0033 Title: 5304001100_CESPN_2020_A_0033_1_20201219T003835.jpg Rated Item: 2. Encroachments Caption: Minimally Acceptable - Units of the mobile home park are within 15 ft of the land side of the flood wall. Looking downstream in the photo. (O&M Manual Station 42+00)</p>

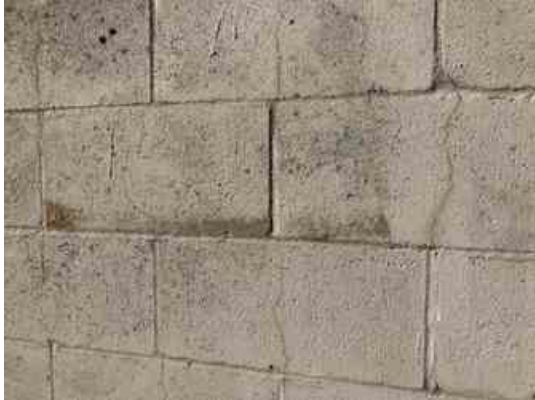
<p>Inspect ID: 2020-0034 Title: 5304001100_CESPN_2020_A_0034_1_20201221T213740.jpg Rated Item: 2. Encroachments Caption: Minimally Acceptable - Units of the mobile home park are within 15 ft of the land side of the flood wall. Looking upstream in the photo. (O&M Manual Station 38+00)</p>

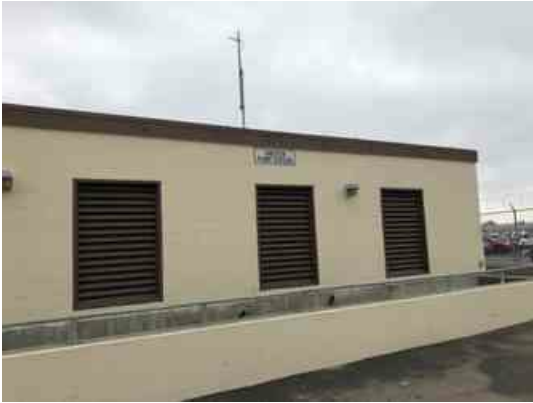
4. Concrete Surfaces	A	A	Negligible spalling, scaling or cracking. If the concrete surface is weathered or holds moisture, it is still satisfactory but should be seal coated to prevent freeze/ thaw damage.	2020-0031 : Minor cracking was observed in the water side of the flood wall at this location. (O&M Manual Station 31+00) (A) Justification: The minor cracking shown in point #31 is representative of other cracks that were observed through the entire flood wall. Sponsor should monitor the cracks and apply seal when necessary.
		M	Spalling, scaling, and open cracking present, but the immediate integrity or performance of the structure is not threatened. Reinforcing steel may be exposed. Repairs/ sealing is necessary to prevent additional damage during periods of thawing and freezing.	
		U	Surface deterioration or deep cracks present that may result in an unreliable structure. Any surface deterioration that exposes the sheet piling or lies adjacent to monolith joints may indicate underlying reinforcement corrosion and is unacceptable.

<p>Inspect ID: 2020-0031 Title: 5304001100_CESPN_2020_A_0031_1_20201219T000921.jpg Rated Item: 4. Concrete Surfaces Caption: Acceptable - Minor cracking was observed in the water side of the flood wall at this location. (O&M Manual Station 31+00)</p>

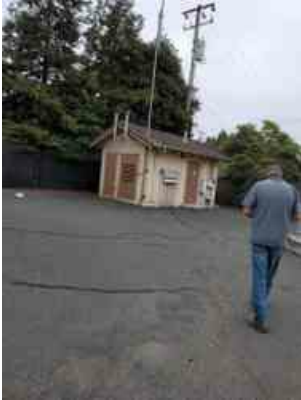
5. Plant Building	A	A	The building is in good structural condition with no major foundation settlement problems. The roof is not leaking, intake & exhaust louvers are clear of debris, fans are operational, etc.	2020-0025 : The building for the Ameron Pump Station was observed to be in good condition. (O&M Manual Station 16+00) (A) 2020-0026 : The building for the Stratford Pump Station was observed to be in good condition. (O&M Manual Station 22+00) (A)
		M	There are minor structural defects, minimal foundation settlement, leaks, or other conditions noted that need repair. Defects do not threaten the structural integrity or stability of the building, and will not impact pumping operations.	
		U	The structural integrity or stability of the building is threatened, or there is damage to the building that threatens safety of the operator or impacts pumping operations.

<p>Inspect ID: 2020-0025 Title: 5304001100_CESPN_2020_A_0025_1_20200924T223146.jpg Rated Item: 5. Plant Building Caption: Acceptable - The building for the Ameron Pump Station was observed to be in good condition. (O&M Manual Station 16+00)</p>

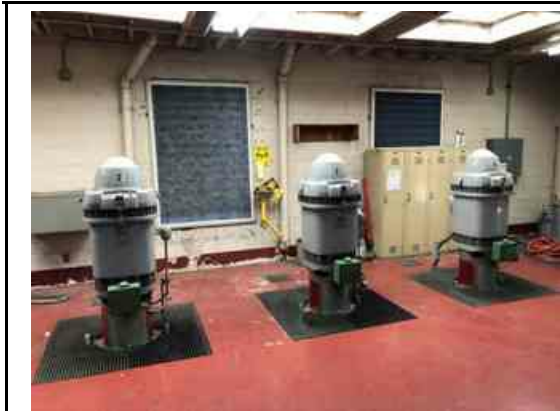
<p>Inspect ID: 2020-0026 Title: 5304001100_CESPN_2020_A_0026_1_20201001T000049.jpg Rated Item: 5. Plant Building Caption: Acceptable - The building for the Stratford Pump Station was observed to be in good condition. (O&M Manual Station 22+00)</p>

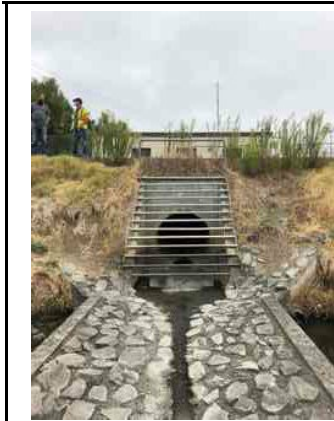
11. Non-Mechanical Trash Racks	A	A	Trash racks are fastened in place and properly maintained.	2020-0009 : Trash rack for the inlet of Ameron Pump Station is properly fastened in place. Trash that has accumulated on the rack should be removed by the sponsor. (O&M Manual Station 16+00) (A) 2020-0027 : The trash rack for the outlet of Ameron Pump Station is properly fastened in place and free of any visible trash. (O&M Manual Station 16+00) (A)
		M	Trash racks are in place but are unfastened or have bent bars that allow debris to enter into the pipe or pump station, bars are corroded to the point that up to 10% of the sectional area may be lost. Repair or replacement is required.	
		U	Trash racks are missing or damaged to the extent that they are no longer functional and must be replaced. (For example, more than 10% of the sectional area may be lost.)	
		N/A	There are no trash racks, or they are covered in the pump stations section of the report.

Inspect ID: 2020-0009 **Title:** 5304001100_CESPN_2020_A_0009_1_20200903T180538.jpg **Rated Item:** 11. Non-Mechanical Trash Racks **Caption:** Acceptable - Trash rack for the inlet of Ameron Pump Station is properly fastened in place. Trash that has accumulated on the rack should be removed by the sponsor. (O&M Manual Station 16+00)

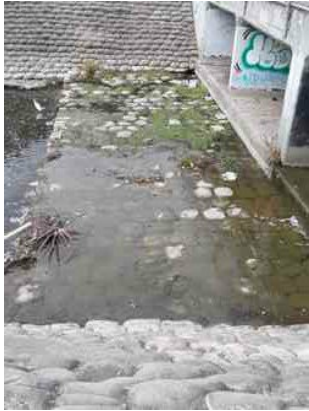
Inspect ID: 2020-0001 **Title:** 5304001100_CESPN_2020_A_0001_2_20200903T172634.jpg **Rated Item:** 1. Vegetation and Obstructions **Caption:** Acceptable - The channel bottom at this location is free of any significant obstructions. There are some trees that overhang the channel. Sponsor should monitor the growth of the trees to ensure their branches do not grow in size and become barriers to flow within the channel. (O&M Manual Station 129+29)

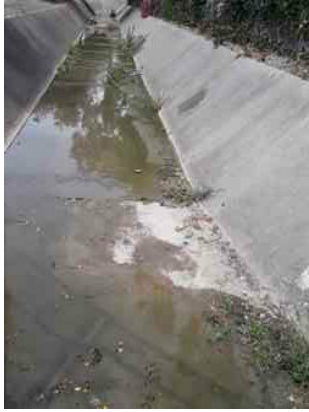
<p>Inspect ID: 2020-0013 Title: 5304001100_CESPN_2020_A_0013_1_20200903T184904.jpg Rated Item: 1. Vegetation and Obstructions Caption: Acceptable - The channel bottom at this location is free of any significant obstructions. Photo is downstream of Folsom Avenue. (O&M Manual Station 46+00)</p>

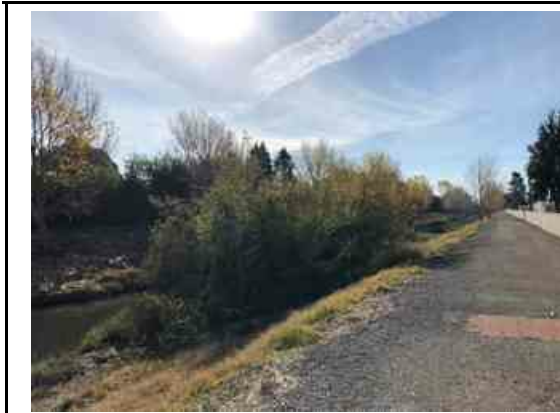
<p>Inspect ID: 2020-0018 Title: 5304001100_CESPN_2020_A_0018_1_20200903T191239.jpg Rated Item: 1. Vegetation and Obstructions Caption: Acceptable - The channel bottom at this location is free of any significant obstructions. There are some trees that overhang the channel. Sponsor should monitor the growth of the trees to ensure their branches do not grow in size and become barriers to flow within the channel. (O&M Manual Station 72+00)</p>

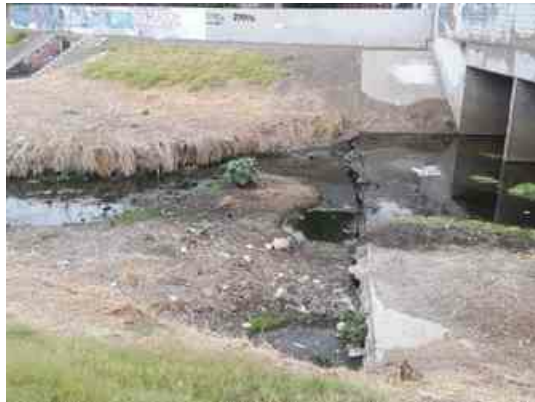
Inspect ID: 2020-0032 **Title:**

5304001100_CESPN_2020_A_0032_1_20201219T002327.jpg **Rated**

Item: 1. Vegetation and Obstructions **Caption:** Minimally Acceptable - A large bush exists on the right channel slope at this location. This bush should be removed before it grows further in size and causes a significant reduction in channel capacity. Looking downstream in the photo. (O&M Manual Station 38+00)

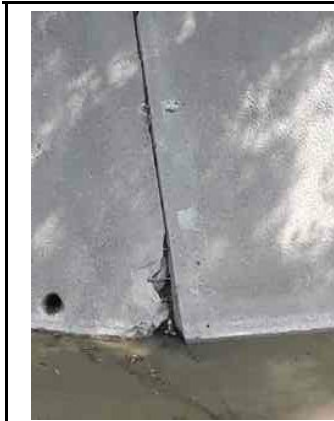
<p>Inspect ID: 2020-0017 Title: 5304001100_CESPN_2020_A_0017_1_20200903T185921.jpg Rated Item: 5. Concrete Surfaces Caption: Minimally Acceptable - Concrete apron in the middle of the channel at this location within the segment was free of any obstructions. (O&M Manual Station 38+00)</p>

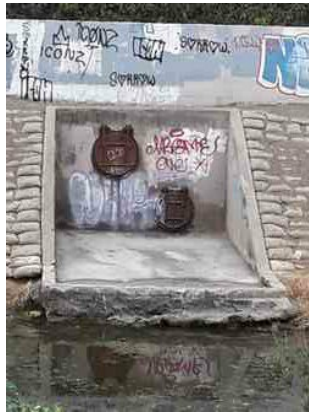
Inspect ID: 2020-0019 **Title:** 5304001100_CESPN_2020_A_0019_1_20200903T191635.jpg **Rated Item:** 5. Concrete Surfaces **Caption:** Minimally Acceptable - Looking at the bottom of the left channel slope at this location. Deteriorated concrete and exposed rebar was observed. (O&M Manual Station 77+00)

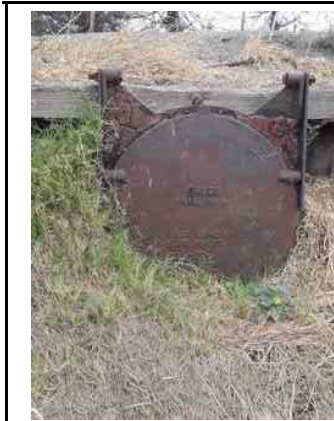
Inspect ID: 2020-0003 **Title:** 5304001100_CESPN_2020_A_0003_1_20200903T174407.jpg **Rated Item:** 9. Flap Gates/ Flap Valves/ Pinch Valves **Caption:** Minimally Acceptable - Flap gates for culverts on the right channel slope at this location within the system were free of obstructions. (O&M Manual Station 22+00)
