# NAPA RIVER LEFT BANK ABOVE TULOCAY CREEK LEVEE

NAPA RIVER/NAPA CREEK FLOOD PROTECTION PROJECT  
NAPA, CALIFORNIA  
NLD SYSTEM ID NO. 5305000080; SEGMENT ID NO. 5304000080

PERIODIC INSPECTION REPORT NO. 1  
SEPTEMBER 2020

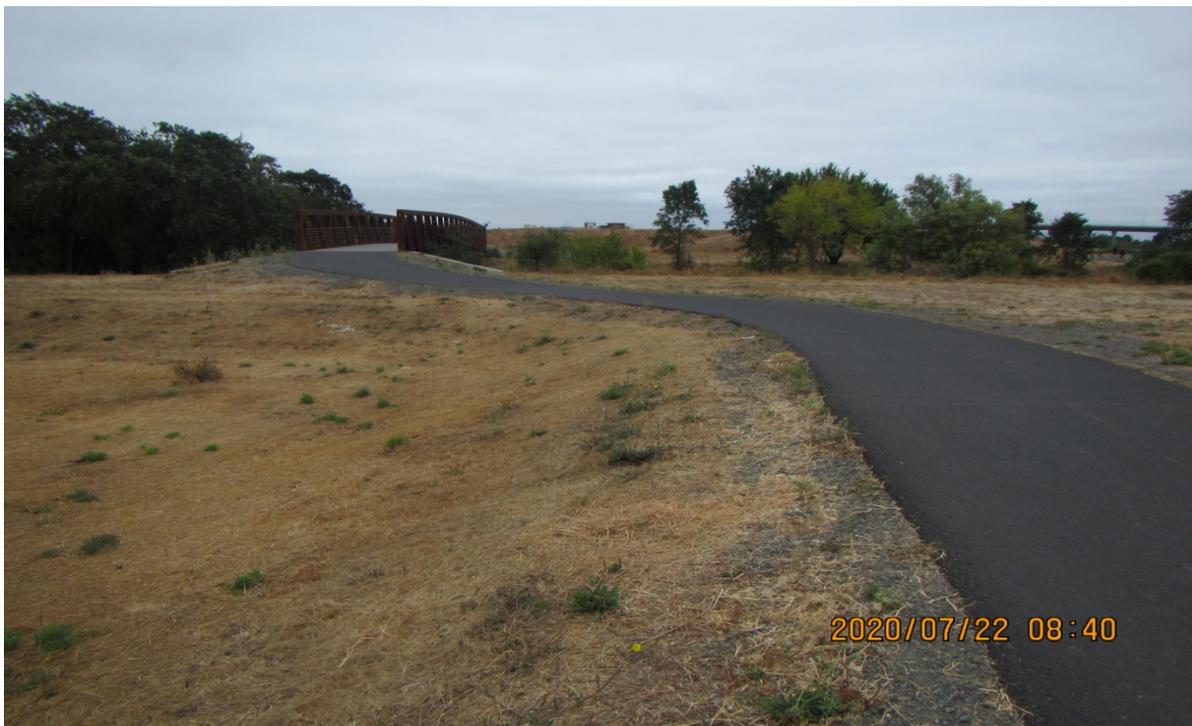
This item was rated “acceptable”. No encroachments were noted during the inspection.

**Figure 5-1: Inspection Point NLT1\_2020\_a\_0001: Downstream end of levee segment.**

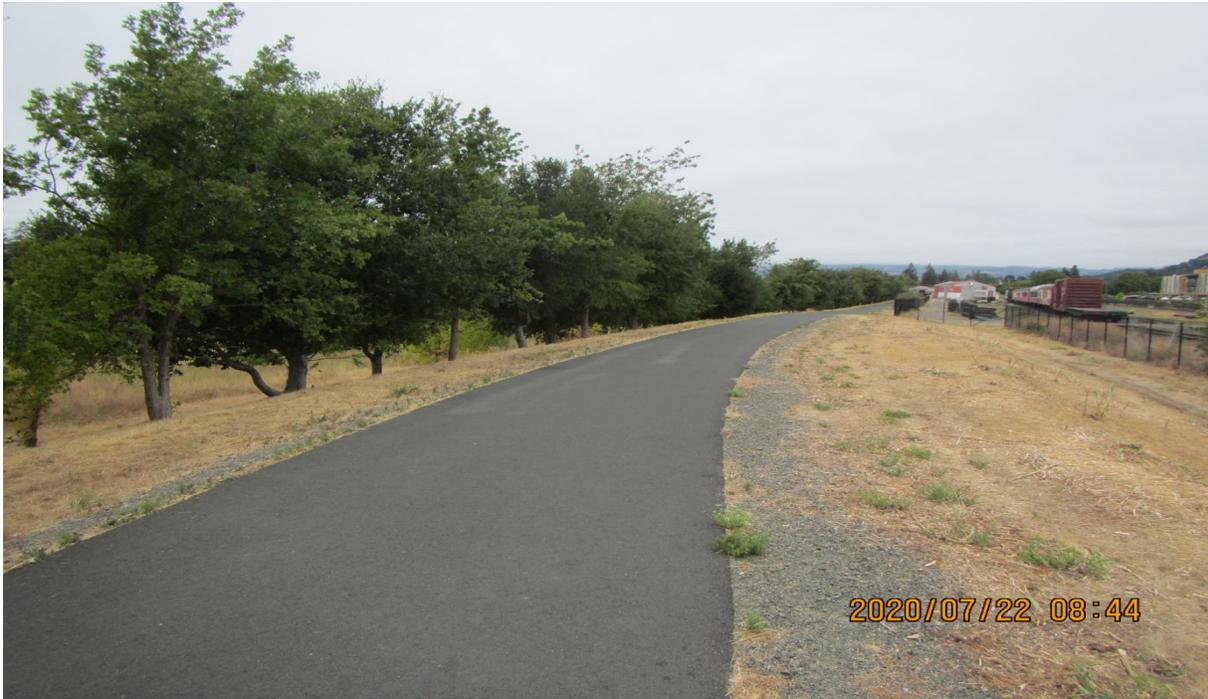
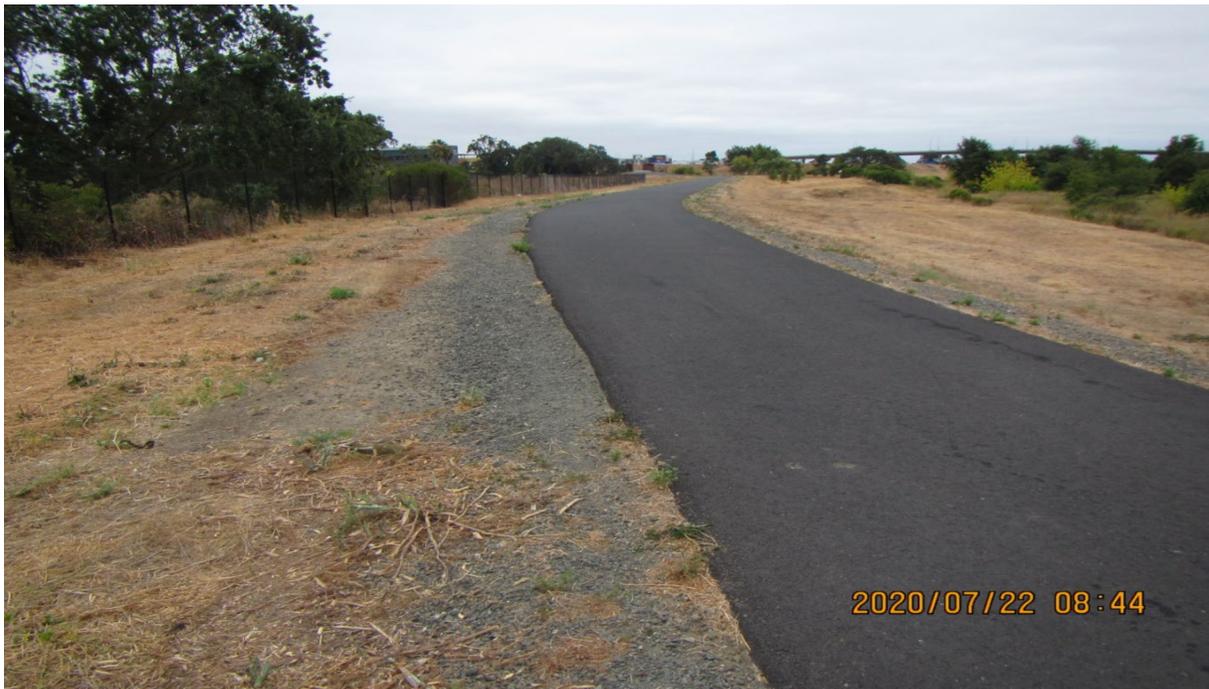
This item was rated “acceptable”. NLT1\_2020\_a\_0002: Drop in crown elevation for the last 200 feet needs to be monitored.

**Figure 5-2: Inspection Point NLT1\_2020\_a\_0002: Drop in crown elevation.**

**Figure 5-3: Inspection Point NLT1\_2020\_a\_0002: Drop in crown elevation.**

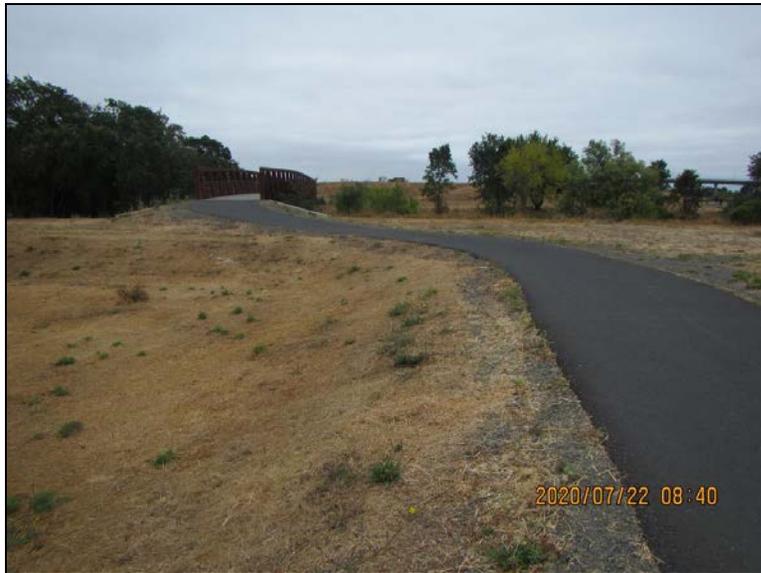
**Inspect ID:** NLT1\_2020\_a\_0001 **Title:** USACE\_CESPN\_NLT1\_2020\_a\_0001\_1.jpg  
**Rated Item:** 3. Encroachments **Caption:** Rating: Acceptable; Remarks: Upstream end of levee segment.; Action: No action required at this time.

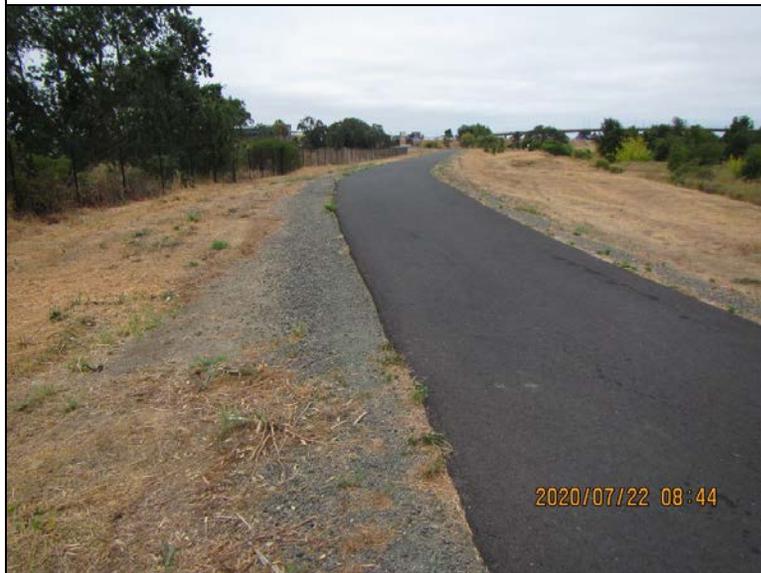
**Inspect ID:** NLT1\_2020\_a\_0002 **Title:** USACE\_CESPN\_NLT1\_2020\_a\_0002\_1.jpg  
**Rated Item:** 6. Erosion/ Bank Caving **Caption:** Rating: Acceptable; Remarks: Drop in crown elevation for the last 200 feet.; Action: Monitor.

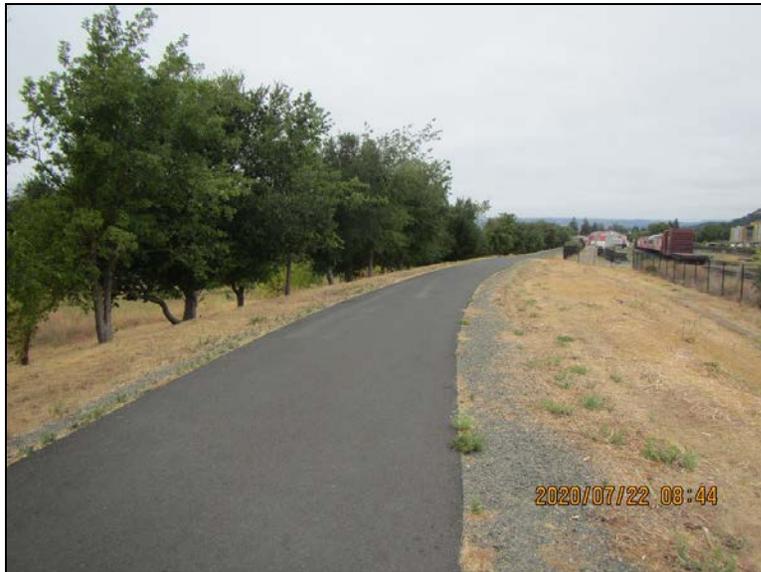
**Inspect ID:** NLT1\_2020\_a\_0002 **Title:** USACE\_CESPN\_NLT1\_2020\_a\_0002\_2.jpg  
**Rated Item:** 6. Erosion/ Bank Caving **Caption:** Rating: Acceptable; Remarks: Drop in crown elevation for the last 200 feet.; Action: Monitor.
