Flood Damage Reduction Segment / System Inspection Report

Name of Segment/ System: Lion Creek, INCR (Zone 12, Line E)

Public Sponsor(s): Alameda County Flood Control & Water Conservation District

Corps of Engineers Inspector: George Fong, PE; Joshua Miller Inspection Start Date: 8/09/2020

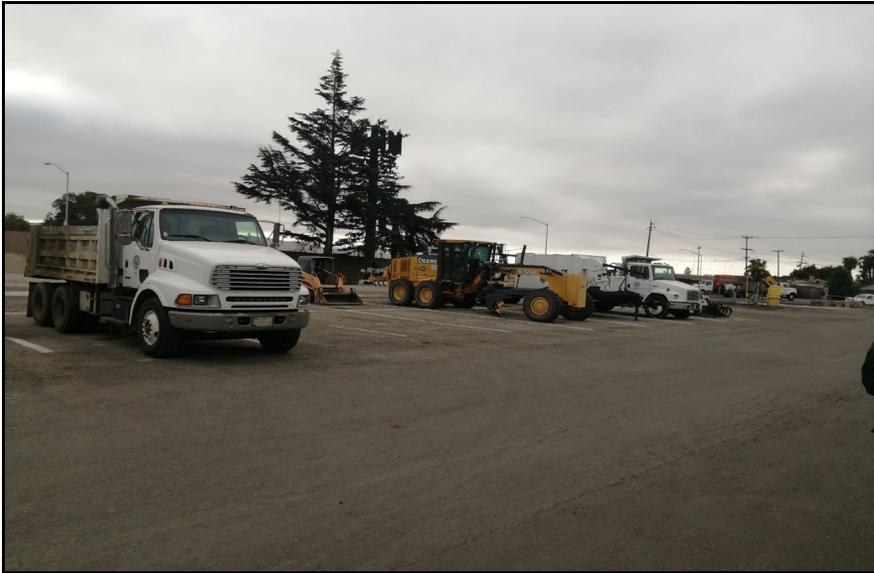
Inspect ID: INCR_2020_a_0017 **Title:** USACE_CESPN_INCR_2020_a_0008_1.jpg
Rated Item: 2. Emergency Supplies and Equipment (A or M only) **Caption:** Rating: Acceptable; Remarks: Emergency supplies and equipment are stored at the Sponsor's maintenance yard at 951 Turner Ct., Hayward, CA 94545. Equipment includes, but not limited to dozers, water tank, and trucks.

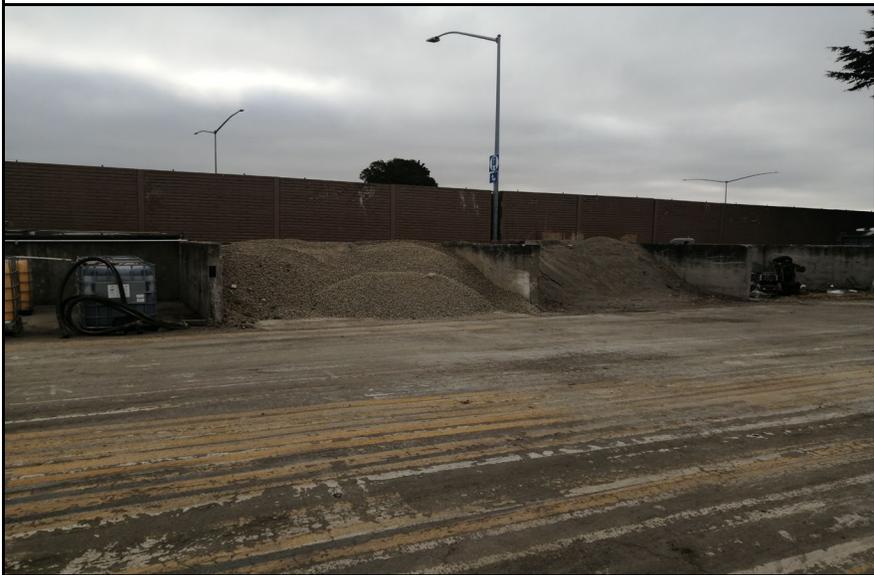
Inspect ID: INCR_2020_a_0017 **Title:** USACE_CESPN_INCR_2020_a_0008_2.jpg
Rated Item: 2. Emergency Supplies and Equipment (A or M only) **Caption:** Rating: Acceptable; Remarks: Emergency supplies and equipment are stored at the Sponsor's maintenance yard at 951 Turner Ct., Hayward, CA 94545. Supplies includes, but not limited to sand, base rock, and riprap.

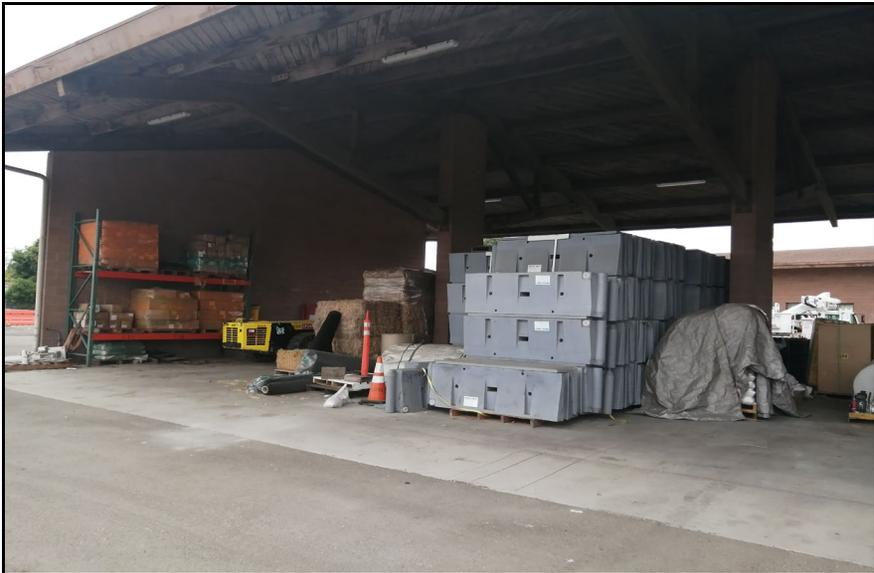
Inspect ID: INCR_2020_a_0017 **Title:** USACE_CESPN_INCR_2020_a_0017_3.jpg
Rated Item: 2. Emergency Supplies and Equipment (A or M only) **Caption:** Rating: Acceptable; Remarks: Emergency supplies and equipment are stored at the Sponsor's maintenance yard at 951 Turner Ct., Hayward, CA 94545 . Supplies includes, but not limited to wood stacks, polyethylene sheeting, and haybales.

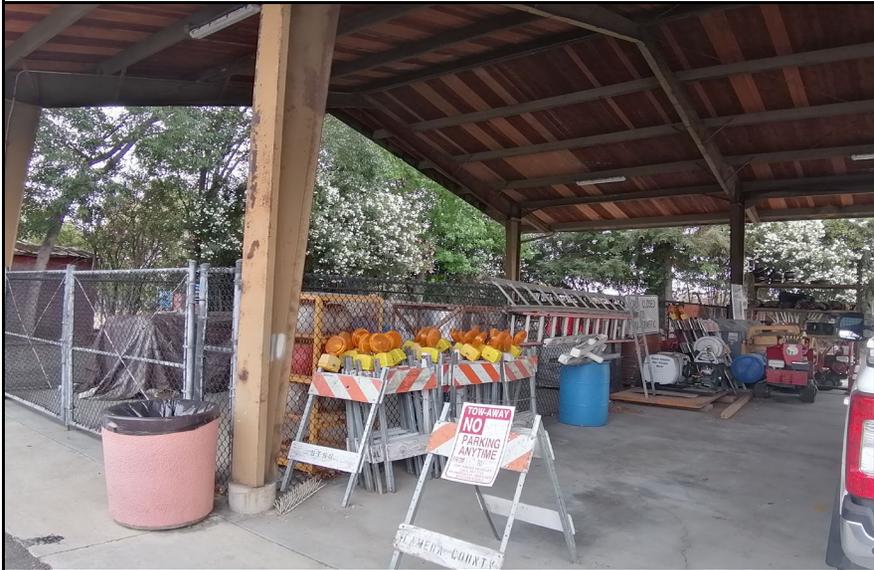
Inspect ID: INCR_2020_a_0017 **Title:** USACE_CESPN_INCR_2020_a_0017_4.jpg
Rated Item: 2. Emergency Supplies and Equipment (A or M only) **Caption:** Rating: Acceptable; Remarks: Emergency supplies and equipment are stored at the Sponsor's maintenance yard at 951 Turner Ct., Hayward, CA 94545. Equipment includes, but not limited to ladders, wheelbarrows, and construction signs.

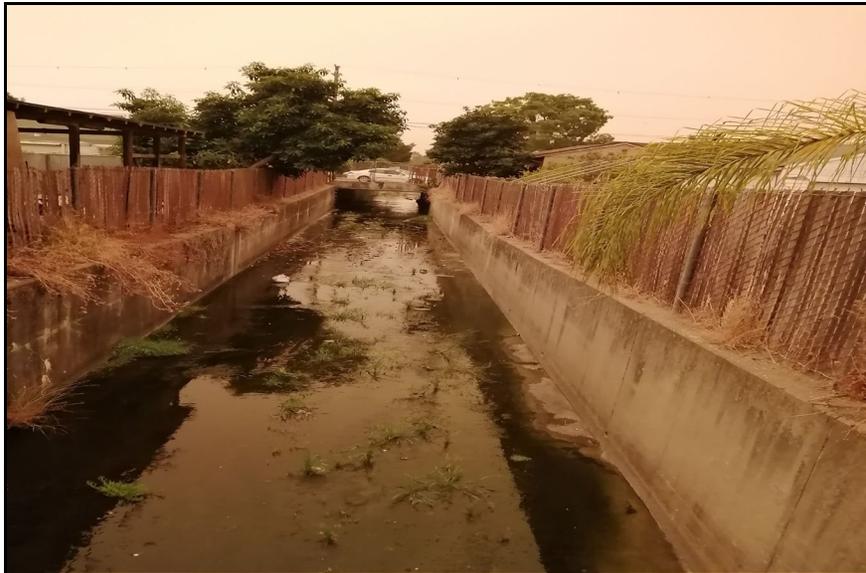
| Rated Item | Rating | Rating Guidelines | | Location/Remarks/Recommendations |
|--|---|---|---|---|
| 1. Vegetation and Obstructions | M | A | No obstructions, vegetation, debris, or sediment accumulation within the channel. Concrete channel joints and weep holes are free of grass and weeds. | INCR_2020_a_0001, _STA 27+00 Looking downstream at channel along the section. Large tree branches overhanging was observed on south side of the channel section. (M) The overhanging vegetation should be trimmed back to the fence lines.; Station_1: 27+00 INCR_2020_a_0002, _STA 21+80. Photo shows the upstream of project, looking downstream approximately 0.5' to 1' thick vegetated shoal spans 15% of the width of the concrete channel. (M) The shoal should be removed if it reduces capacity in a high flow event. INCR_2020_a_0005, STA 6+00 Photo is looking upstream at bridge of San Leandro Street, trash, debris, and other obstructions present within the channel and easement area were observed. The unwanted items in the channel should be removed. |

Inspect ID: INCR_2020_a_0001 **Title:** USACE_CESPN_INCR_2020_a_0001_1.jpg
Rated Item: 1. Vegetation and Obstructions **Caption:** Rating: Minimally Acceptable;
Remarks: Looking downstream at channel along the section. Large tree branches overhanging was observed on south side of the channel section.; **Action:** The overhanging vegetation should be trimmed back to the fence lines.; **Station_1:** 27+00

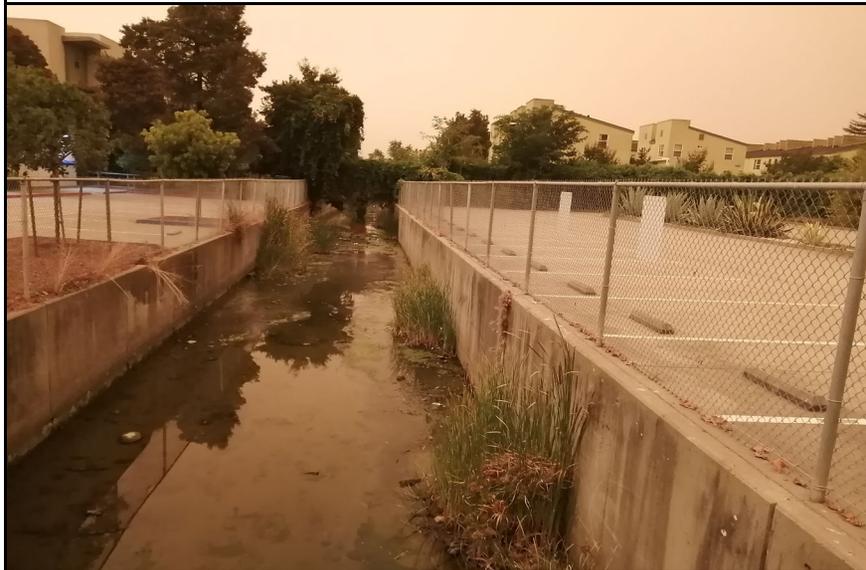
Inspect ID: INCR_2020_a_0002 **Title:** USACE_CESPN_INCR_2020_a_0002_1.jpg
Rated Item: 1. Vegetation and Obstructions **Caption:** Rating: Minimally Acceptable;
Remarks: Photo shows the upstream of project, looking downstream approximately 0.5' to 1' thick vegetated shoal spans 15% of the width of the concrete channel. ; **Action:** The shoal should be removed if it reduces capacity in a high flow event; **Station_1:** 21+80

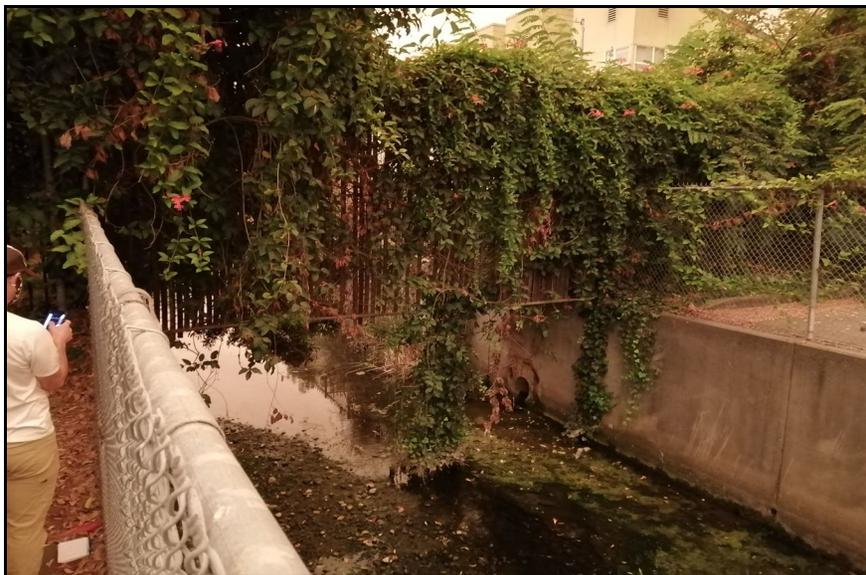
Inspect ID: INCR_2020_a_0003 **Title:** USACE_CESPN_INCR_2020_a_0003_1.jpg
Rated Item: 3. Encroachments **Caption:** Rating: Unacceptable; Remarks: Chain-link fence built across the top of channel was observed ; Action: A Section 408 Modification request should be submitted to the Corps for approval.; Station_1: 20+50

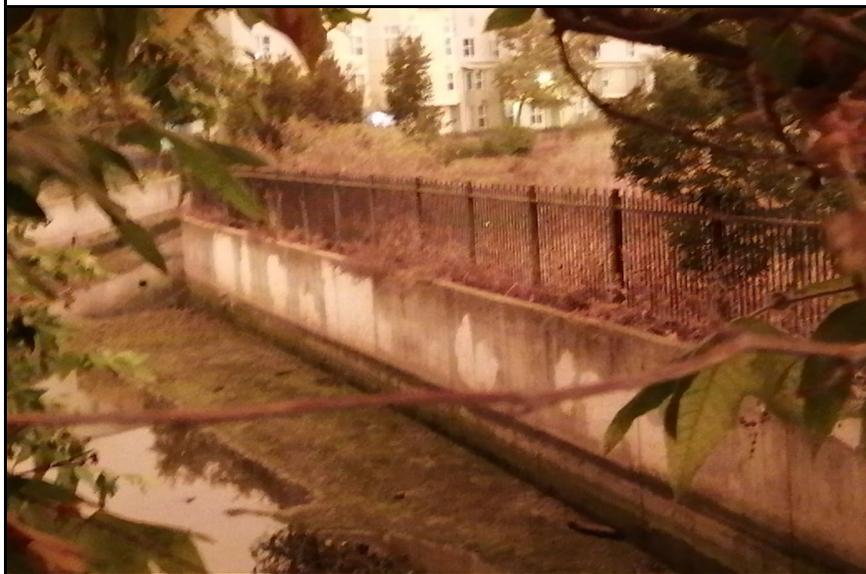
| Rated Item | Rating | Rating Guidelines | | Location/Remarks/Recommendations |
|---|---|---|--|--|
| 5. Concrete Surfaces | A | A | Negligible spalling, scaling or cracking. If the concrete surface is weathered or holds moisture, it is still satisfactory but should be seal coated to prevent freeze/ thaw damage. | INCR_2020_a_0004_STA 14+00. Photo is looking upstream at U-shape concrete channel, there was no sign of spalling, scaling or cracking. within the channel cross-section. (A) |

Inspect ID: INCR_2020_a_0004 **Title:** USACE_CESPN_INCR_2020_a_0004_1.jpg
Rated Item: 5. Concrete Surfaces **Caption:** Rating: Acceptable; Remarks: Photo is looking upstream at U-shape concrete channel, there was no sign of spalling, scaling or cracking. within the channel cross-section.; Station_1: 14+00

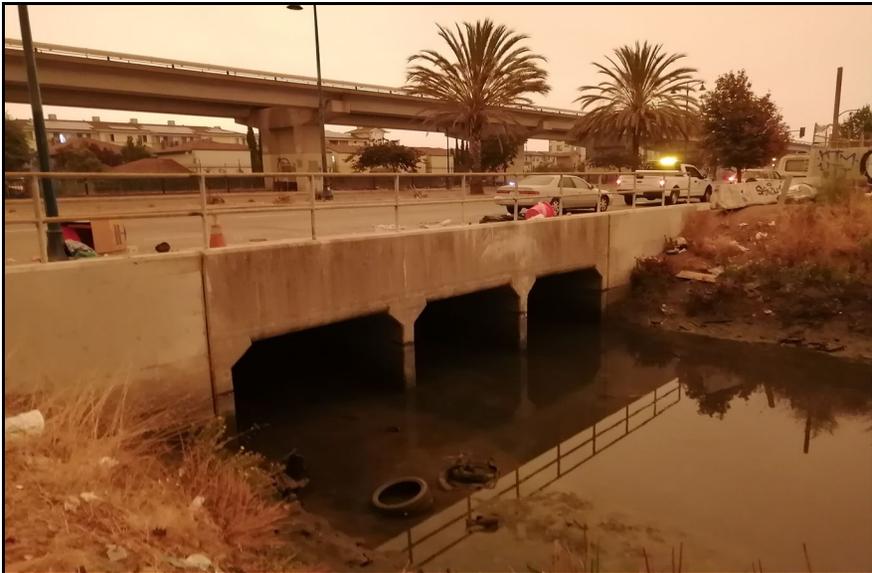
Inspect ID: INCR_2020_a_0005 **Title:** USACE_CESPN_INCR_2020_a_0005_1.jpg
Rated Item: 3. Encroachments **Caption:** Rating: Minimally Acceptable; Remarks: Photo is looking upstream at bridge of San Leandro Street, trash, debris, and other obstructions present within the channel and easement area were observed; Action: the unwanted items should be removed.; Station_1: 6+00

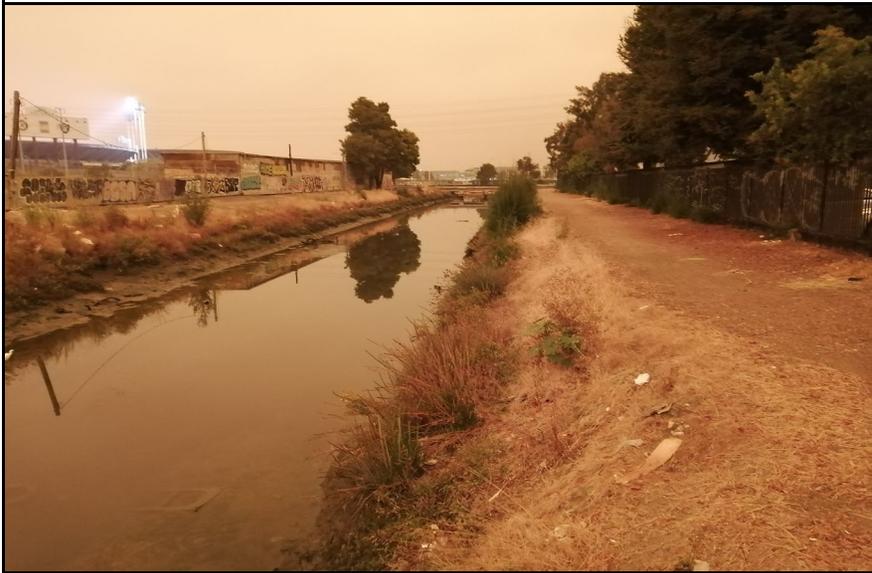
| Rated Item | Rating | Rating Guidelines | | Location/Remarks/Recommendations |
|---|---|---|--|--|
| 4. Erosion | A | A | No head cutting or horizontal deviation observed. | INCR_2020_a_0006, STA 4+00. No erosion was observed. (A) |

Inspect ID: INCR_2020_a_0006 **Title:** USACE_CESPN_INCR_2020_a_0006_1.jpg
Rated Item: 4. Erosion **Caption:** Rating: Acceptable; Remarks: No erosion was observed; Station_1: 4+00

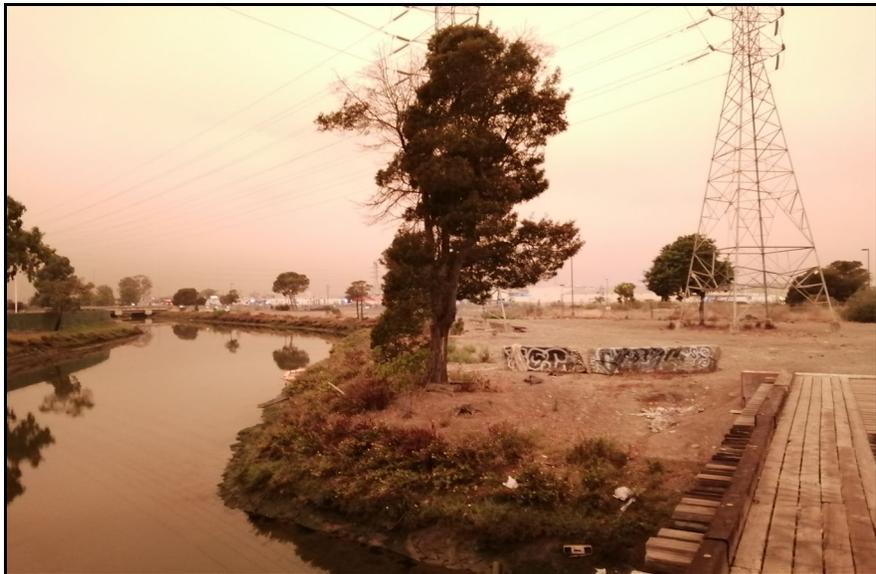
| Rated Item | Rating | Rating Guidelines | | Location/Remarks/Recommendations |
|---|---|---|--|--|
| | | U | Head cutting and horizontal deviation of more than 1 foot from the designed grade or cross section. Corrective actions required to stop or slow erosion. | INCR_2020_a_0007, STA 1+00_ No erosion was observed. (A) |

Inspect ID: INCR_2020_a_0007 **Title:** USACE_CESPN_INCR_2020_a_0007_1.jpg
Rated Item: 4. Erosion **Caption:** Rating: Acceptable; Remarks: No erosion was observed; Station_1: 1+00
