## Flood Damage Reduction Segment / System Inspection Report

Name of Segment/ System: Seminary Creek, SMNR (Zone 12, Line E)

Public Sponsor(s): Alameda County Flood Control & Water Conservation District

Corps of Engineers Inspector: George Fong, PE; Joshua Miller Inspection Start Date: 8/09/2020

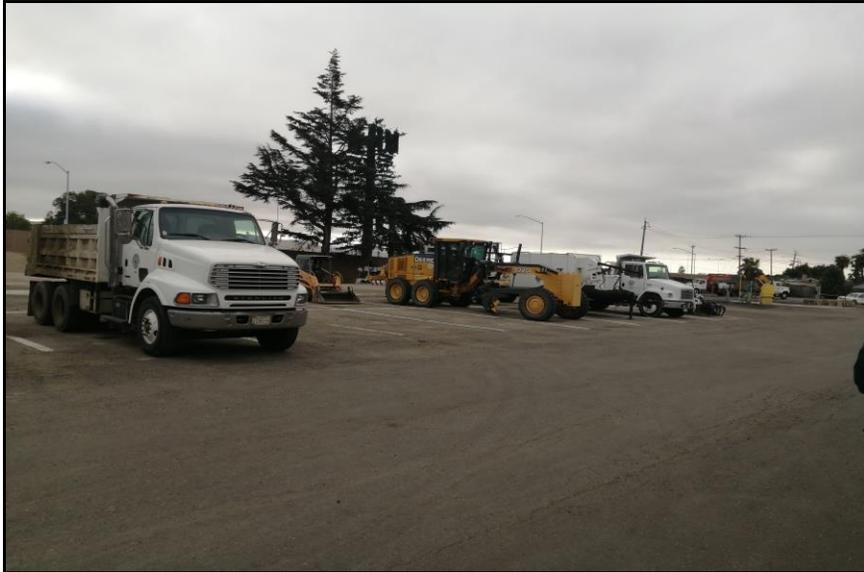
**Inspect ID:** SMNR\_2020\_a\_0017 **Title:** USACE\_CESPN\_SMNR\_2020\_a\_0008\_1.jpg  
**Rated Item:** 2. Emergency Supplies and Equipment (A or M only) **Caption:** Rating: Acceptable; Remarks: Emergency supplies and equipment are stored at the Sponsor's maintenance yard at 951 Turner Ct., Hayward, CA 94545. Equipment includes, but not limited to dozers, water tank, and trucks.; Action: NA; Station\_1:

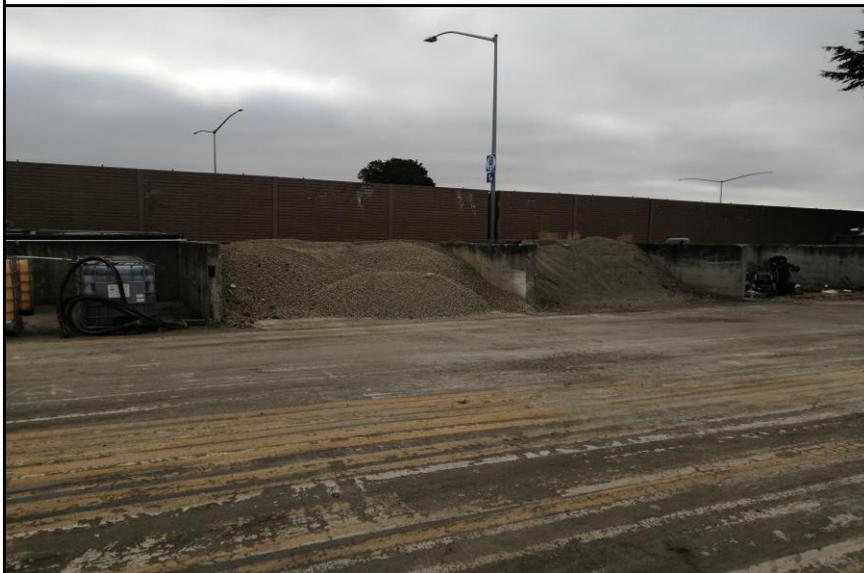
**Inspect ID:** SMNR\_2020\_a\_0017 **Title:** USACE\_CESPN\_SMNR\_2020\_a\_0008\_2.jpg  
**Rated Item:** 2. Emergency Supplies and Equipment (A or M only) **Caption:** Rating: Acceptable; Remarks: Emergency supplies and equipment are stored at the Sponsor's maintenance yard at 951 Turner Ct., Hayward, CA 94545. Supplies includes, but not limited to sand, base rock, and riprap; Action: NA; Station\_1:

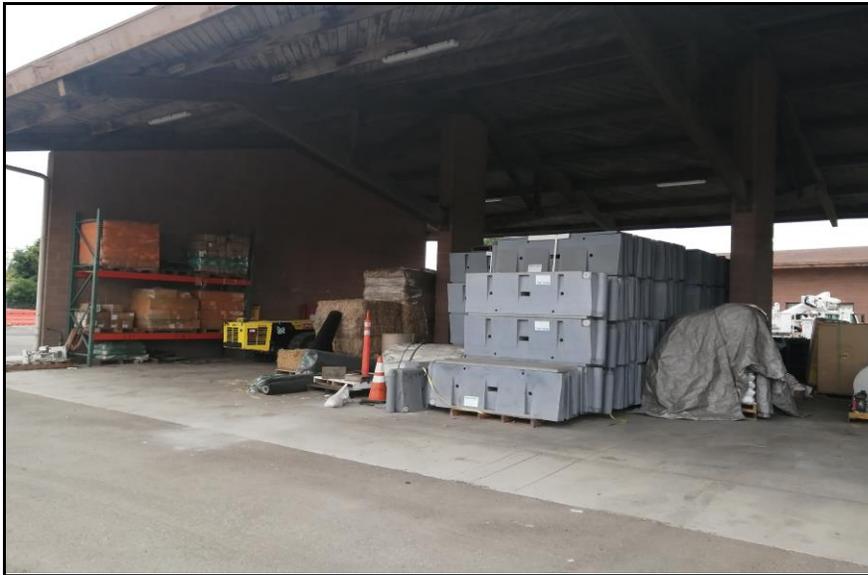
**Inspect ID:** SMNR\_2020\_a\_0017 **Title:** USACE\_CESPN\_SMNR\_2020\_a\_0017\_3.jpg  
**Rated Item:** 2. Emergency Supplies and Equipment (A or M only) **Caption:** Rating: Acceptable; Remarks: Emergency supplies and equipment are stored at the Sponsor's maintenance yard at 951 Turner Ct., Hayward, CA 94545 . Supplies includes, but not limited to wood stacks, polyethylene sheeting, and haybales; Action: NA; Station\_1:

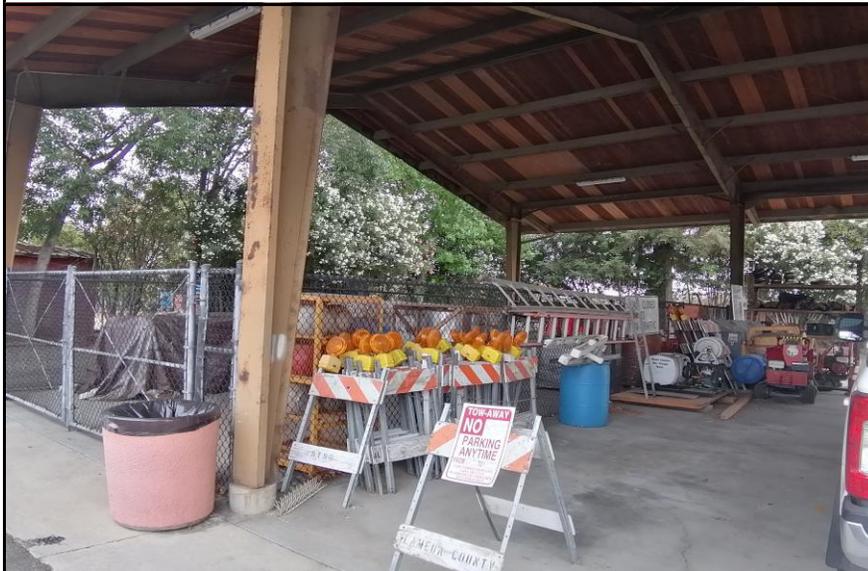
**Inspect ID:** SMNR\_2020\_a\_0017 **Title:** USACE\_CESPN\_SMNR\_2020\_a\_0017\_4.jpg  
**Rated Item:** 2. Emergency Supplies and Equipment (A or M only) **Caption:** Rating: Acceptable; Remarks: Emergency supplies and equipment are stored at the Sponsor's maintenance yard at 951 Turner Ct., Hayward, CA 94545 . Equipment includes, but not limited to ladders, wheelbarrows, and construction signs.; Action: NA; Station\_1:

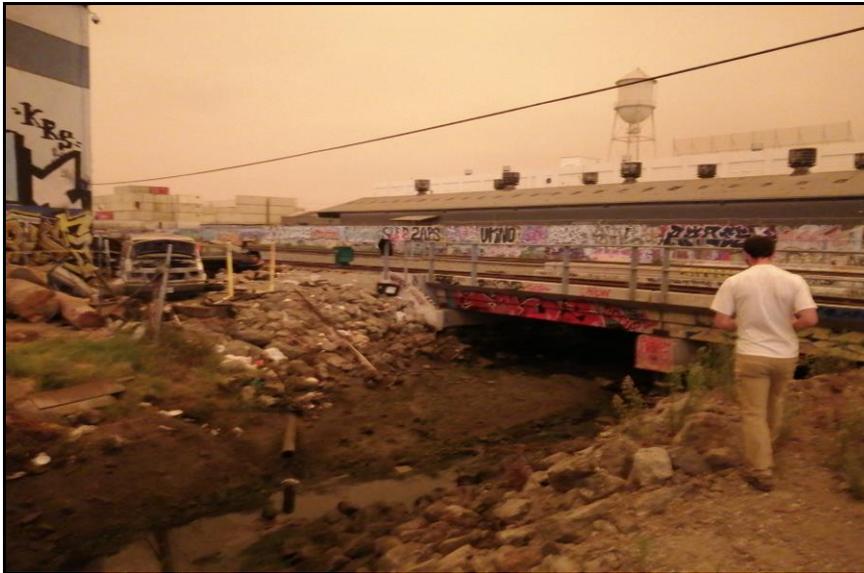
2. Shoaling <sup>1</sup> (sediment deposition)	<b>M</b>	<b>A</b>	No shoaling or minor, non-vegetated shoaling is present.	SMNR_2020_a_0001_1.jpg A shoal that spanned approximately 50% of the channel width under the railroad bridge was observed (M); Action: The Sponsor should remove the sediment and trash in the channel if it reduces channel capacity and may cause a flood in a high flow event.; Station: 25+00 Shoaling was observed throughout the project reaches. The photos and rating are the same as Rated Item 1 of the Table. The impacts of shoaling and vegetation on channel hydraulics are unknowns. Shoals should be monitored and surveyed, and the channel capacity should be checked.
		<b>M</b>	More widespread vegetated and non-vegetated shoaling is present. Non-aquatic grasses are present on shoal. No trees or brush is present on shoal, and channel flow is not significantly reduced. Sediment and debris removal recommended.

**Inspect ID:** SMNR\_2020\_a\_0001 **Title:** USACE\_CESPN\_SMNR\_2020\_a\_0001\_1.jpg  
**Rated Item:** 2. Shoaling (sediment deposition) **Caption:** Rating: Minimally acceptable; Remarks: A shoal that spanned approximately 50% of the channel width under the railroad bridge was observed; Action: The Sponsor should remove if the sediment and trash in the channel reduce channel capacity and may cause a flood in a high flow event.; Station: 25+00

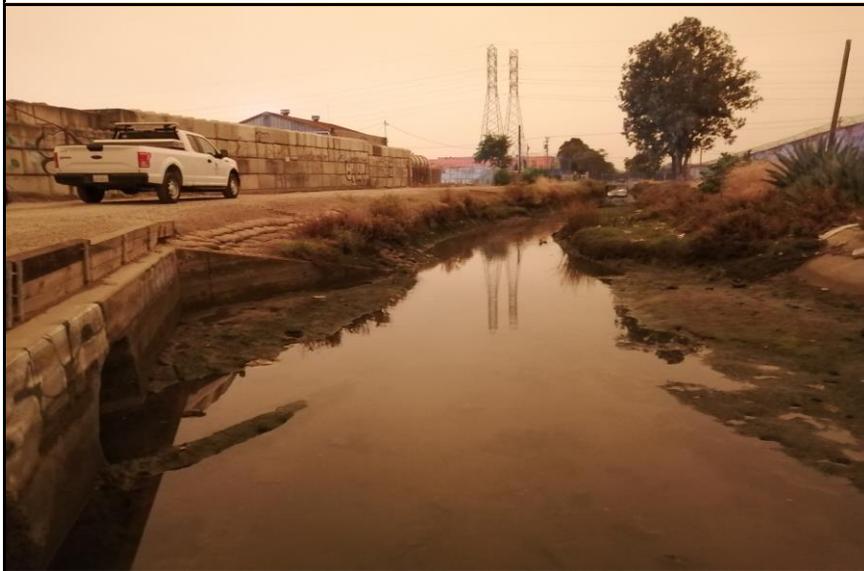
10. Riprap Revetments & Banks	<b>A</b>	<b>A</b>	No riprap displacement or stone degradation that could pose an immediate threat to the integrity of channel bank. Riprap intact with no woody vegetation present.	SMNR_2020_a_0002_1.jpg Photo shows the upstream of project, looking downstream at the banks, no displaced riprap on side slopes was observed.; Station: 23+00
		<b>M</b>	Minor riprap displacement or stone degradation that could pose an immediate threat to the integrity of the channel bank. Unwanted vegetation must be cleared or sprayed with an appropriate herbicide.

**Inspect ID:** SMNR\_2020\_a\_0002 **Title:** USACE\_CESPN\_SMNR\_2020\_a\_0002\_1.jpg  
**Rated Item:** 10 Riprap Revetments & Banks **Caption:** Rating: Acceptable; Remarks: Photo shows the upstream of project, looking downstream at the banks, no displaced riprap on side slopes was observed.; Station: 23+00

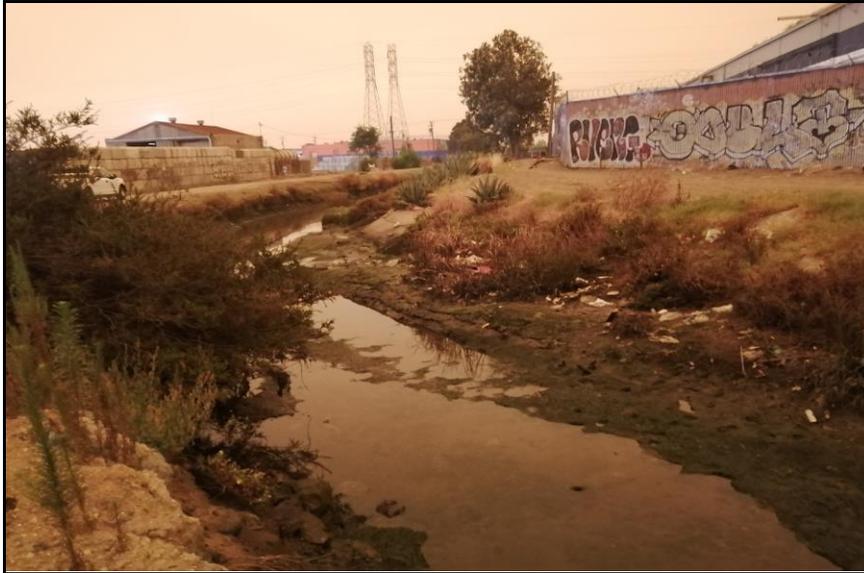
**Inspect ID:** SMNR\_2020\_a\_0003 **Title:** USACE\_CESPN\_SMNR\_2020\_a\_0003\_1.jpg  
**Rated Item:** 1. Vegetation and Obstructions **Caption:** Rating: Minimally Acceptable;  
**Remarks:** Photo is looking downstream at the channel. A vegetated shoal that spanned approximately 30% of the channel width was observed.; **Action:** The shoal should be removed if it reduces channel capacity resulting in flood in a high flow event.;  
**Station:** 21+00

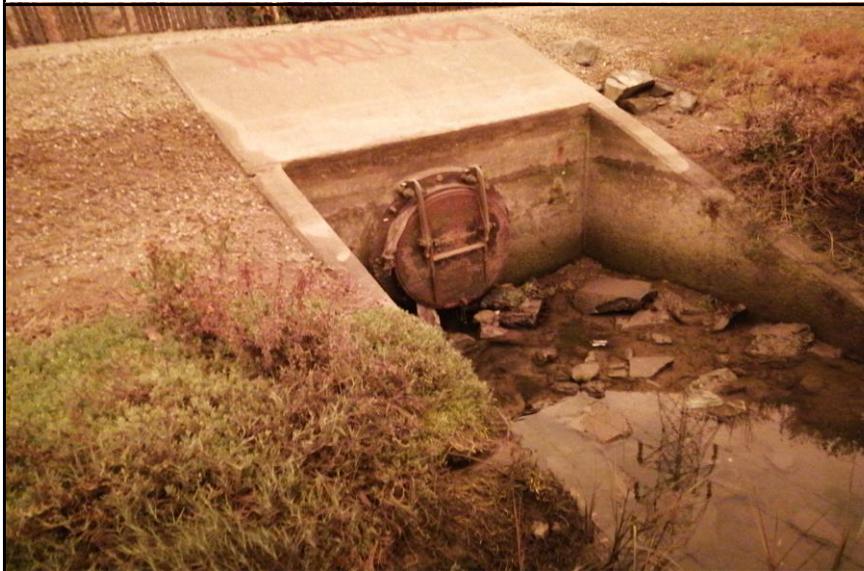
**Inspect ID:** SMNR\_2020\_a\_0004 **Title:** USACE\_CESPN\_SMNR\_2020\_a\_0004\_1.jpg  
**Rated Item:** 11. Culverts / Discharge Pipes **Caption:** Rating: Acceptable; **Remarks:** The culvert flap gate was observed to be in good condition ; **Action:** The Sponsor should perform a video inspection for the culverts every 5 years. At this time the video inspection is not overdue; however, this item should be followed up in next inspection; **Station:** 19+50

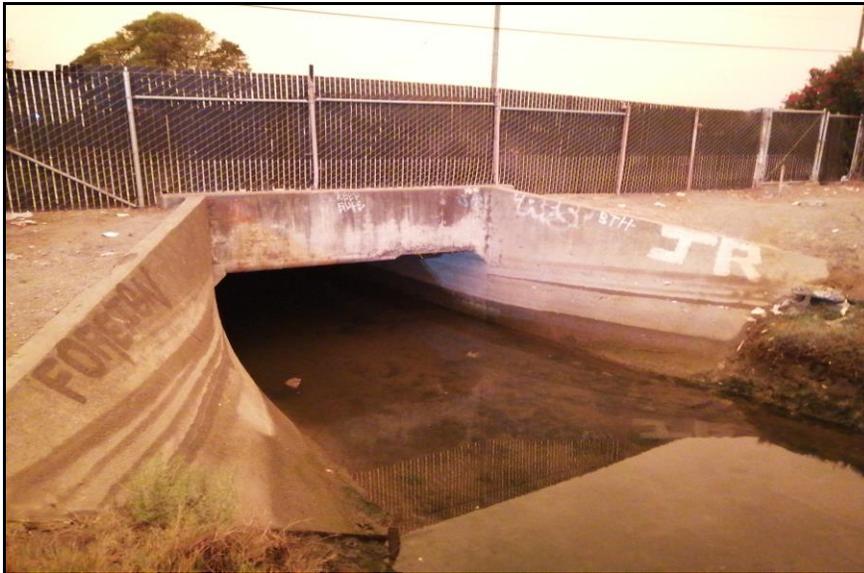
**Inspect ID:** SMNR\_2020\_a\_0005 **Title:** USACE\_CESPN\_SMNR\_2020\_a\_0005\_1.jpg  
**Rated Item:** 5. Concrete Surfaces **Caption:** Rating: Minimally Acceptable; Remarks: Photo is looking downstream at concrete culvert, Concrete spalling and exposed rebar was observed on the culvert entrance. Action: The Sponsor should initiate the repair as soon as possible to prevent further deterioration. ; Station: 19+00

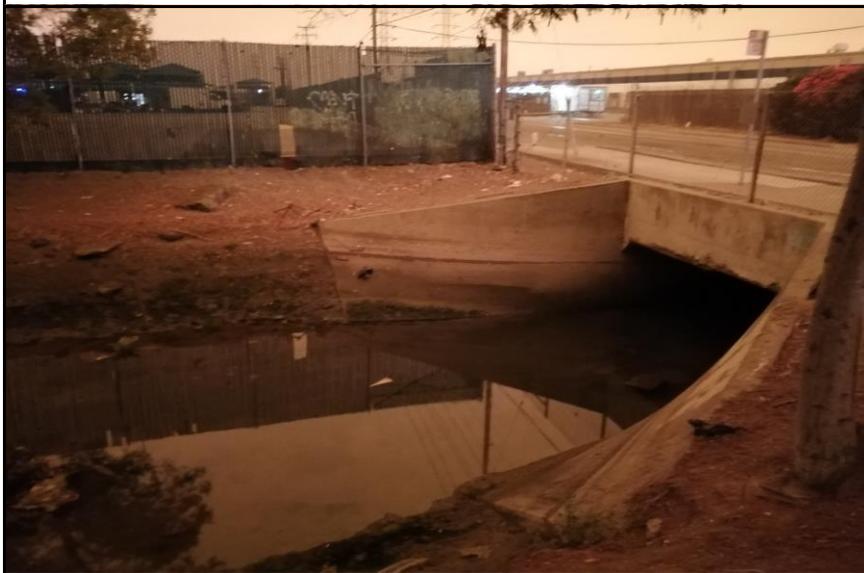
4. Erosion	<b>M</b>	<b>A</b>	No head cutting or horizontal deviation observed.	SMNR_2020_a_0005_2.jpg Minor erosion was observed on the bridge wingwalls (M); Station: 19+00 SMNR_2020_a_0006_1.jpg A broken concrete swale drain that extended from adjacent parking lot to the channel is causing erosion on the channel slope (M); Action: The Sponsor should repair before the erosion getting larger. Station: 16+00 SMNR_2020_a_0008_1.jpg Looking upstream. Eroded areas varied in size from 4 feet long by 3 feet wide to 12 feet long by 3 feet wide (M).; Station: 2+00
		<b>M</b>	Head cutting and horizontal deviation evident, but is less than 1 foot from the designed grade or cross section.	
		<b>U</b>	Head cutting and horizontal deviation of more than 1 foot from the designed grade or cross section. Corrective actions required to stop or slow erosion.

**Inspect ID:** SMNR\_2020\_a\_0005 **Title:** USACE\_CESPN\_SMNR\_2020\_a\_0005\_2.jpg  
**Rated Item:** 4. Erosion **Caption:** Rating: Minimally Acceptable; Remarks: minor erosion was observed on the bridge wingwalls; Station: 19+00

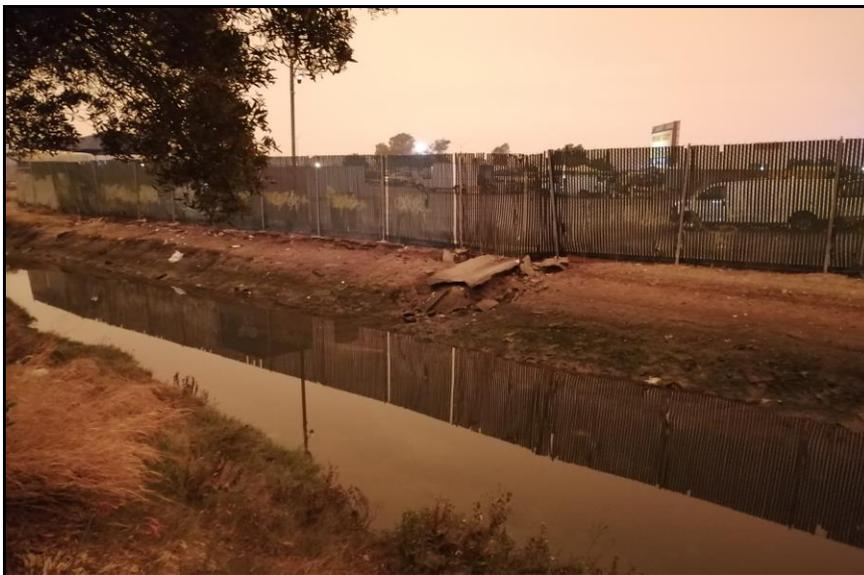
**Inspect ID:** SMNR\_2020\_a\_0006 **Title:** USACE\_CESPN\_SMNR\_2020\_a\_0006\_1.jpg  
**Rated Item:** 4. Erosion **Caption:** Rating: Minimally Acceptable; Remarks: A broken concrete swale drain that extended from adjacent parking lot to the channel is causing erosion on the channel slope; Action: The Sponsor should repair before the erosion getting larger. Station: 16+00

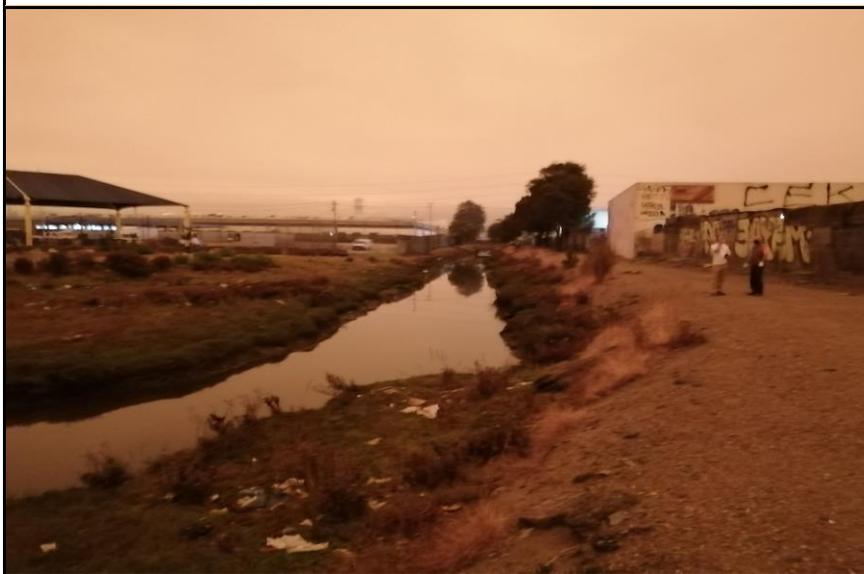
**Inspect ID:** SMNR\_2020\_a\_0007 **Title:** USACE\_CESPN\_SMNR\_2020\_a\_0007\_1.jpg  
**Rated Item:** 3. Encroachments **Caption:** Rating: Minimally Acceptable; Remarks: Trash and debris such as plastics, bottles. etc. were found scattered along the channel.; Action: The Sponsor should clean the channel periodically; Station: 13+00

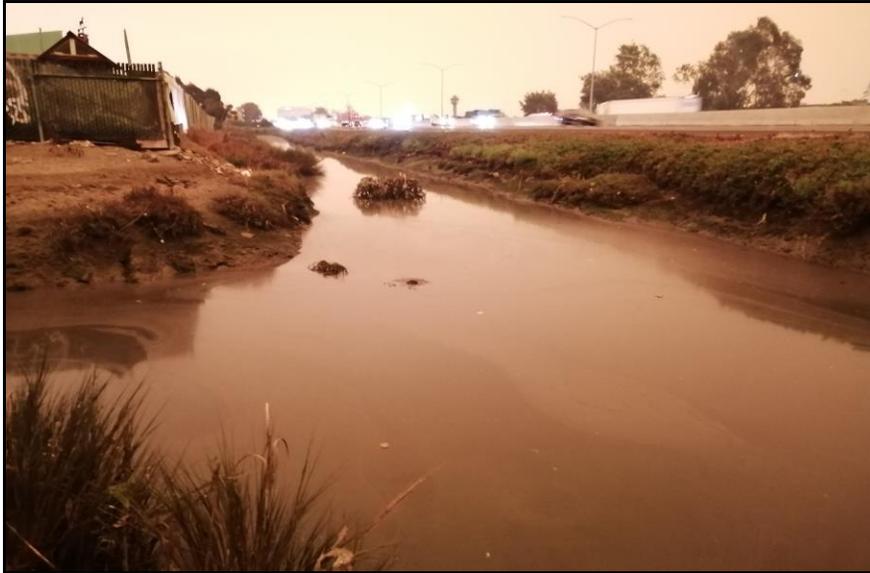
**Inspect ID:** SMNR\_2020\_a\_0008 **Title:** USACE\_CESPN\_SMNR\_2020\_a\_0008\_1.jpg  
**Rated Item:** 4. Erosion **Caption:** Rating: Minimally Acceptable; Remarks: Looking upstream from STA 02+00. Erosion can be sporadically observed on the side slope. Eroded areas varied in size from 4 feet long by 3 feet wide to 12 feet long by 3 feet wide.; Station: 2+00. Repairs should be done to prevent expansion of erosion pockets on slope.
