# NAPA RIVER LEFT BANK TULOCAY CREEK LEVEE

NAPA RIVER/NAPA CREEK FLOOD PROTECTION PROJECT  
NAPA, CALIFORNIA  
NLD SYSTEM ID NO. 5305000100; SEGMENT ID No. 5304000100

PERIODIC INSPECTION REPORT NO. 1  
SEPTEMBER 2020

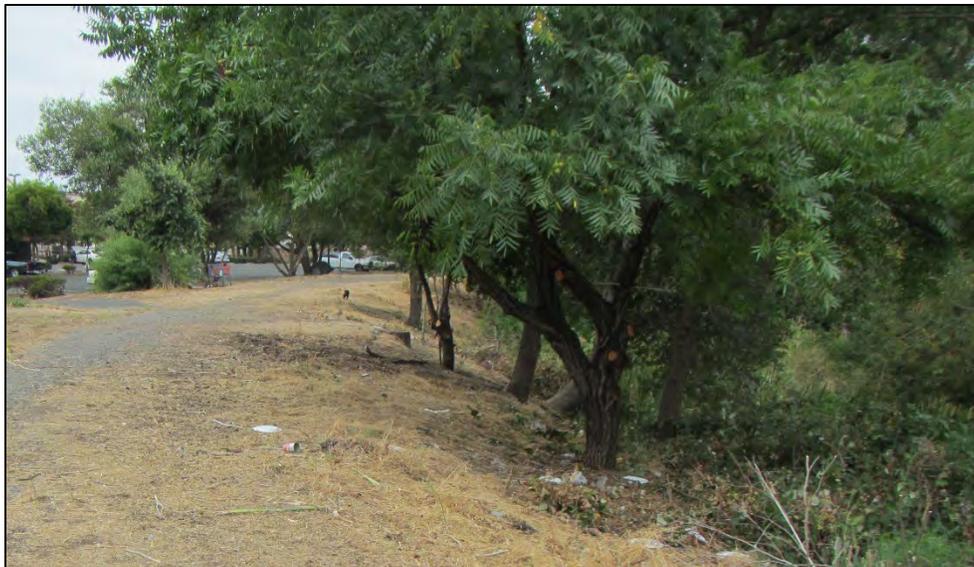
This item was rated “unacceptable”. Dense vegetation was observed on both levee slopes. There are locations where the sponsor has been proactive with vegetation removal, however there are also locations that need additional maintenance. Remove non-compliant vegetation to allow for maintenance, inspection and flood fighting activities.

**Figure 5-1: Inspection Point NLT2\_2020\_a\_0003: Vegetation on the levee slopes.**

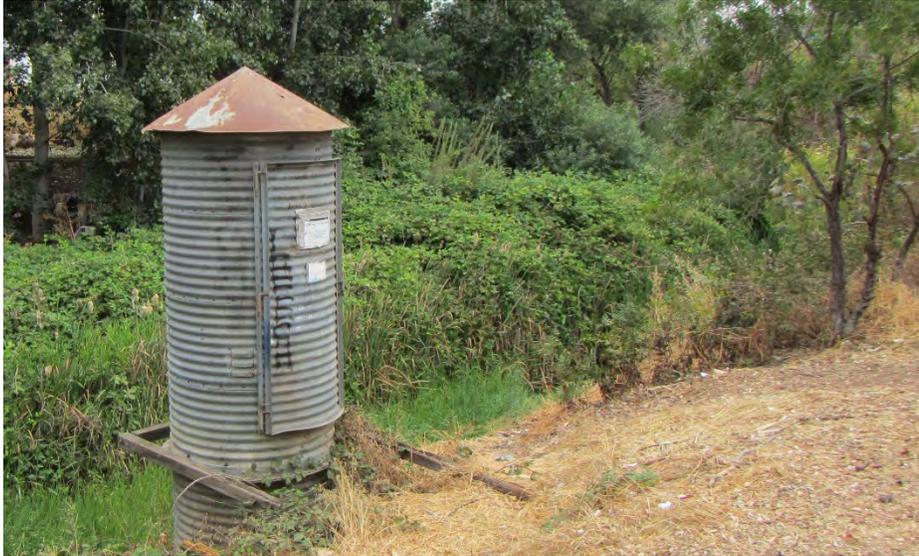
This item was rated “minimally acceptable”. Numerous areas were noted where the public has been camping, left debris on the levee and modified the levee cross section. A gage station was noted within the levee cross section. Debris and structures not approved should be removed from the levee cross section to allow for maintenance and flood fight activities. Examples of these items are shown in Figure 5-2 and Figure 5-3 below.

**Figure 5-2: Inspection Point NLT2\_2008\_0012: Old gaging station.**

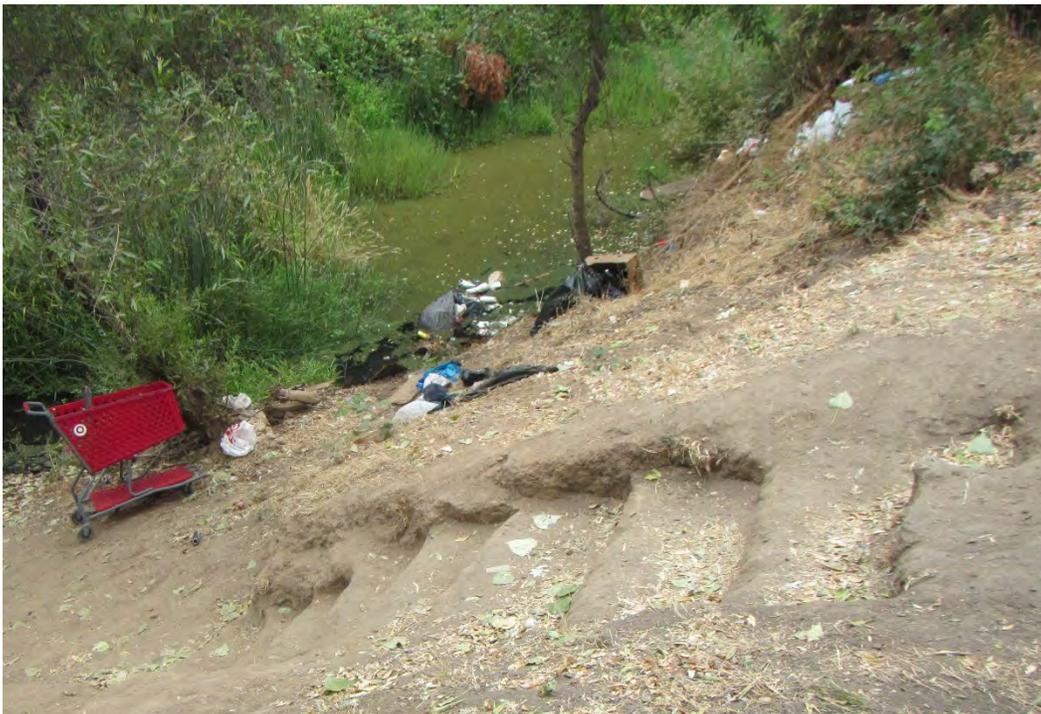
**Figure 5-3: Inspection Point NLT2\_2020\_0007: Debris and unapproved modifications to the levee slope.**

the levee for access by the public. A photo of this is shown above in Figure 5-3. These areas should be repaired to return the levee cross section to its original condition.

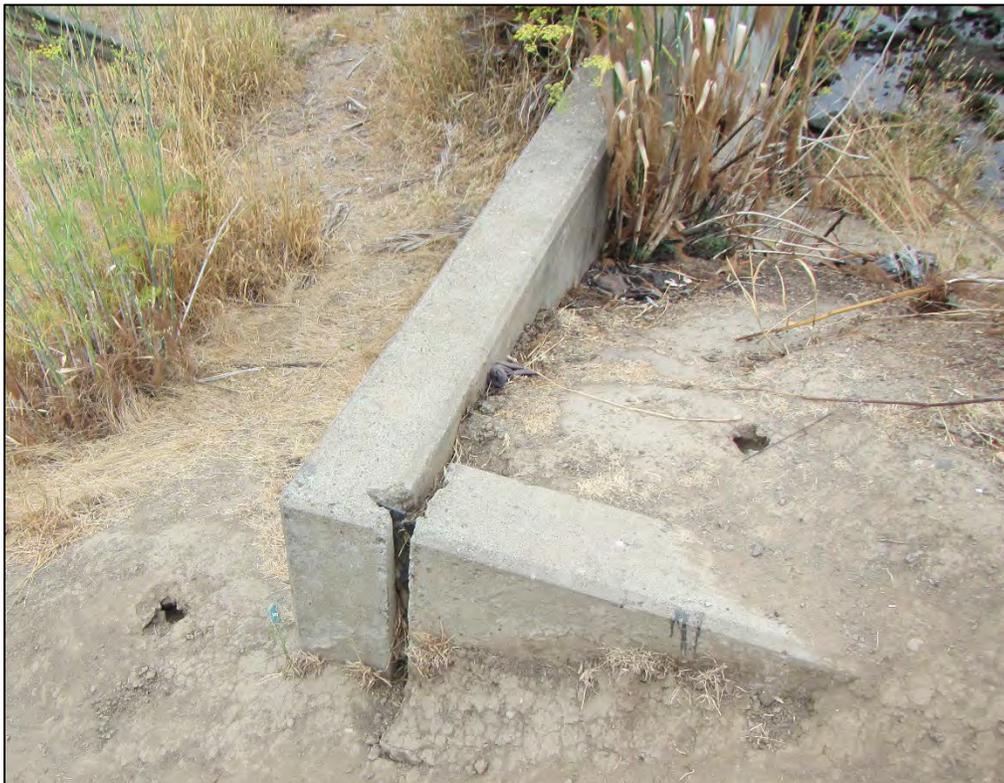
**Figure 5-4: Inspection Point NLT2\_2020\_a\_0002: Concrete wall movement**

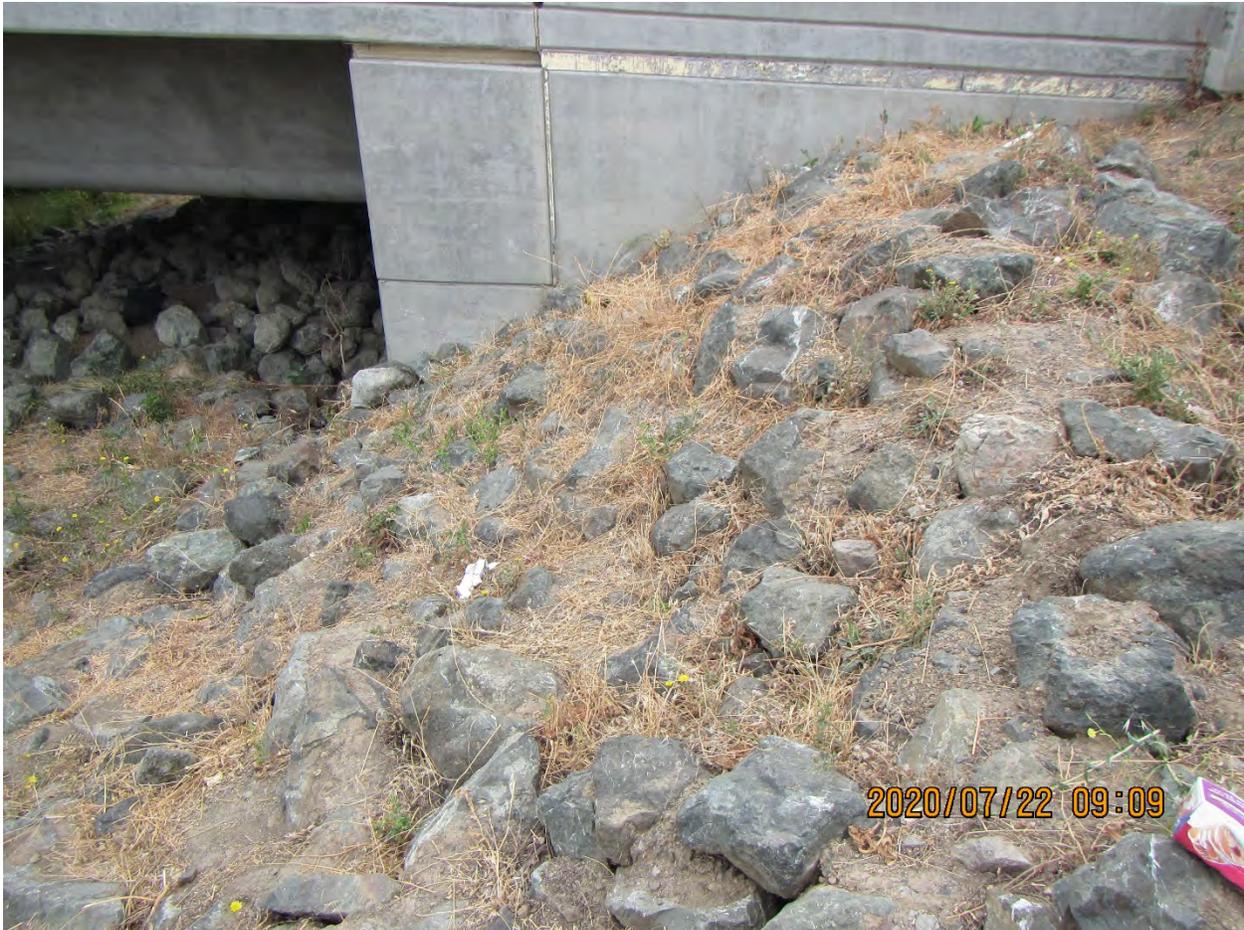
This item was rated “minimally acceptable”. Riprap at the Gasser Drive Bridge appears to be poorly keyed in. Slope protection is an important part of maintaining bridge crossings. Monitor the site during high flows and repair as necessary if erosion begins in this area.

**Figure 5-5: Inspection Point NLT2\_2020\_a\_0004: Poorly keyed riprap revetment at Gasser Street Bridge abutment.**

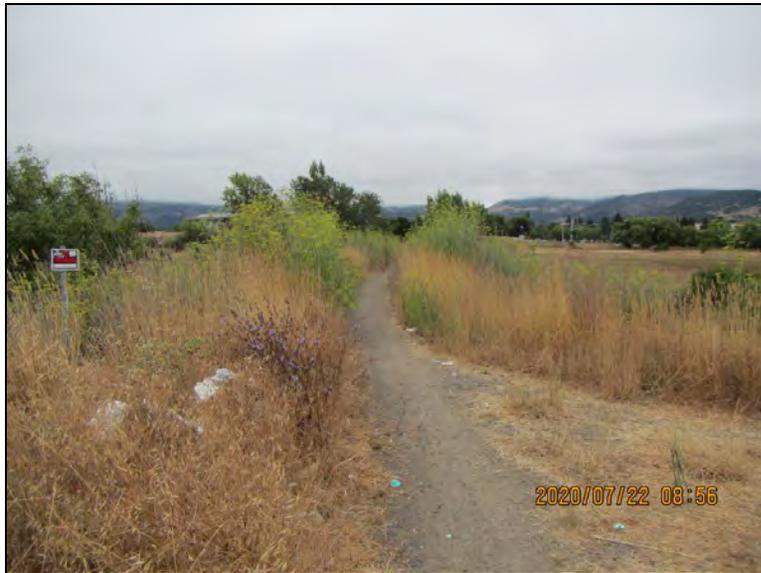
**Inspect ID:** NLT2\_2020\_a\_0003 **Title:** USACE\_CESPN\_NLT2\_2020\_a\_0003\_1.jpg  
**Rated Item:** 1. Unwanted Vegetation Growth **Caption:** Rating: Unacceptable; Remarks: Dense vegetation observed on both levee slopes.; Action: Remove unwanted vegetation to allow maintenance, inspection, and flood fighting activities.

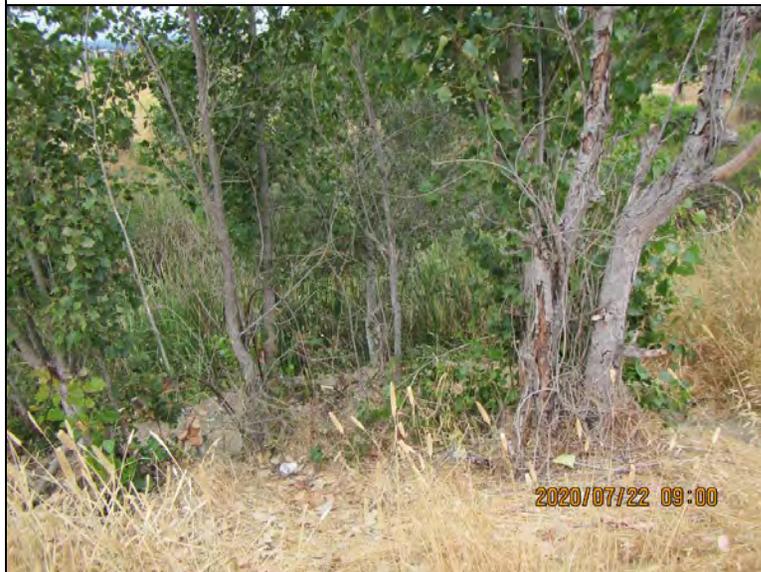
**Inspect ID:** NLT2\_2020\_a\_0003 **Title:** USACE\_CESPN\_NLT2\_2020\_a\_0003\_2.jpg  
**Rated Item:** 1. Unwanted Vegetation Growth **Caption:** Rating: Unacceptable; Remarks: Dense vegetation observed on both levee slopes.; Action: Remove unwanted vegetation to allow maintenance, inspection, and flood fighting activities.

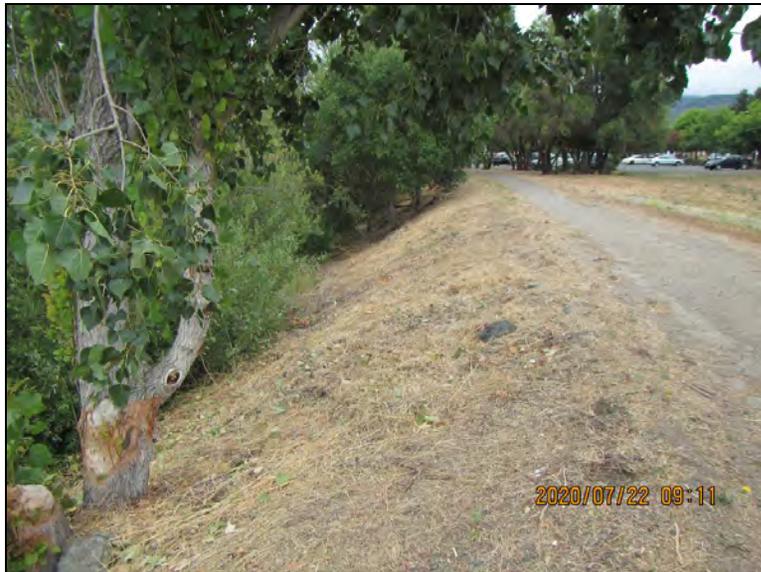
**Inspect ID:** NLT2\_2020\_a\_0003 **Title:** USACE\_CESPN\_NLT2\_2020\_a\_0003\_3.jpg  
**Rated Item:** 1. Unwanted Vegetation Growth **Caption:** Rating: Unacceptable; Remarks: Dense vegetation observed on both levee slopes.; Action: Remove unwanted vegetation to allow maintenance, inspection, and flood fighting activities.

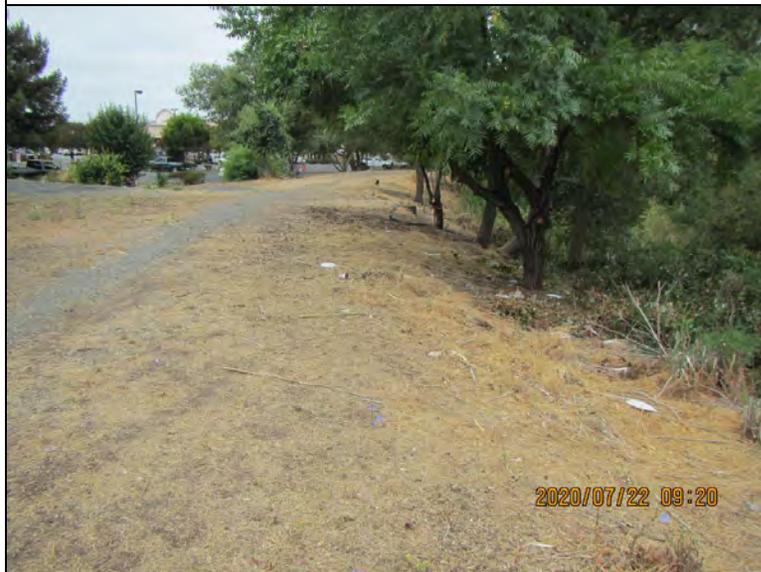
**Inspect ID:** NLT2\_2020\_a\_0003 **Title:** USACE\_CESPN\_NLT2\_2020\_a\_0003\_4.jpg  
**Rated Item:** 1. Unwanted Vegetation Growth **Caption:** Rating: Unacceptable; Remarks: Dense vegetation observed on both levee slopes.; Action: Remove unwanted vegetation to allow maintenance, inspection, and flood fighting activities.

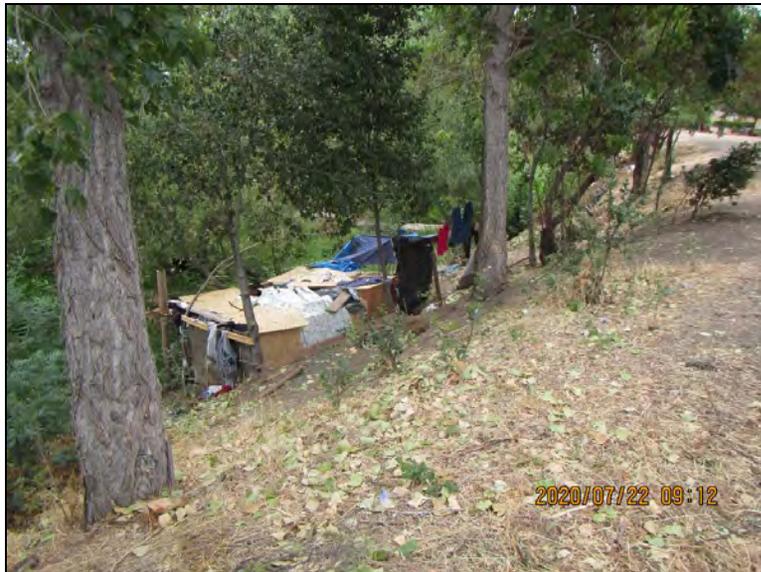
**Inspect ID:** NLT2\_2020\_a\_0006 **Title:** USACE\_CESPN\_NLT2\_2020\_a\_0006\_1.jpg  
**Rated Item:** 3. Encroachments **Caption:** Rating: Acceptable; Remarks: Homeless camp built into riverside slope.; Action: Remove encroachment and return slope to origin design.

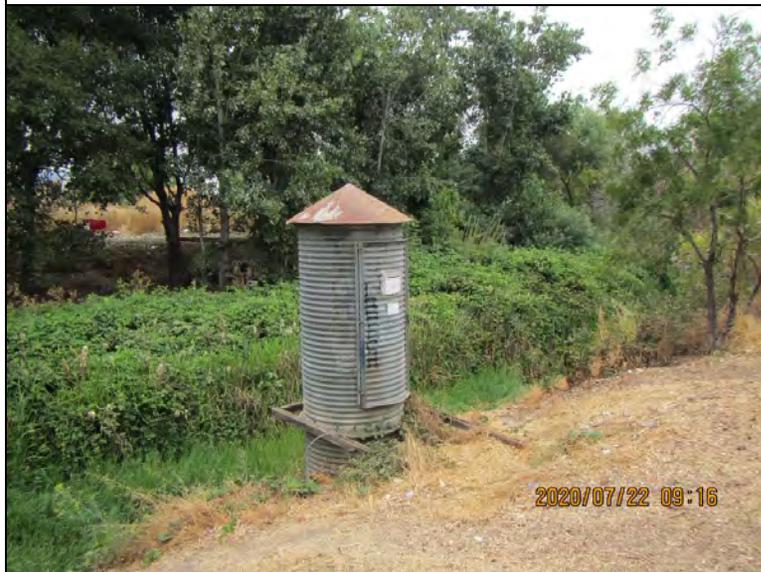
**Inspect ID:** NLT2\_2020\_a\_0008 **Title:** USACE\_CESPN\_NLT2\_2020\_a\_0008\_1.jpg  
**Rated Item:** 3. Encroachments **Caption:** Rating: Acceptable; Remarks: Old gaging station.; Action: Remove if no longer in use.

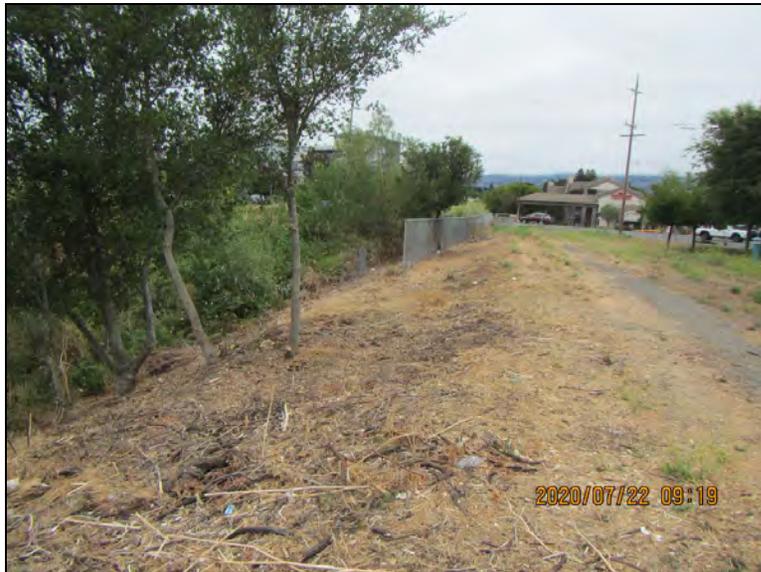
**Inspect ID:** NLT2\_2020\_a\_0009 **Title:** USACE\_CESPN\_NLT2\_2020\_a\_0009\_1.jpg  
**Rated Item:** 3. Encroachments **Caption:** Rating: Acceptable; Remarks: Upstream end of levee system. ; Action: No action required at this time.; ;

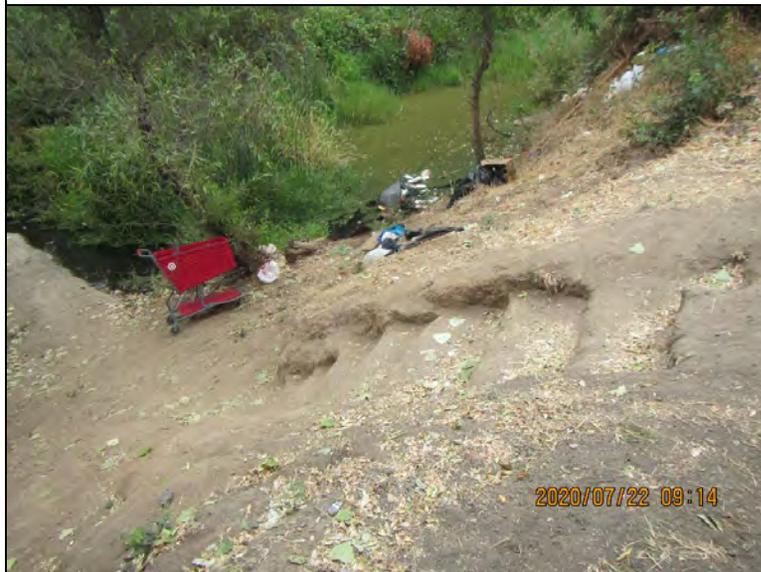
**Inspect ID:** NLT2\_2020\_a\_0007 **Title:** USACE\_CESPN\_NLT2\_2020\_a\_0007\_1.jpg  
**Rated Item:** 5. Slope Stability **Caption:** Rating: Acceptable; Remarks: Steps built into levee slope. ; Action: Fill and compact to reestablish levee cross section.; ;

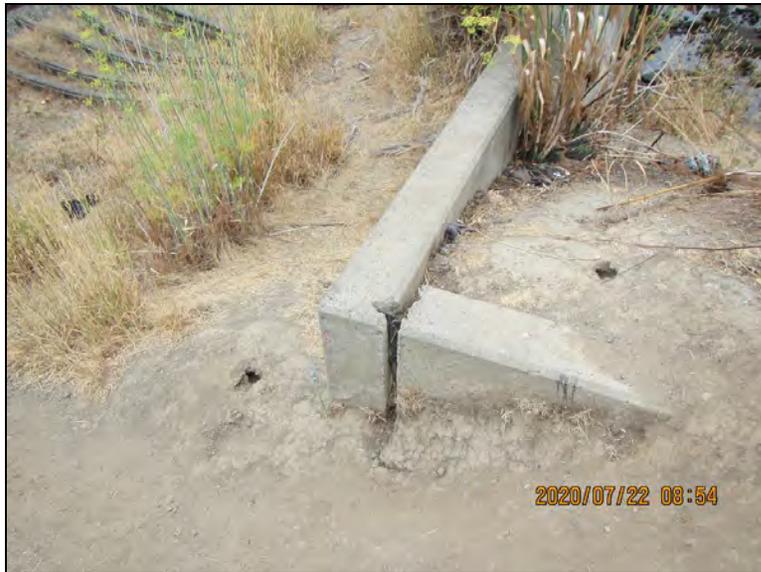
**Inspect ID:** NLT2\_2020\_a\_0002 **Title:** USACE\_CESPN\_NLT2\_2020\_a\_0002\_1.jpg  
**Rated Item:** 6. Erosion/ Bank Caving **Caption:** Rating: Minimally Acceptable;  
**Remarks:** Suspected movement of concrete wall.; **Action:** Monitor.

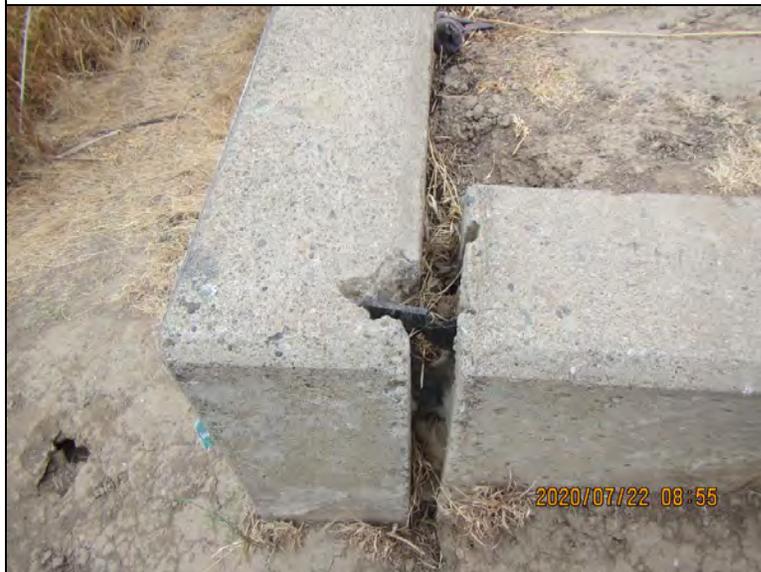
**Inspect ID:** NLT2\_2020\_a\_0002 **Title:** USACE\_CESPN\_NLT2\_2020\_a\_0002\_2.jpg  
**Rated Item:** 6. Erosion/ Bank Caving **Caption:** Rating: Minimally Acceptable;  
**Remarks:** Suspected movement of concrete wall.; **Action:** Monitor.

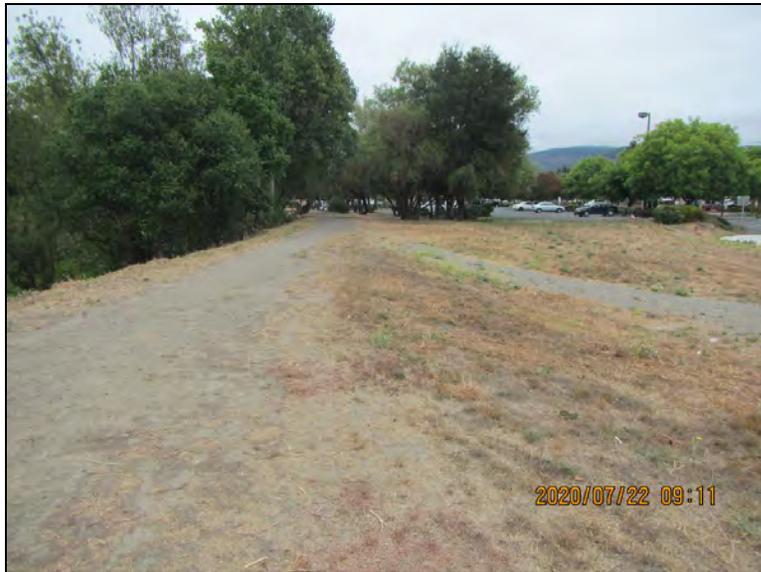
**Inspect ID:** NLT2\_2020\_a\_0005 **Title:** USACE\_CESPN\_NLT2\_2020\_a\_0005\_1.jpg  
**Rated Item:** 6. Erosion/ Bank Caving **Caption:** Rating: Minimally Acceptable;  
**Remarks:** Foot path observed on landside slope.; **Action:** Fill and compact to reestablish levee cross section.

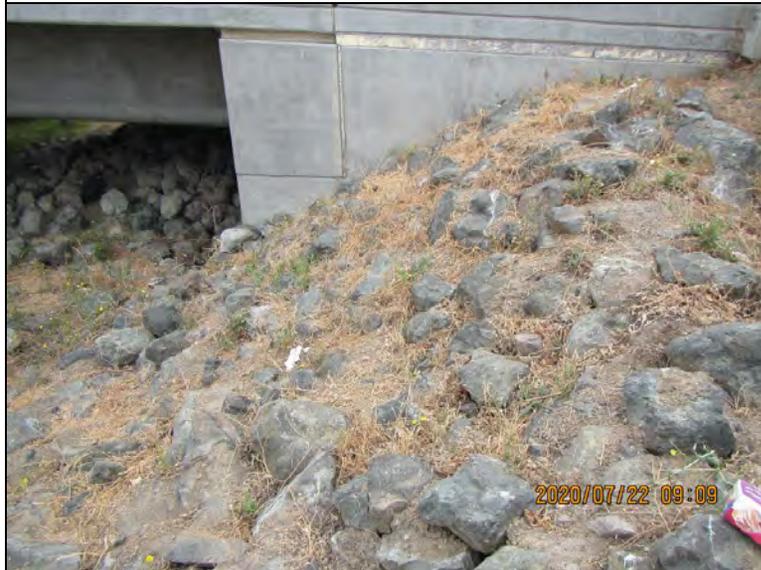
**Inspect ID:** NLT2\_2020\_a\_0004 **Title:** USACE\_CESPN\_NLT2\_2020\_a\_0004\_1.jpg  
**Rated Item:** 12. Riprap Revetments & Bank Protection **Caption:** Rating: Minimally Acceptable;  
**Remarks:** Riprap placed when bridge was built, appears to be poorly keyed in.; **Action:** Rekey riprap as needed.
