Flood Damage Reduction Segment / System Inspection Report

Name of Segment / System: Pajaro R. Right bank US FFCP PJRU

Inspection Start Date: 9/4/2019

Type of Inspection: **Initial Eligibility Inspection**
 Continuing Eligibility Inspection (Routine)
 Continuing Eligibility Inspection (Periodic)

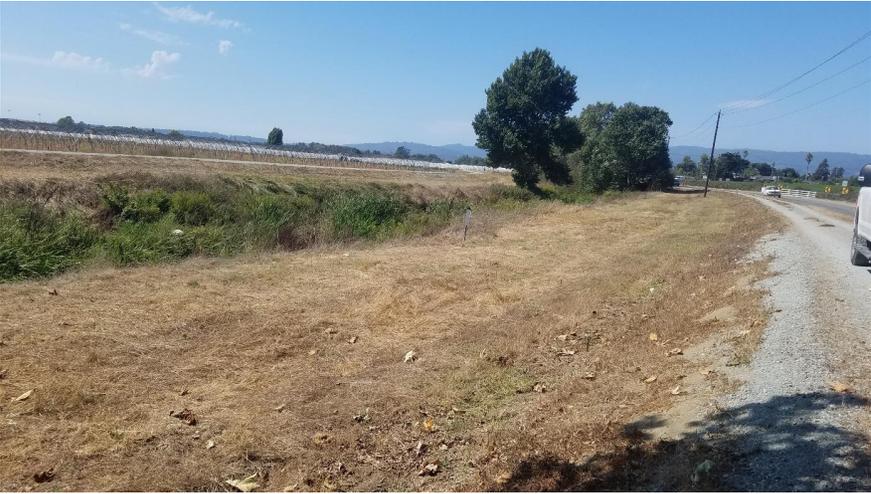
<p>Inspect ID: PJRU_2019_a_0002 Title: USACE_CESPN_PJRU_2019_a_0002_2.jpg Rated Item: 1. Unwanted Vegetation Growth Caption: Rating: Unacceptable; Remarks: Tree more than 10 feet tall and with a trunk diameter greater than 12 inches observed within the 15 ft vegetation-free zone.; Action: The tree should be managed in accordance with ETL 1110-2-583 or a vegetation variance should be obtained.; Station_1: 83+00</p>

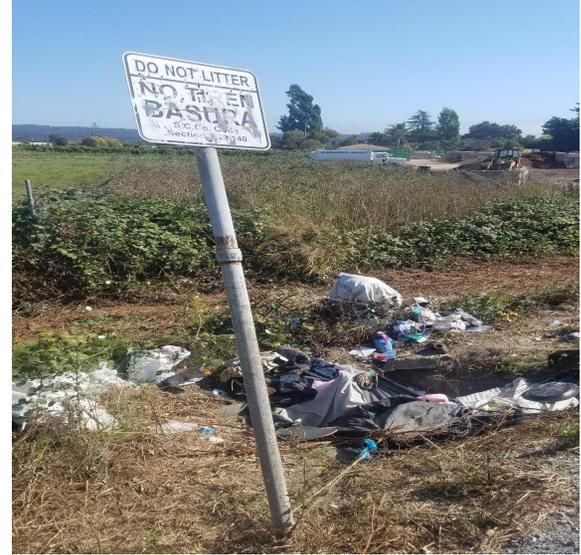
<p>Inspect ID: PJRU_2019_a_0009 Title: USACE_CESPN_PJRU_2019_a_0009_1.jpg Rated Item: 1. Unwanted Vegetation Growth Caption: Rating: Acceptable; Remarks: Trash was present on the landside levee slope.; Action: The trash should be removed.; Station_1: 24+00</p>

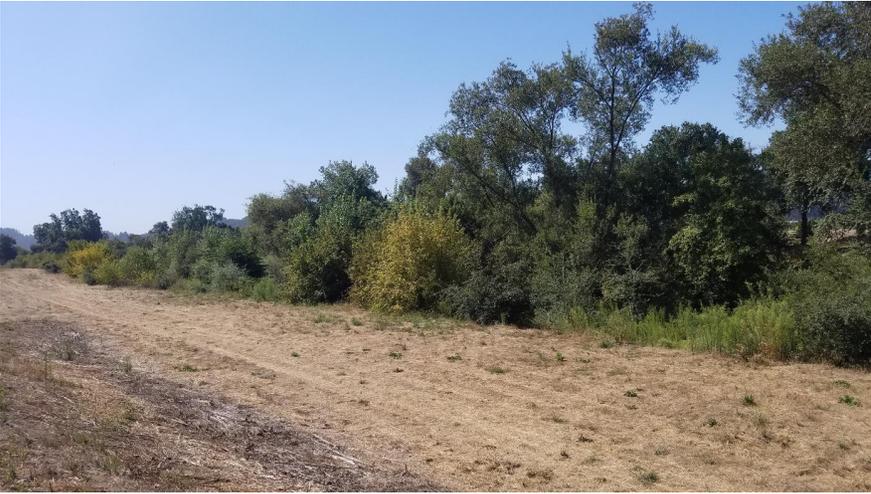
<p>Inspect ID: PJRU_2019_a_0017 Title: USACE_CESPN_PJRU_2019_a_0017_1.jpg Rated Item: 1. Unwanted Vegetation Growth Caption: Rating: Unacceptable; Remarks: Dense vegetation on the waterside slope and trees more than 10 ft tall and with trunk diameters greater than 12 inches were observed within the 15 ft vegetation-free zone.; Action: Vegetation growth should be managed in accordance with USACE policy.; Station_1: 522+00</p>

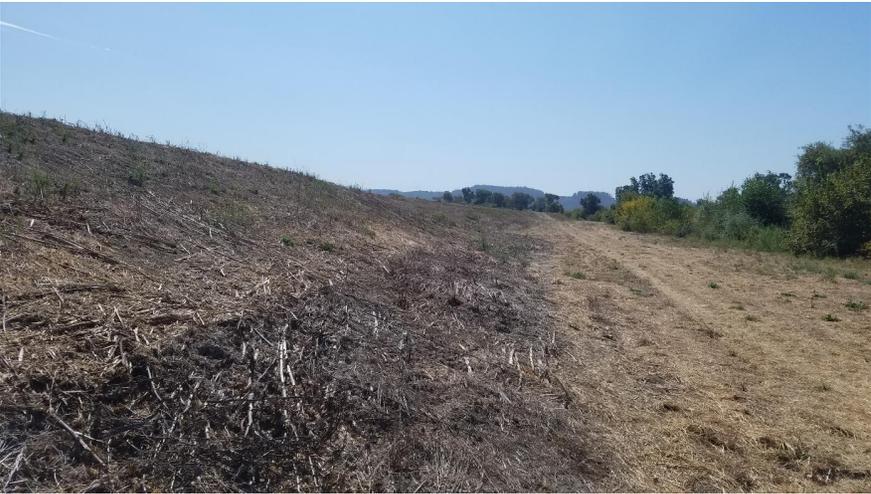
2. Sod Cover	M	A	There is good coverage of sod over the levee.	PJRU_2019_a_0018: Station_1 523+00: Levee waterside slope lacking adequate sod coverage, perennial grasses, or weedy growth.: The sponsor should consider manually mowing the levee slope to allow root masses to develop and new growth to be established before the winter season. (U)
		M	Approximately 25% of the sod cover is missing or damaged over a significant portion or over significant portions of the levee embankment. This may be the result of over-grazing or feeding on the levee, unauthorized vehicular traffic, chemical or insect problems, or burning during inappropriate seasons.	
		U	Over 50% of the sod cover is missing or damaged over a significant portion or portions of the levee embankment.	
		N/A	Surface protection is provided by other means.

<p>Inspect ID: PJRU_2019_a_0018 Title: USACE_CESPN_PJRU_2019_a_0018_1.jpg Rated Item: 2. Sod Cover Caption: Rating: Unacceptable; Remarks: Levee waterside slope lacking adequate sod coverage, perennial grasses, or weedy growth.; Action: The sponsor should consider manually mowing the levee slope to allow root masses to develop and new growth to be established before the winter season.; Station_1: 523+00</p>

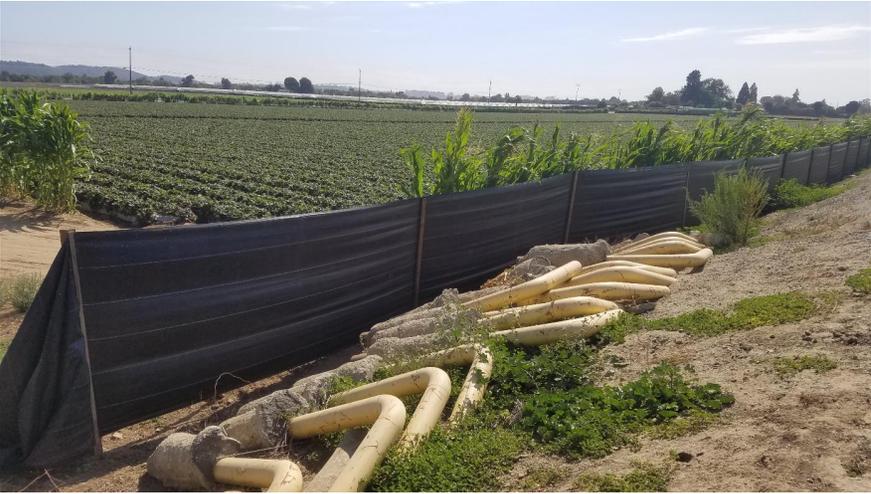
<p>Inspect ID: PJRU_2019_a_0003 Title: USACE_CESPN_PJRU_2019_a_0003_1.jpg Rated Item: 3. Encroachments Caption: Rating: Minimally Acceptable; Remarks: Construction materials and debris observed encroaching on the landside toe of the levee prism.; Action: Encroachments should be permitted or otherwise removed.; Station_1: 54+00</p>

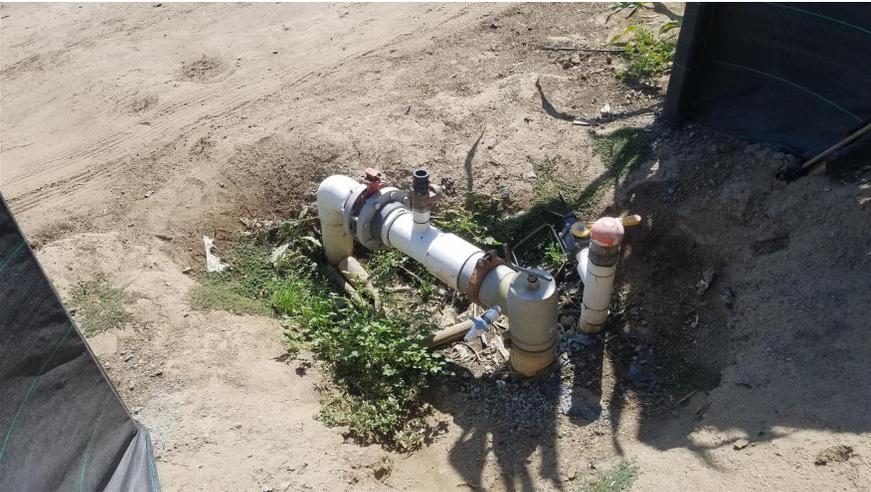
<p>Inspect ID: PJRU_2019_a_0004 Title: USACE_CESPN_PJRU_2019_a_0004_1.jpg Rated Item: 3. Encroachments Caption: Rating: Unacceptable; Remarks: Unauthorized drainage pipes encroaching into the landside toe of the levee prism.; Action: Encroachment should be permitted or otherwise removed.; Station_1: 47+00</p>

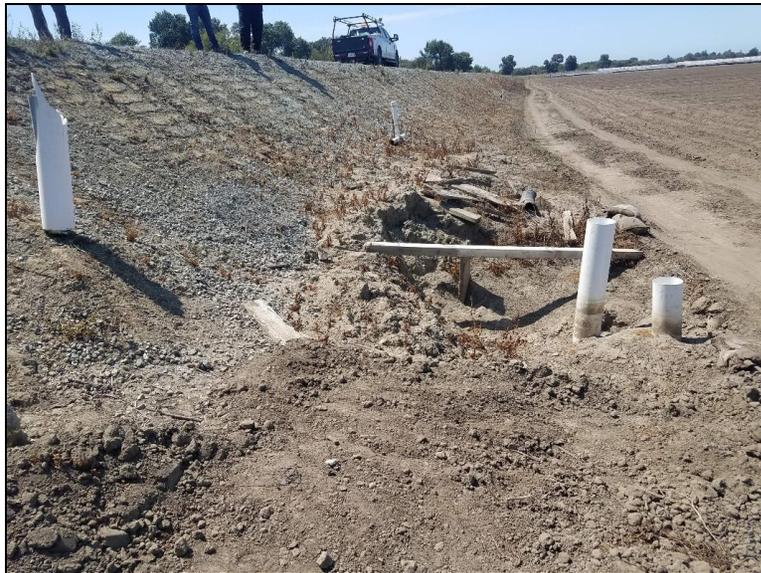
Inspect ID: PJRU_2019_a_0010 **Title:** USACE_CESPN_PJRU_2019_a_0010_1.jpg
Rated Item: 3. Encroachments **Caption:** Rating: Unacceptable; Remarks: Unauthorized excavation observed at the toe of the landside slope.; Action: Recommend a section 408 modification request be submitted, or the site be restored to as-built conditions and the slope be restored to the lines and grades in the O&M manual.; Station_1: 363+00

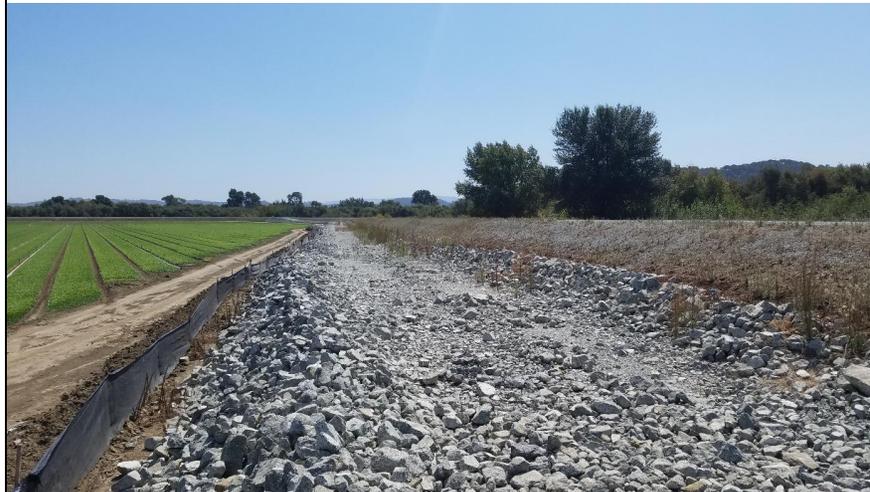
Rated Item	Rating	Rating Guidelines		Location/Remarks/Recommendations
				PJRU_2019_a_0013: Station_1 410+00: Gravel deposited at the toe of the landside slope.: Recommend a section 408 modification request be submitted, or the area should be restored to as-built conditions. (M)

Inspect ID: PJRU_2019_a_0013 **Title:** USACE_CESPN_PJRU_2019_a_0013_1.jpg
Rated Item: 3. Encroachments **Caption:** Rating: Minimally Acceptable; Remarks: Gravel deposited at the toe of the landside slope.; Action: Recommend a section 408 modification request be submitted, or the area should be restored to as-built conditions.; Station_1: 410+00

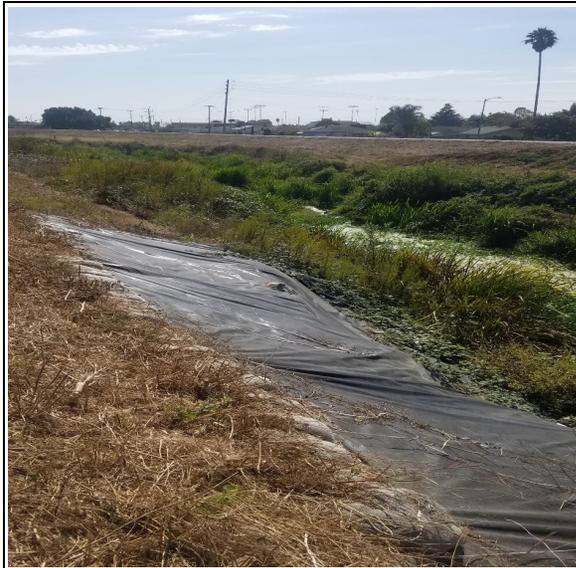
6. Erosion/ Bank Caving	U	A	No erosion or bank caving is observed on the landward or riverward sides of the levee that might endanger its stability.	PJRU_2019_a_0008: Station_1 25+00: Erosion occurring on waterside slope of the levee prism along the Salsipuedes Creek segment. Covered with geomembrane for temporary protection: Recommend the levee prism slope be regraded back to the as-built slope to prevent additional erosion from storm runoff. This area should also be monitored during high water events to see if any soil loss is occurring due to seepage. (U)
		M	There are areas where minor erosion is occurring or has occurred on or near the levee embankment, but levee integrity is not threatened.	
		U	Erosion or caving is occurring or has occurred that threatens the stability and integrity of the levee. The erosion or caving has progressed into the levee section or into the extended footprint of the levee foundation and has compromised the levee foundation stability.

Inspect ID: PJRU_2019_a_0008 **Title:** USACE_CESPN_PJRU_2019_a_0008_1.jpg
Rated Item: 6. Erosion/ Bank Caving **Caption:** Rating: Unacceptable; Remarks: Erosion occurring on waterside slope of the levee prism along the Salsipuedes Creek segment. Covered with geomembrane for temporary protection ; Action: Recommend the levee prism slope be regraded back to the as-built slope to prevent additional erosion from storm runoff. This area should also be monitored during high water events to see if any soil loss is occurring due to seepage.; Station_1: 25+00; ; ;

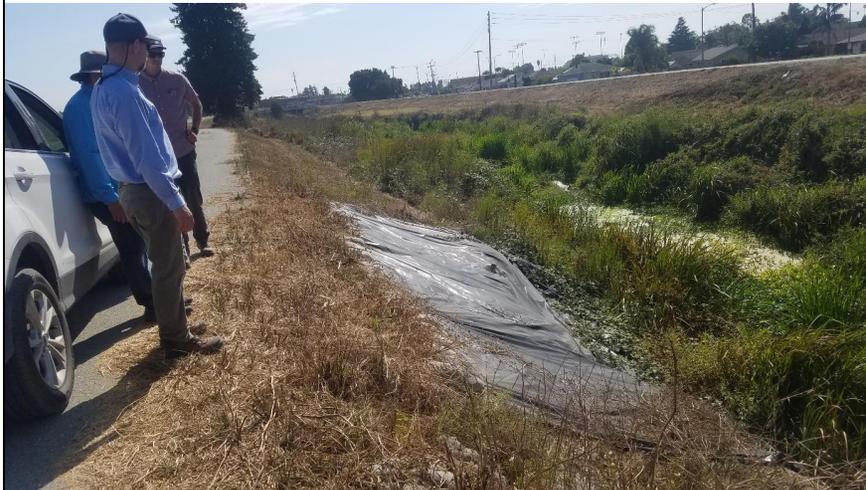
Inspect ID: PJRU_2019_a_0008 **Title:** USACE_CESPN_PJRU_2019_a_0008_2.jpg
Rated Item: 6. Erosion/ Bank Caving **Caption:** Rating: Unacceptable; Remarks: Erosion occurring on waterside slope of the levee prism along the Salsipuedes Creek segment. Covered with geomembrane for temporary protection ; Action: Recommend the levee prism slope be regraded back to the as-built slope to prevent additional erosion from storm runoff. This area should also be monitored during high water events to see if any soil loss is occurring due to seepage.; Station_1: 25+00; ; ;

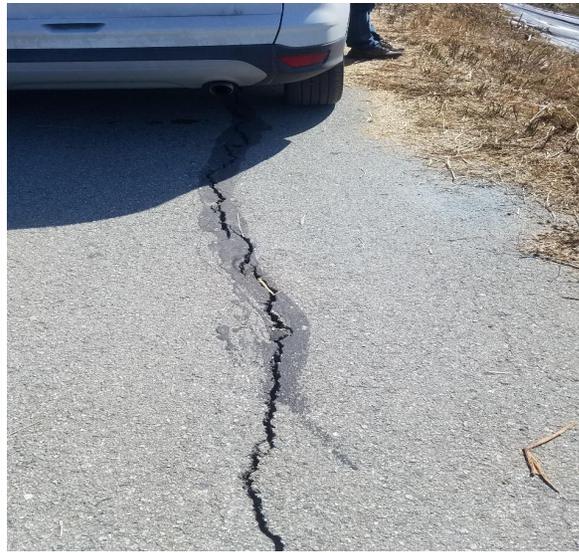
Inspect ID: PJRU_2019_a_0006 **Title:** USACE_CESPN_PJRU_2019_a_0006_1.jpg
Rated Item: 9. Cracking **Caption:** Rating: Minimally Acceptable; Remarks: Longitudinal cracking observed along the crest of the levee prism.; Action: Cracks should be sealed; Station_1: 30+00

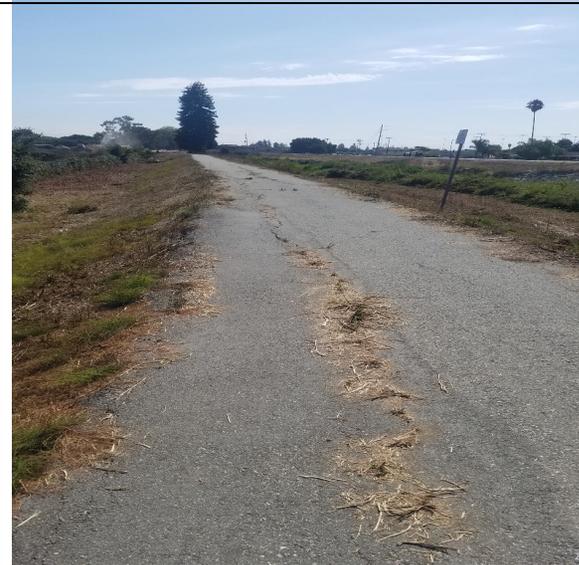
Inspect ID: PJRU_2019_a_0006 **Title:** USACE_CESPN_PJRU_2019_a_0006_2.jpg
Rated Item: 9. Cracking **Caption:** Rating: Minimally Acceptable; Remarks: Longitudinal cracking observed along the crest of the levee prism.; Action: Cracks should be sealed; Station_1: 30+00

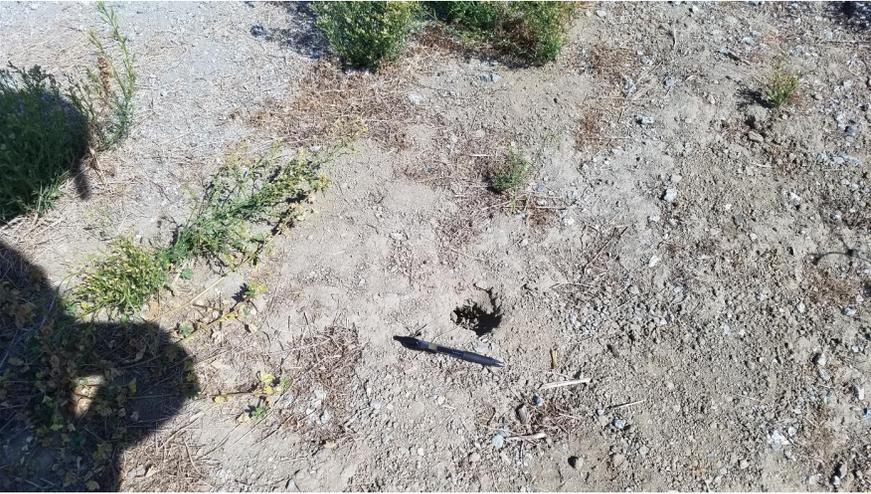
<p>Inspect ID: PJRU_2019_a_0011 Title: USACE_CESPN_PJRU_2019_a_0011_1.jpg Rated Item: 10. Animal Control Caption: Rating: Minimally Acceptable; Remarks: Animal burrows observed on the levee slope; Action: The sponsor should monitor this area and continue to work on their animal abatement program.; Station_1: 380+00</p>

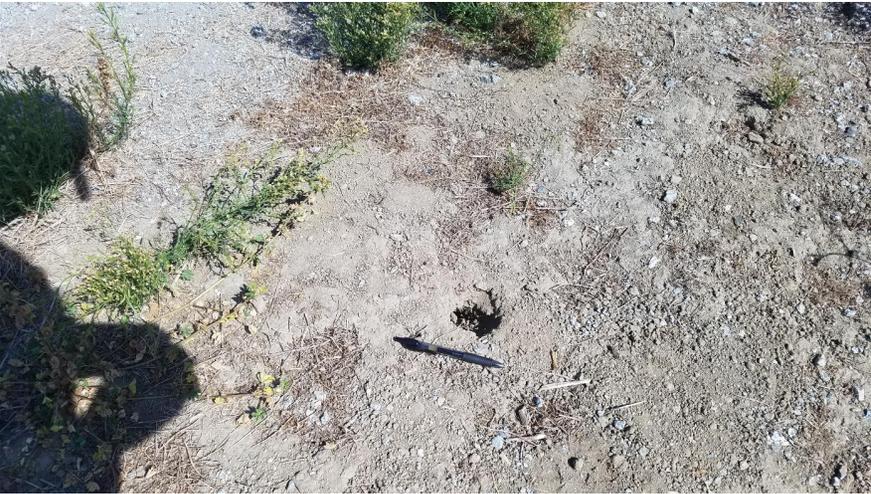
<p>Inspect ID: PJRU_2019_a_0020 Title: USACE_CESPN_PJRU_2019_a_0020_1.jpg Rated Item: 10. Animal Control Caption: Rating: Minimally Acceptable; Remarks: Animal burrows observed on the levee slope.; Action: The sponsor should monitor this area and continue to work on their animal abatement program.; Station_1: 580+00</p>

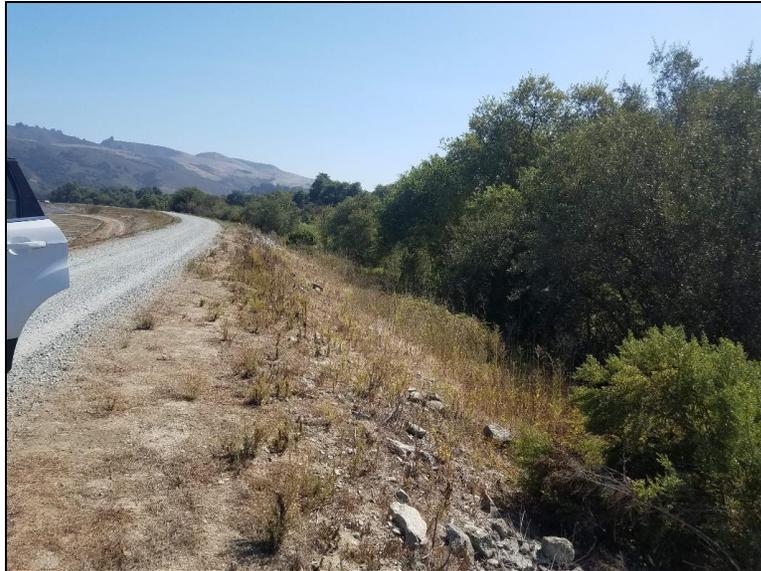
12. Riprap Revetments & Bank Protection	M	A No riprap displacement or stone degradation that could pose an immediate threat to the integrity of channel bank. Riprap intact with no woody vegetation present.	PJRU_2019_a_0019: Station_1 565+00: Vegetation growing through the riprap on the waterside slope of the levee prism.: Remove vegetation growth and restore any displaced riprap. (M)
		M Minor riprap displacement or stone degradation that could pose an immediate threat to the integrity of the channel bank. Unwanted vegetation must be cleared or sprayed with an appropriate herbicide.	
		U Significant riprap displacement, exposure of bedding, or stone degradation observed. Scour activity is undercutting banks, eroding embankments, or impairing channel flows by causing turbulence or shoaling. Rock protection is hidden by dense brush, trees, or grasses.	
		N/A There is no riprap protecting this feature of the segment / system, or riprap is discussed in another section.

Inspect ID: PJRU_2019_a_0019 **Title:** USACE_CESPN_PJRU_2019_a_0019_1.jpg
Rated Item: 12. Riprap Revetments & Bank Protection **Caption:** Rating: Minimally Acceptable; Remarks: Vegetation growing through the riprap on the waterside slope of the levee prism.; Action: Remove vegetation growth and restore any displaced riprap.; Station_1: 565+00

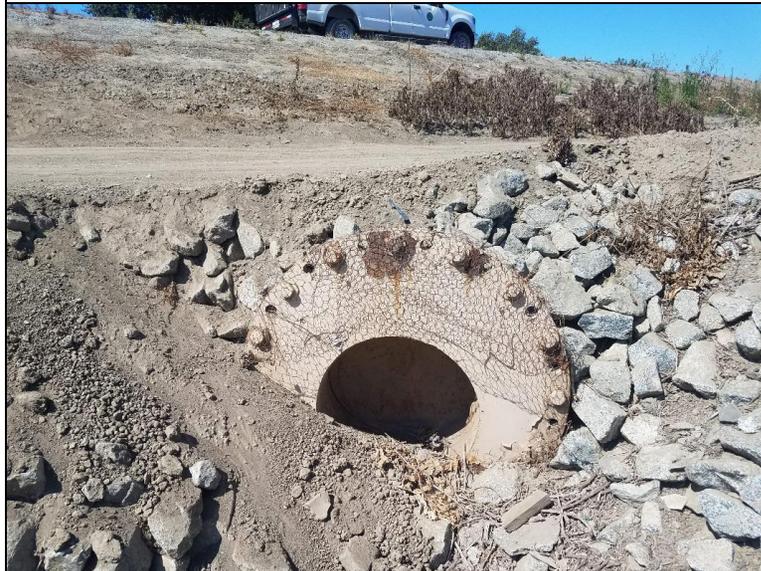
Inspect ID: PJRU_2019_a_0015 **Title:** USACE_CESPN_PJRU_2019_a_0015_1.jpg
Rated Item: 9. Culverts/ Discharge Pipes **Caption:** Rating: Acceptable; Remarks: Modifications made to culvert and headwall. ; Action: NA; Station_1: 499+00; ;

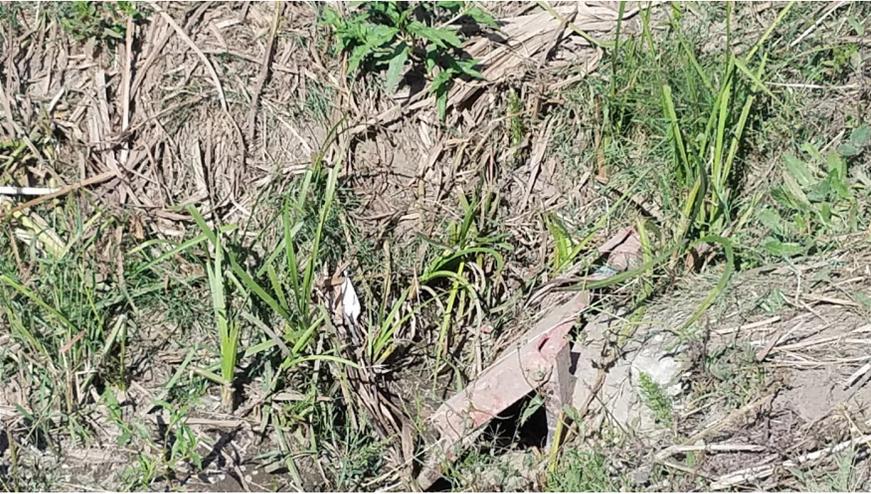
<p>Inspect ID: PJRU_2019_a_0005 Title: USACE_CESPN_PJRU_2019_a_0005_1.jpg Rated Item: 11. Flap Gates/ Flap Valves/ Pinch Valves Caption: Rating: Minimally Acceptable; Remarks: Interior drainage flap gate blocked by sediment and vegetation.; Action: Remove obstruction from flap gate outflow path and confirm the flap gate is functional.; Station_1: 34+00</p>

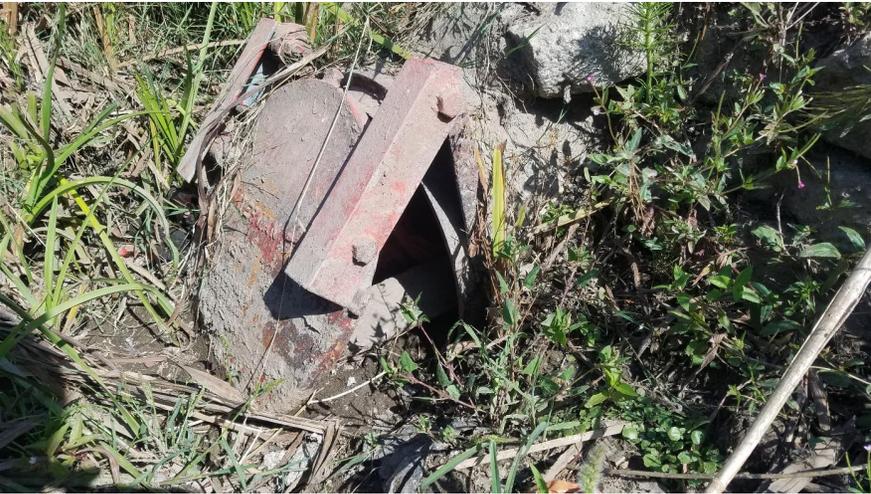
<p>Inspect ID: PJRU_2019_a_0005 Title: USACE_CESPN_PJRU_2019_a_0005_2.jpg Rated Item: 11. Flap Gates/ Flap Valves/ Pinch Valves Caption: Rating: Minimally Acceptable; Remarks: Interior drainage flap gate blocked by sediment and vegetation.; Action: Remove obstruction from flap gate outflow path and confirm the flap gate is functional.; Station_1: 34+00</p>

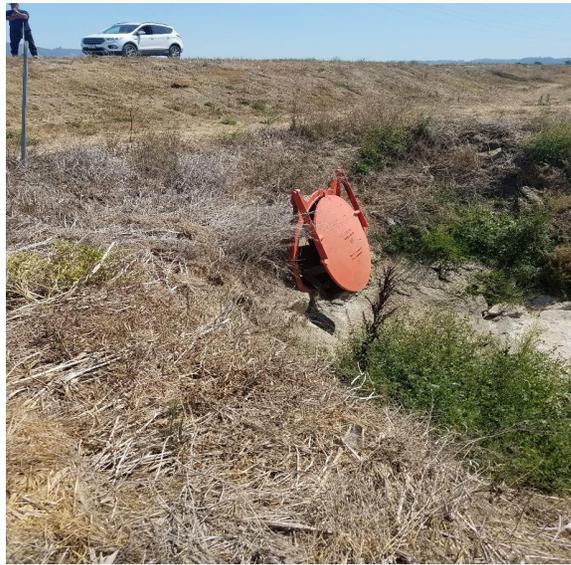
Inspect ID: PJRU_2019_a_0012 **Title:** USACE_CESPN_PJRU_2019_a_0012_1.jpg
Rated Item: 11. Flap Gates/ Flap Valves/ Pinch Valves **Caption:** Rating: Minimally Acceptable; Remarks: Flap gate blocked by debris and vegetation growth.; Action: Debris should be removed, and flap gate operational status should be confirmed.; Station_1: 392+00

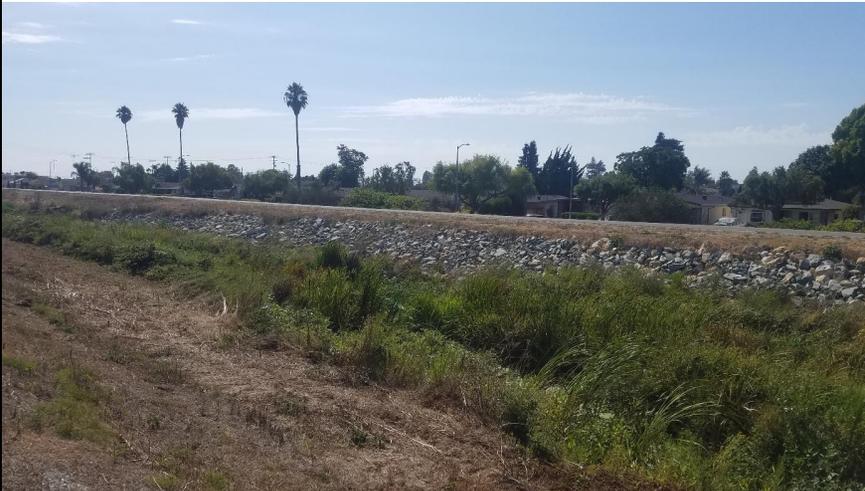
Inspect ID: PJRU_2019_a_0007 **Title:** USACE_CESPN_PJRU_2019_a_0007_1.jpg
Rated Item: 2. Shoaling (sediment deposition) **Caption:** Rating: Unacceptable; Remarks: Dense vegetation and shoaling approximately 1000 ft long observed in the channel.; Action: A Hydrologic and Hydraulic analysis should be performed to confirm the capacity of the channel. The shoal should be removed absent analysis demonstrating the hydraulic capacity is otherwise maintained.; Station_1: 27+00

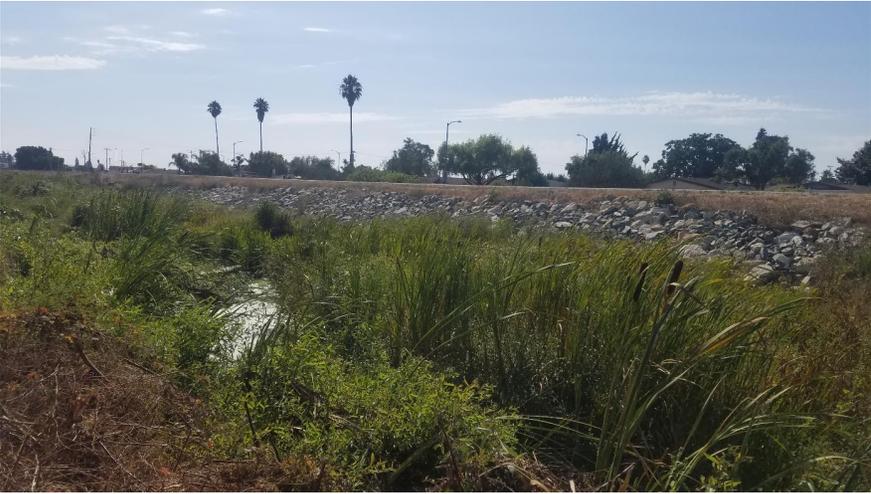
<p>Inspect ID: PJRU_2019_a_0007 Title: USACE_CESPN_PJRU_2019_a_0007_2.jpg Rated Item: 2. Shoaling (sediment deposition) Caption: Rating: Unacceptable; Remarks: Dense vegetation and shoaling approximately 1000 ft long observed in the channel.; Action: A Hydrologic and Hydraulic analysis should be performed to confirm the capacity of the channel. The shoal should be removed absent analysis demonstrating the hydraulic capacity is otherwise maintained.; Station_1: 27+00</p>
