# Assessment of Creosote-Treated Structures and Other Artificial Substrates in San Francisco Bay

Long-Term Management Strategy Science Symposium

# Subtidal Habitat Goals Project

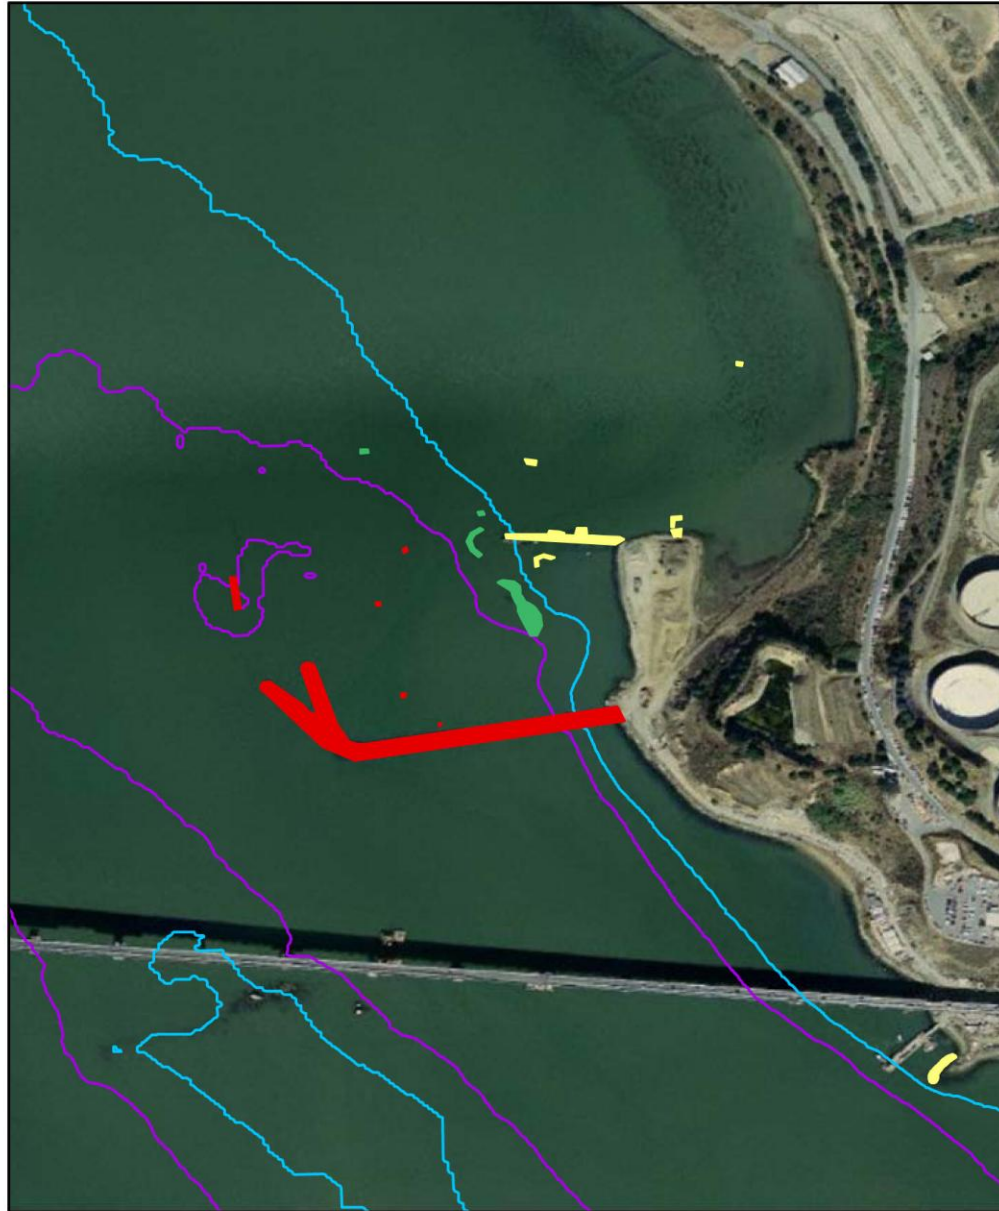
# Bathymetry

## Piling Location by Average Depth

### Average Piling Depth below MLLW

greater than 12 ft
-

11.99 to 6 ft
-

5.99 to 0 ft

### Bathymetric Contour Lines

6 ft below MLLW
-

12 ft below MLLW

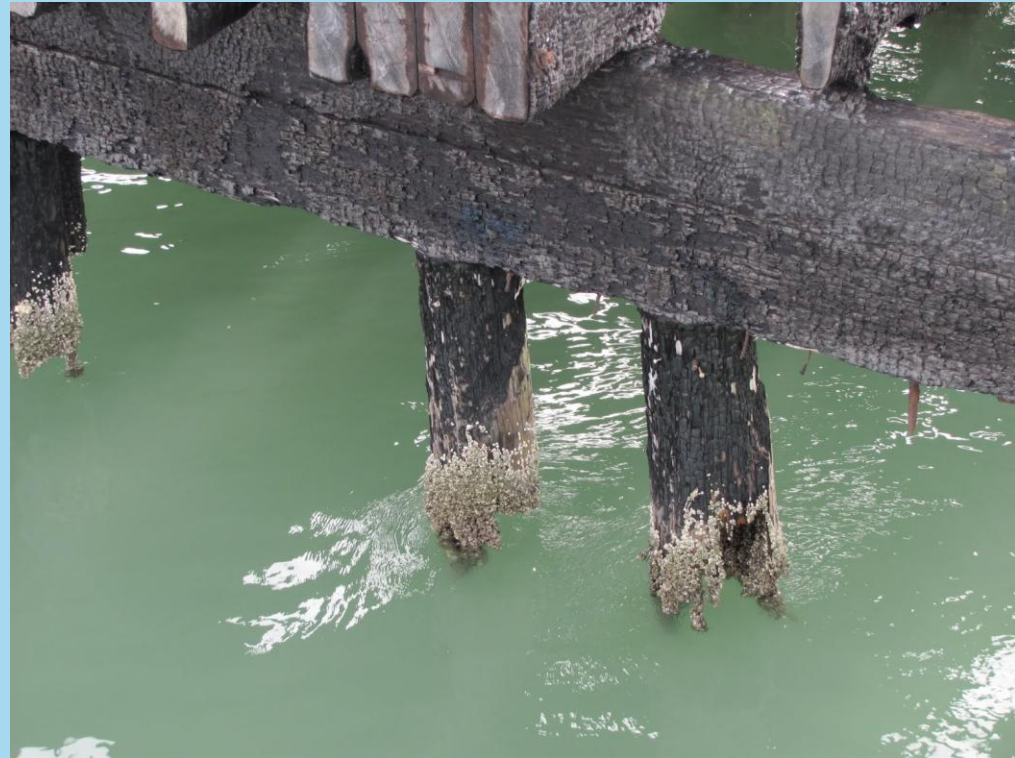
# Water Depth Requirements for Water Based Equipment

- Large marine equipment = 6 feet at MLLW
- Small marine equipment = 3 feet at MLLW
- Special considerations needed in areas of sensitive habitat e.g. eelgrass
