**GEOTECHNICAL DATA REPORT
LAGUNITAS ROAD BRIDGE
PROJECT
ROSS, CALIFORNIA**

**Job No. 43-00067008.00
January 30, 2002**

Final Geotechnical Data Report
San Francisco District COE
IDC DACW07-00-D-0003
Lagunitas Road Bridge Project
Ross, California

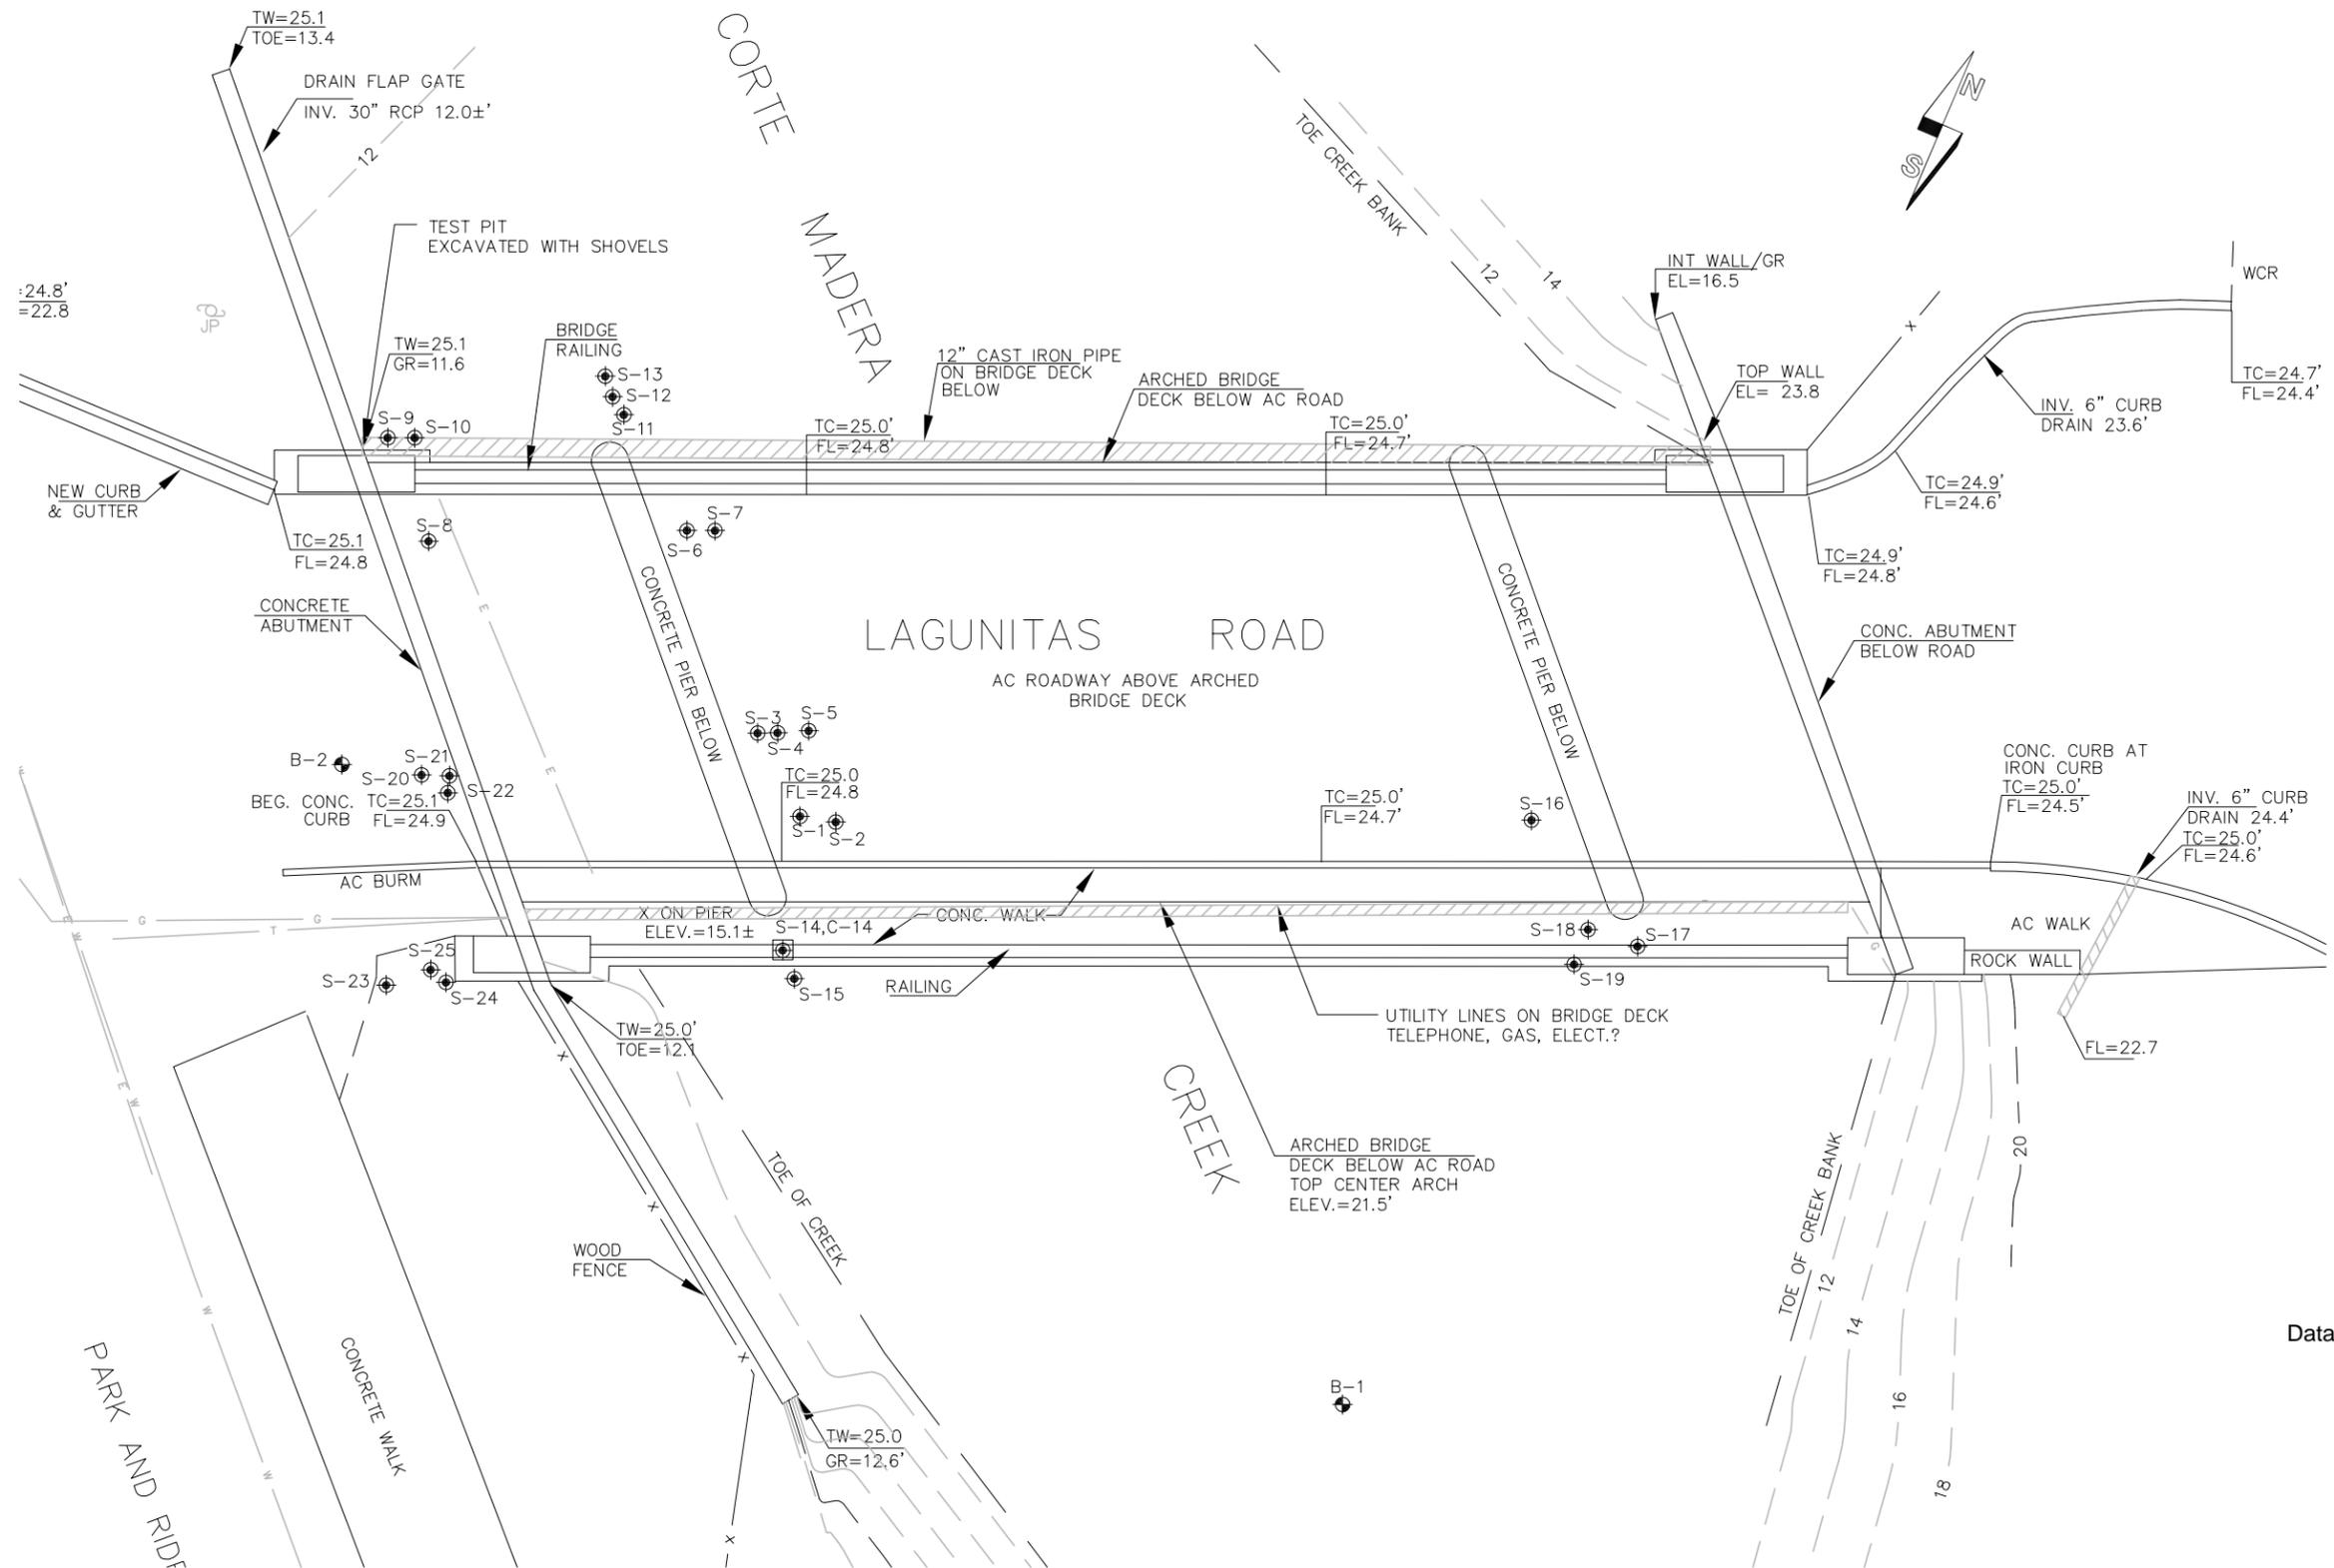
FIGURE 2

- ⊕ Auger Soundings
- ⊕ Auger Sounding and Foundation Core Hole
- ⊕ Geotechnical Boreholes

Based on soundings S-9 and S-10 (Table 4) and the excavated test pit (location shown on Figure 2), the retaining wall is supported on a spread footing foundation that extends 33 inches east from the wall face. The top of the foundation is 1.1 feet below the streambed level (at the time of exploration) and the bottom is 2.1 feet below the streambed level. Based on the elevation at the time of our exploration, the top of the foundation is 10.5 feet NGVD.

Sounding S-8 (Figure 2) indicates any foundation extending beyond the east face of the west headwall is less than 18 inches. No foundation was encountered in S-8 within the 14.4 foot depth investigated (Table 4). Soundings S-20 and S-22 did not encounter a foundation within the depths investigated (S-20, 36.5 feet and S-22, 30.5 feet). Sounding holes S-23 through S-25 did not encounter any wing wall coming off the west headwall. The bottom elevation of the west abutment headwall cannot be determined from this exploration since no foundation was encountered in soundings S-8 and S-22.

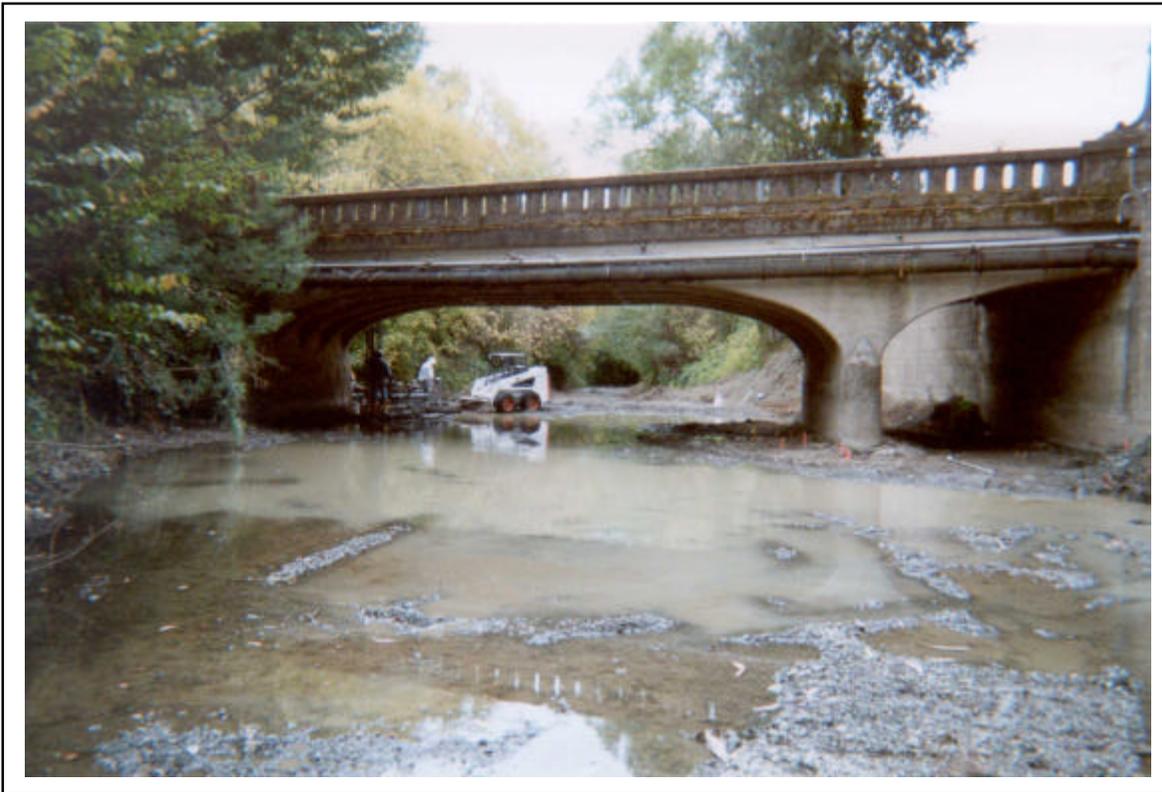
FIGURE 3

Photograph 1: Elevation View of Lagunitas Road Bridge - looking to south from the middle of the streambed.

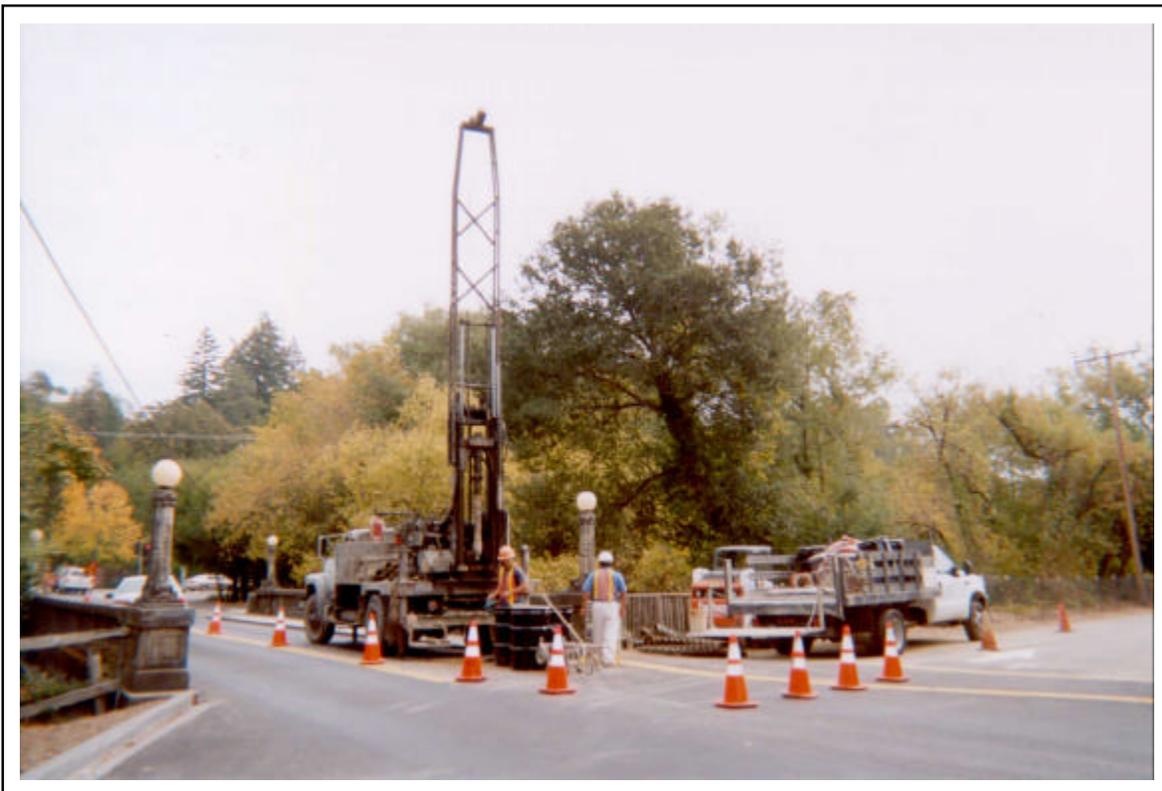
Photograph 2: Roadway View of Lagunitas Road Bridge - looking towards east (Sir Francis Drake Blvd.). Also, shows CME 75 rig drilling a sounding hole in the west abutment.

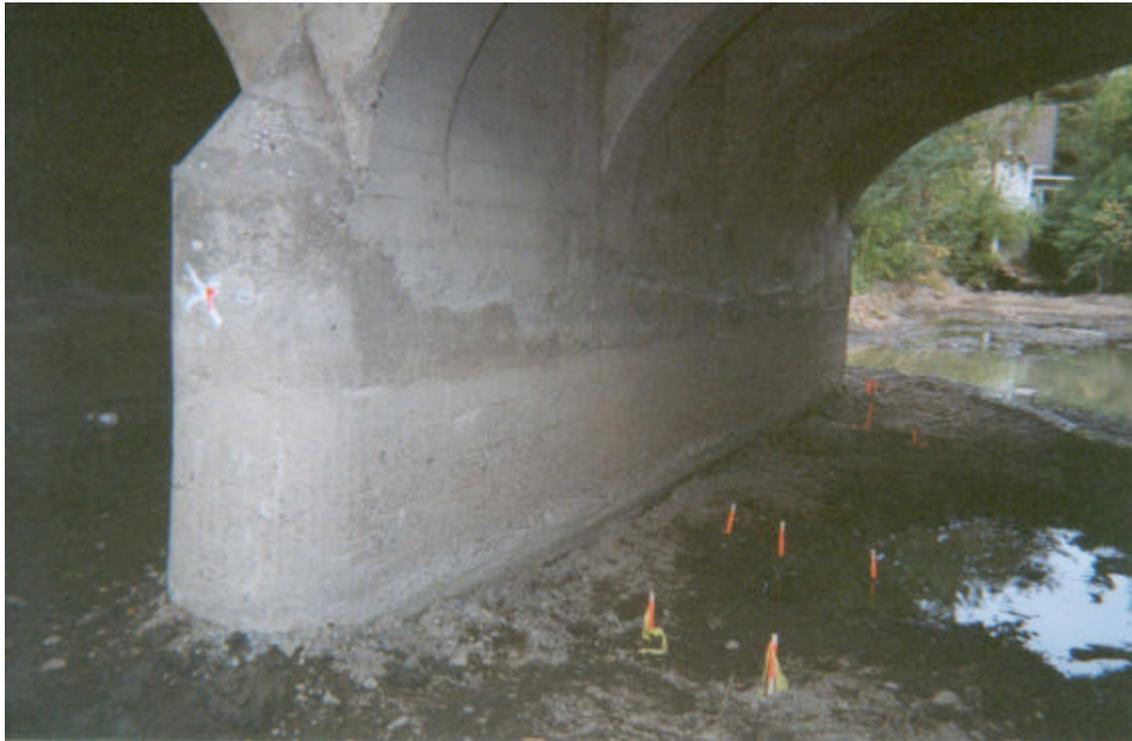
FIGURE 4

Photograph 3: View of west bridge pier - looking to north. Shows staked locations of 10 sounding holes drilled along east and north sides of the west pier.

Along the east side of the west bridge pier seven sounding holes were drilled. The staked locations (i.e., after drilling) of the seven sounding holes are shown on Photograph 3, Figure 4. In addition, three soundings were drilled north of the west pier and two soundings were drilled south of the west pier. Specific locations of the twelve soundings drilled adjacent to the west pier are presented in Figure 2, Boring and Sounding Location Plan. At sounding location S-14, the pier foundation concrete was cored (C-14) to evaluate the condition of the concrete and to determine the foundation thickness.

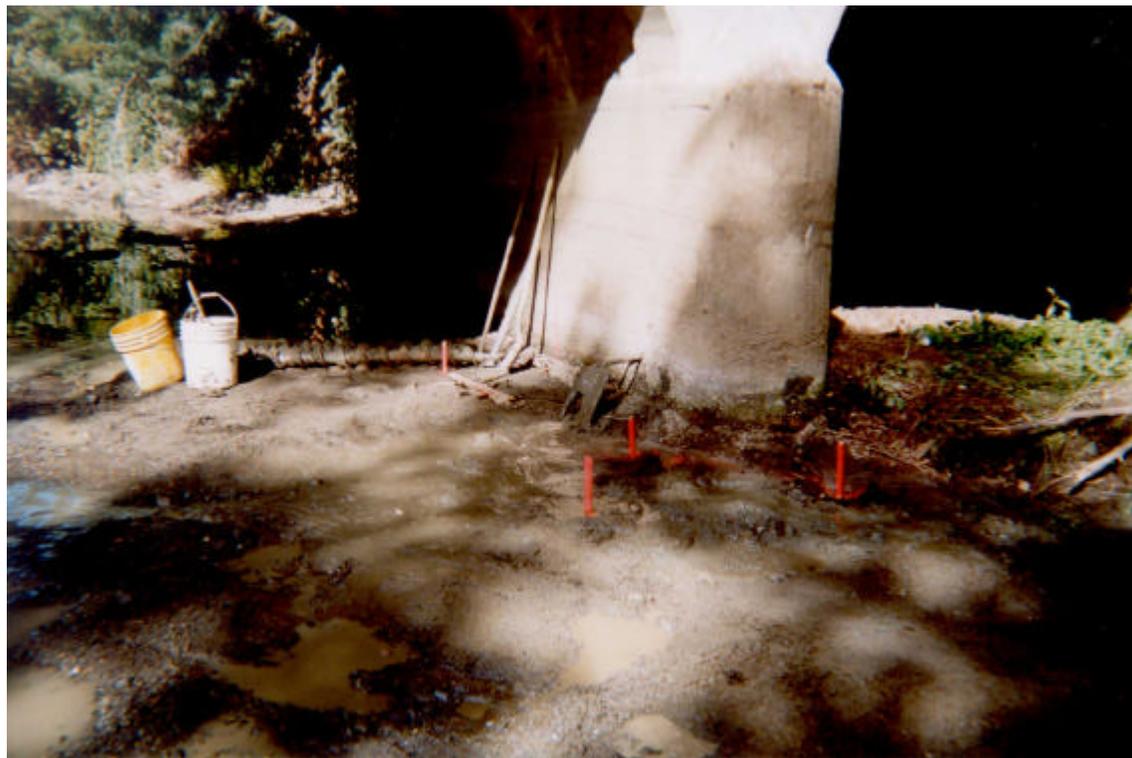
Photograph 4: View of east bridge pier - looking to north. Shows staked locations of 4 sounding holes drilled west and south of the east pier.

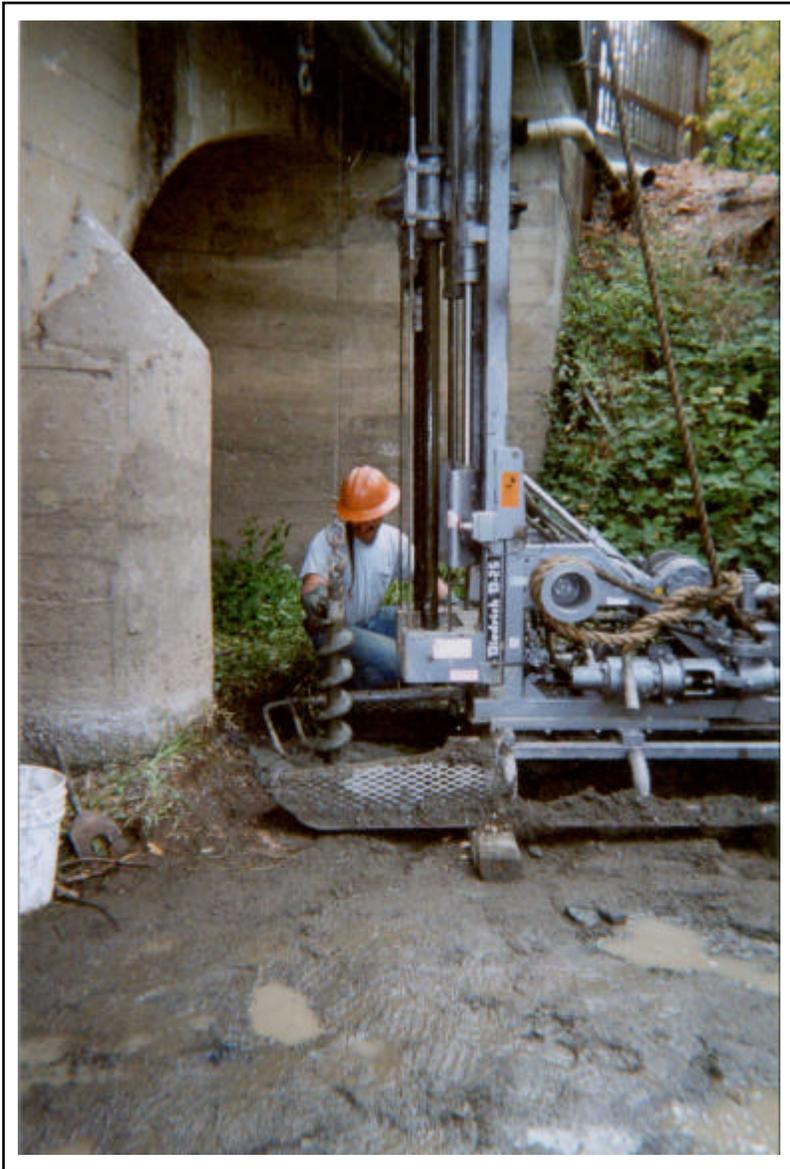
FIGURE 5

Photograph 5: Shows skid-mounted Diedrich D-25 rig drilling sounding hole S-17 south of the east bridge pier.

The streambed soundings were advanced using a skid-mounted Diedrich D-25 rig with 6-inch-diameter solid shaft continuous flight augers. The surrounding holes were advanced until foundation concrete (refusal) was encountered or to a maximum depth of 19.4 feet. The drilling contractor for this work was HEW Drilling Company, Inc. (HEW). The rig and drilling method are shown in Photograph 5, Figure 5. The Diedrich D-25 rig was lowered into the creek with a 30-ton crane and was moved with a Bobcat loader.

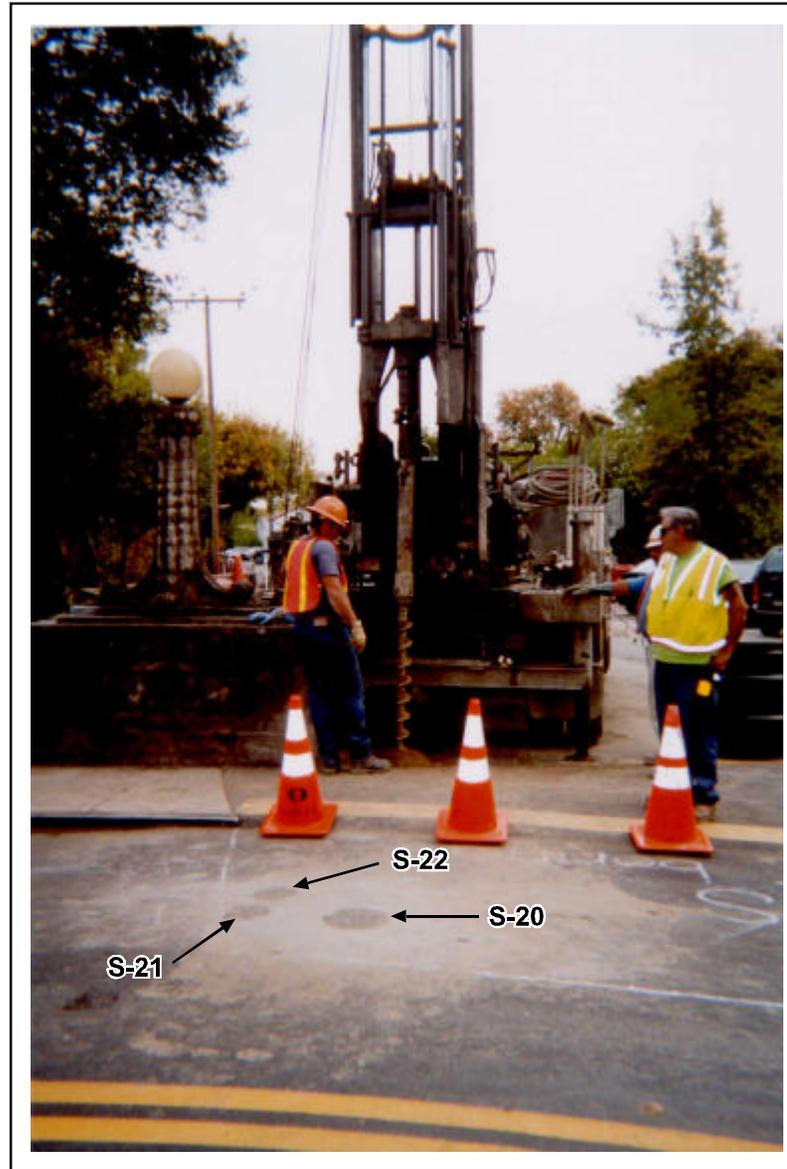
Photograph 6: Shows truck-mounted CME 75 rig drilling sounding hole S-25 and the locations of sounding holes S-20, S-21, and S-22 in the west abutment.

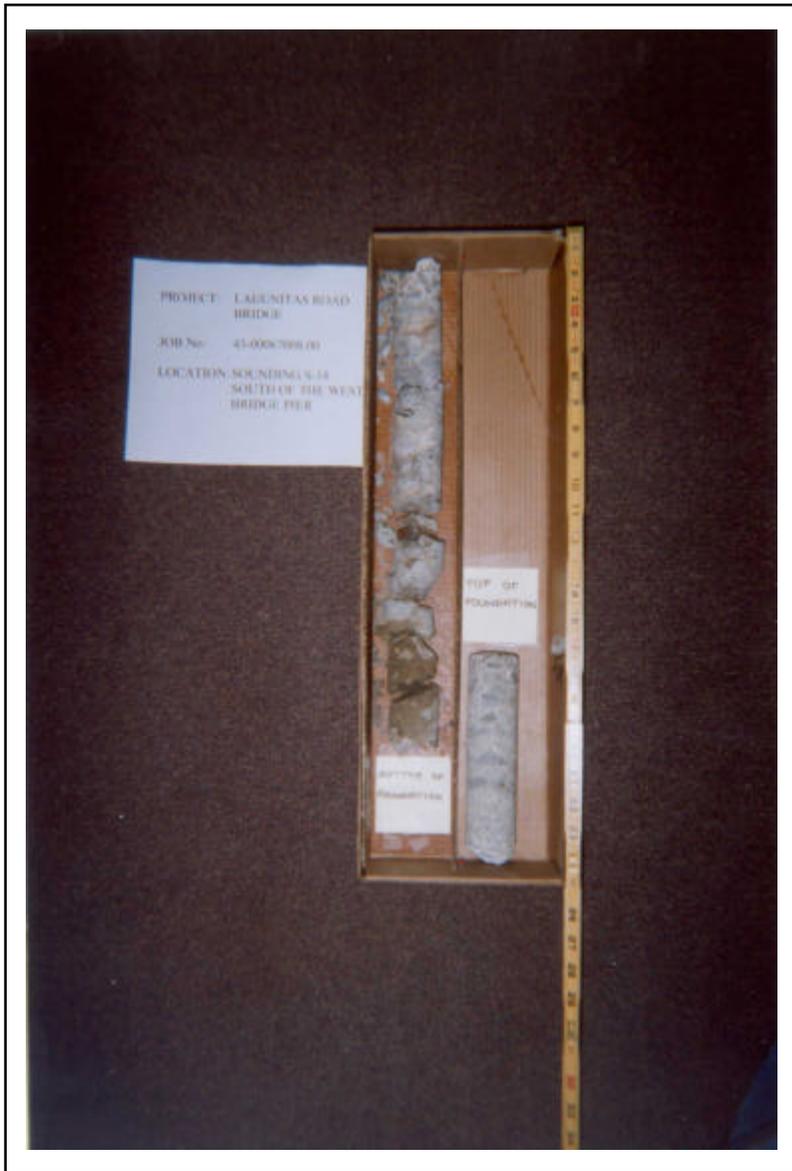
FIGURE 6

Photograph 7: Shows core of foundation concrete sounding S-14, C-14 recovered from the south end of the west bridge pier. Total length of the concrete core is 27 inches.

For drilling the foundation core boring (S-14/C-14), the skid-mounted Diedrich D-25 rig was used. Hollow stem continuous augers were used to case through the overburden soils above the west pier foundation. After setting the hollow stem augers on the foundation, the drilling method was converted to a rotary/diamond coring procedure.

The double-tube core barrel with a 5-foot-long split inner barrel and a diamond bit was used to core the foundation concrete (S-14/C-14) and the rock (B-2). A “NV” size core (1.99-inch diameter) was recovered.

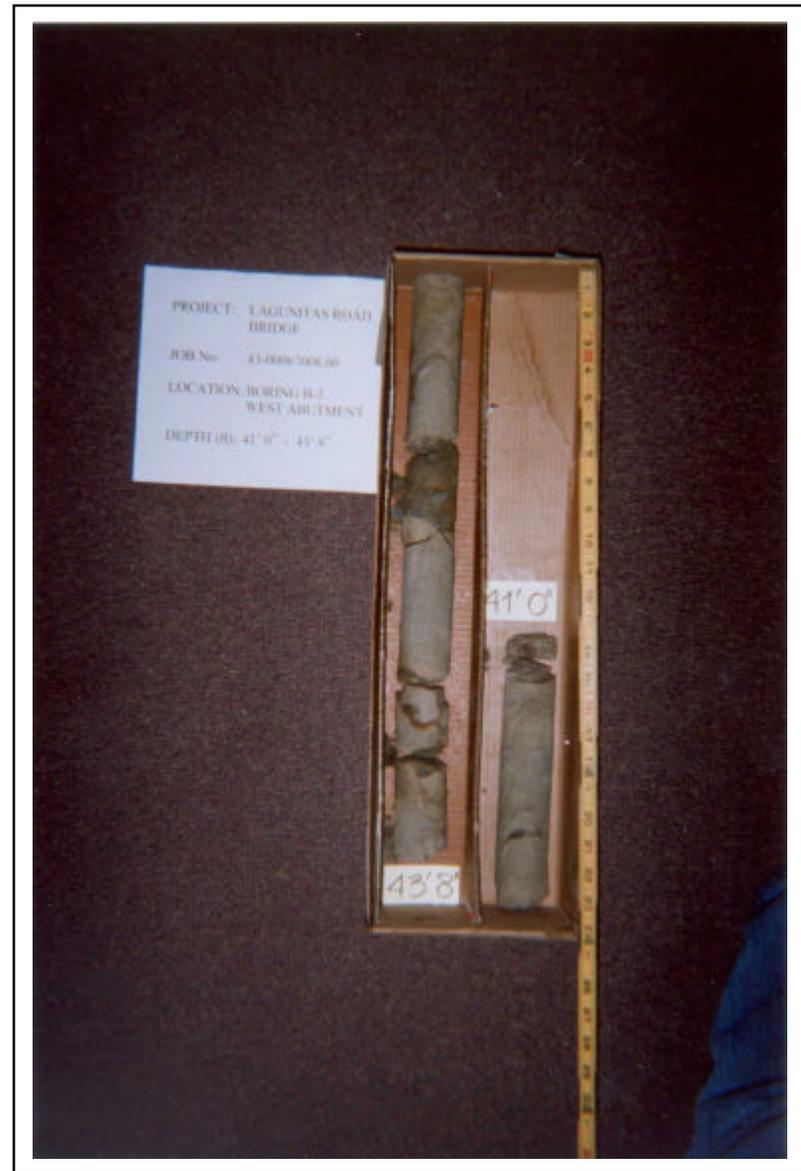
Photograph 8: Shows rock core recovered from geotechnical borehole B-2 (west abutment). Rock is graywacke sandstone.

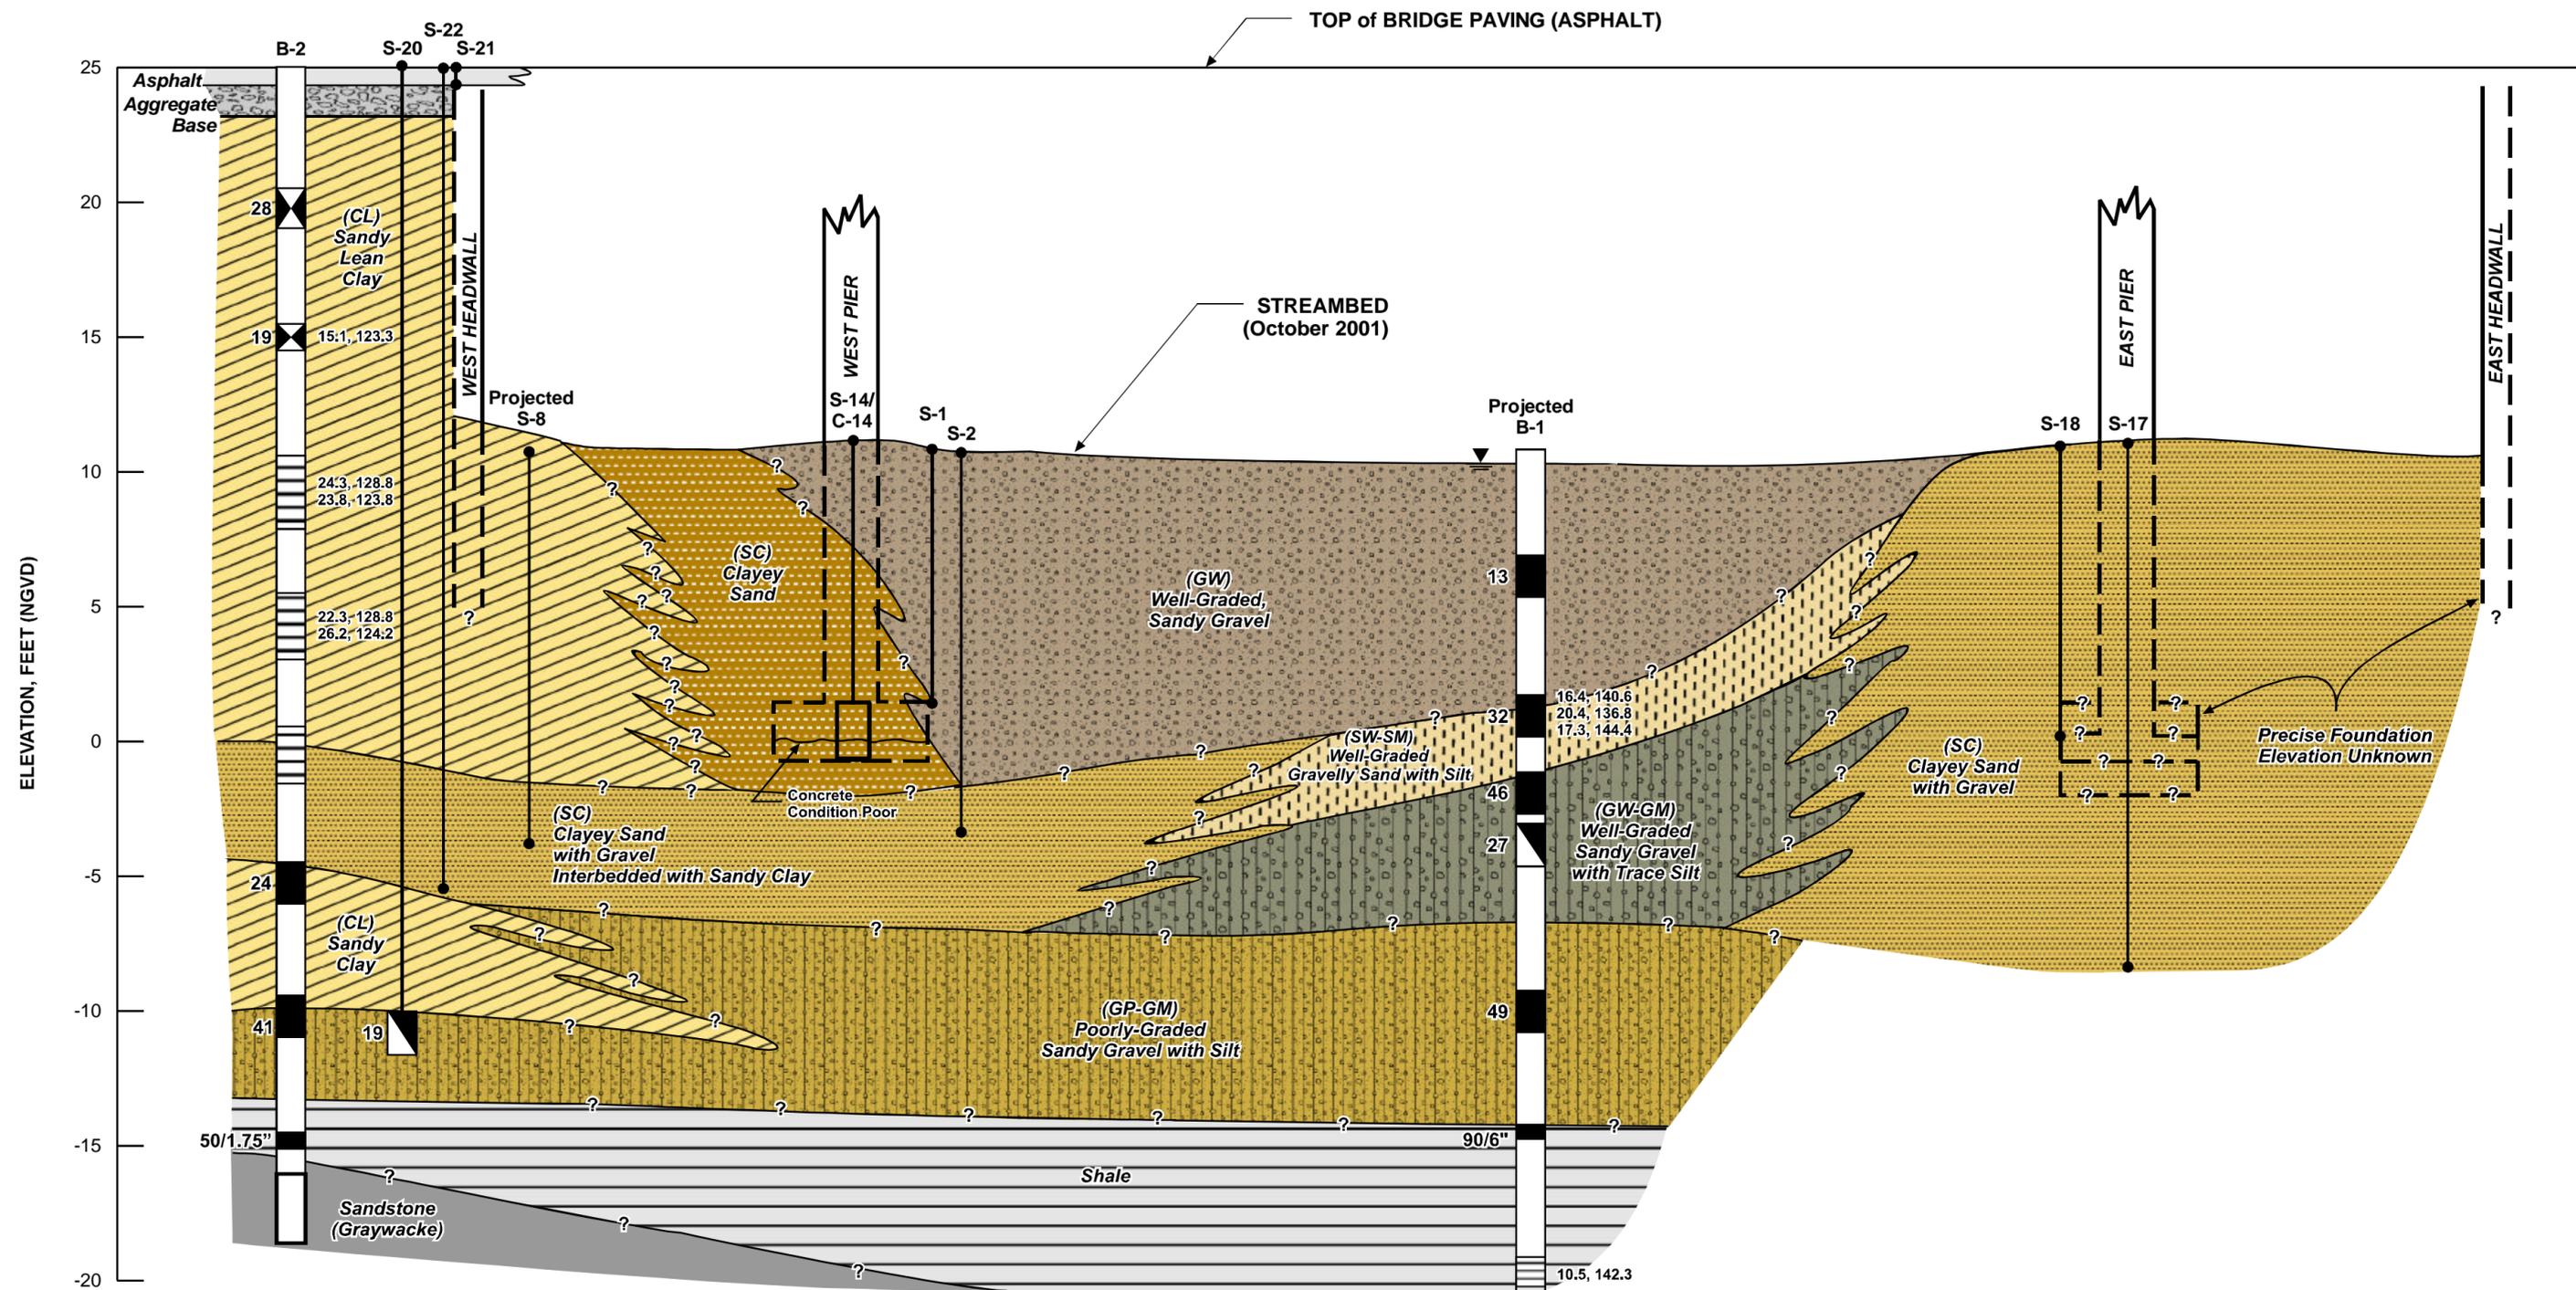
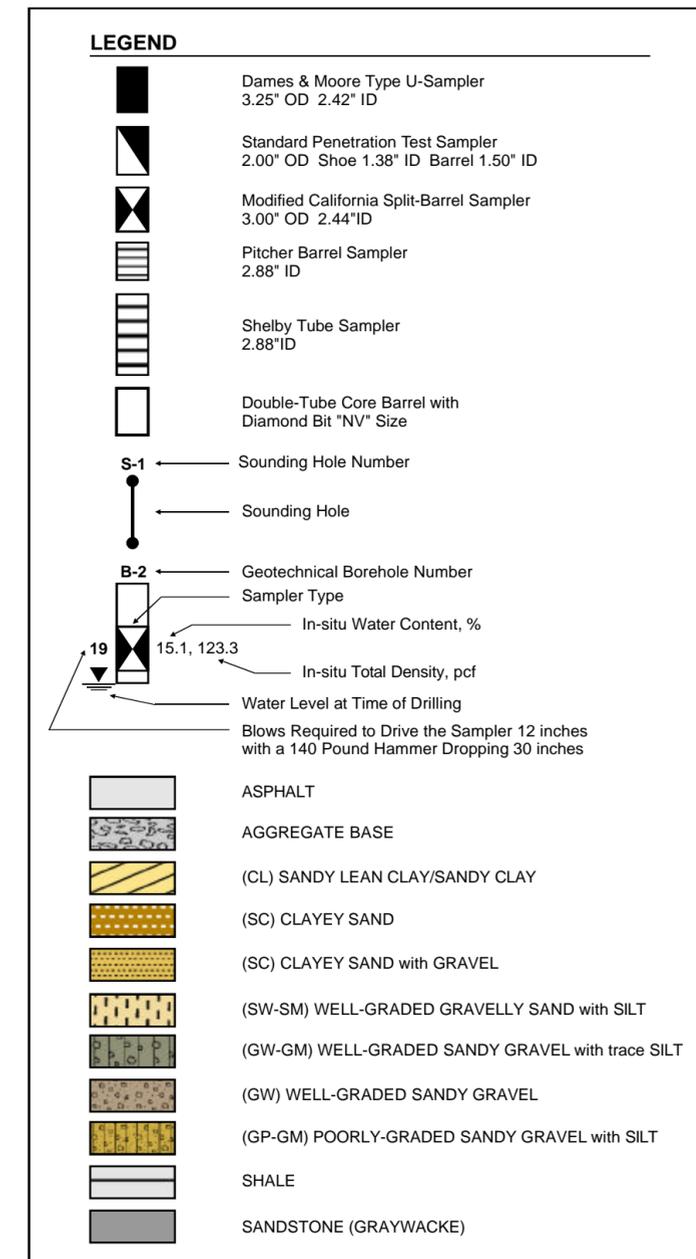
SUBSURFACE PROFILE
 Lagunitas Road Bridge Project
 Geotechnical Data Report
 January 2002
 43-00067008.00
 Ross, California

Sounding holes S-1, S-3, S-6, S-11, S-12, and S-14 encountered very hard drilling and/or auger refusal at about 9.2 to 9.8 feet below the streambed level at the time of our exploration. The soil conditions and description of drilling conditions for 12 sounding holes advanced adjacent to the west bridge pier are presented in Table 4. The very hard drilling and/or auger refusal encountered in six sounding holes is related to the west pier foundation. This conclusion was confirmed with the recovery of the 27 inch concrete core from S-14/C-14, and the visual inspection conducted by Sverdrup/Gerwick JV in the test pit dug to expose the foundation along the west side of the west bridge pier (oral communication with Robert Filgas, November 5, 2001). Based on the Sverdrup/Gerwick JV inspection, the west bridge pier is supported on a spread footing foundation. The estimated dimensions of the west pier foundation are 5.7 feet wide, 32.5 feet long, and 2.3 feet (27 inches) deep. Based on the concrete core, the lower 10 inches of the 27-inch core indicates that the concrete was placed under water because of secretion evidence (i.e., cement paste washed out) as shown in Photograph 7, Figure 6. The west pier foundation elevation is shown in Figure 7. The top of the footing foundation is at elevation 1.5 feet (NGVD) and the bottom is at elevation -0.75 feet (NGVD).

Based on sounding S-18 (Table 4), the top of the pier foundation may be at 10.7 feet below the streambed level at the time of our exploration. The four sounding holes would indicate that the width of the foundation is 5 feet and that it extends less than 1.5 feet on the southern side of the east pier. Based on the data collected at the southern end of the east pier, the estimated dimensions of the foundation are 5 feet wide and 30 feet long. Since the west bridge pier is supported on a spread footing foundation, it is assumed that the east bridge pier is also supported on the same type of foundation. A precise foundation elevation was not determined for the east bridge pier. Estimated foundation elevations are presented in Figure 7. The top of the footing foundation may be at elevation 1.5 feet (NGVD), based on the data from the west pier location or at elevation 0.25 feet (NGVD), based on the results of S-18.

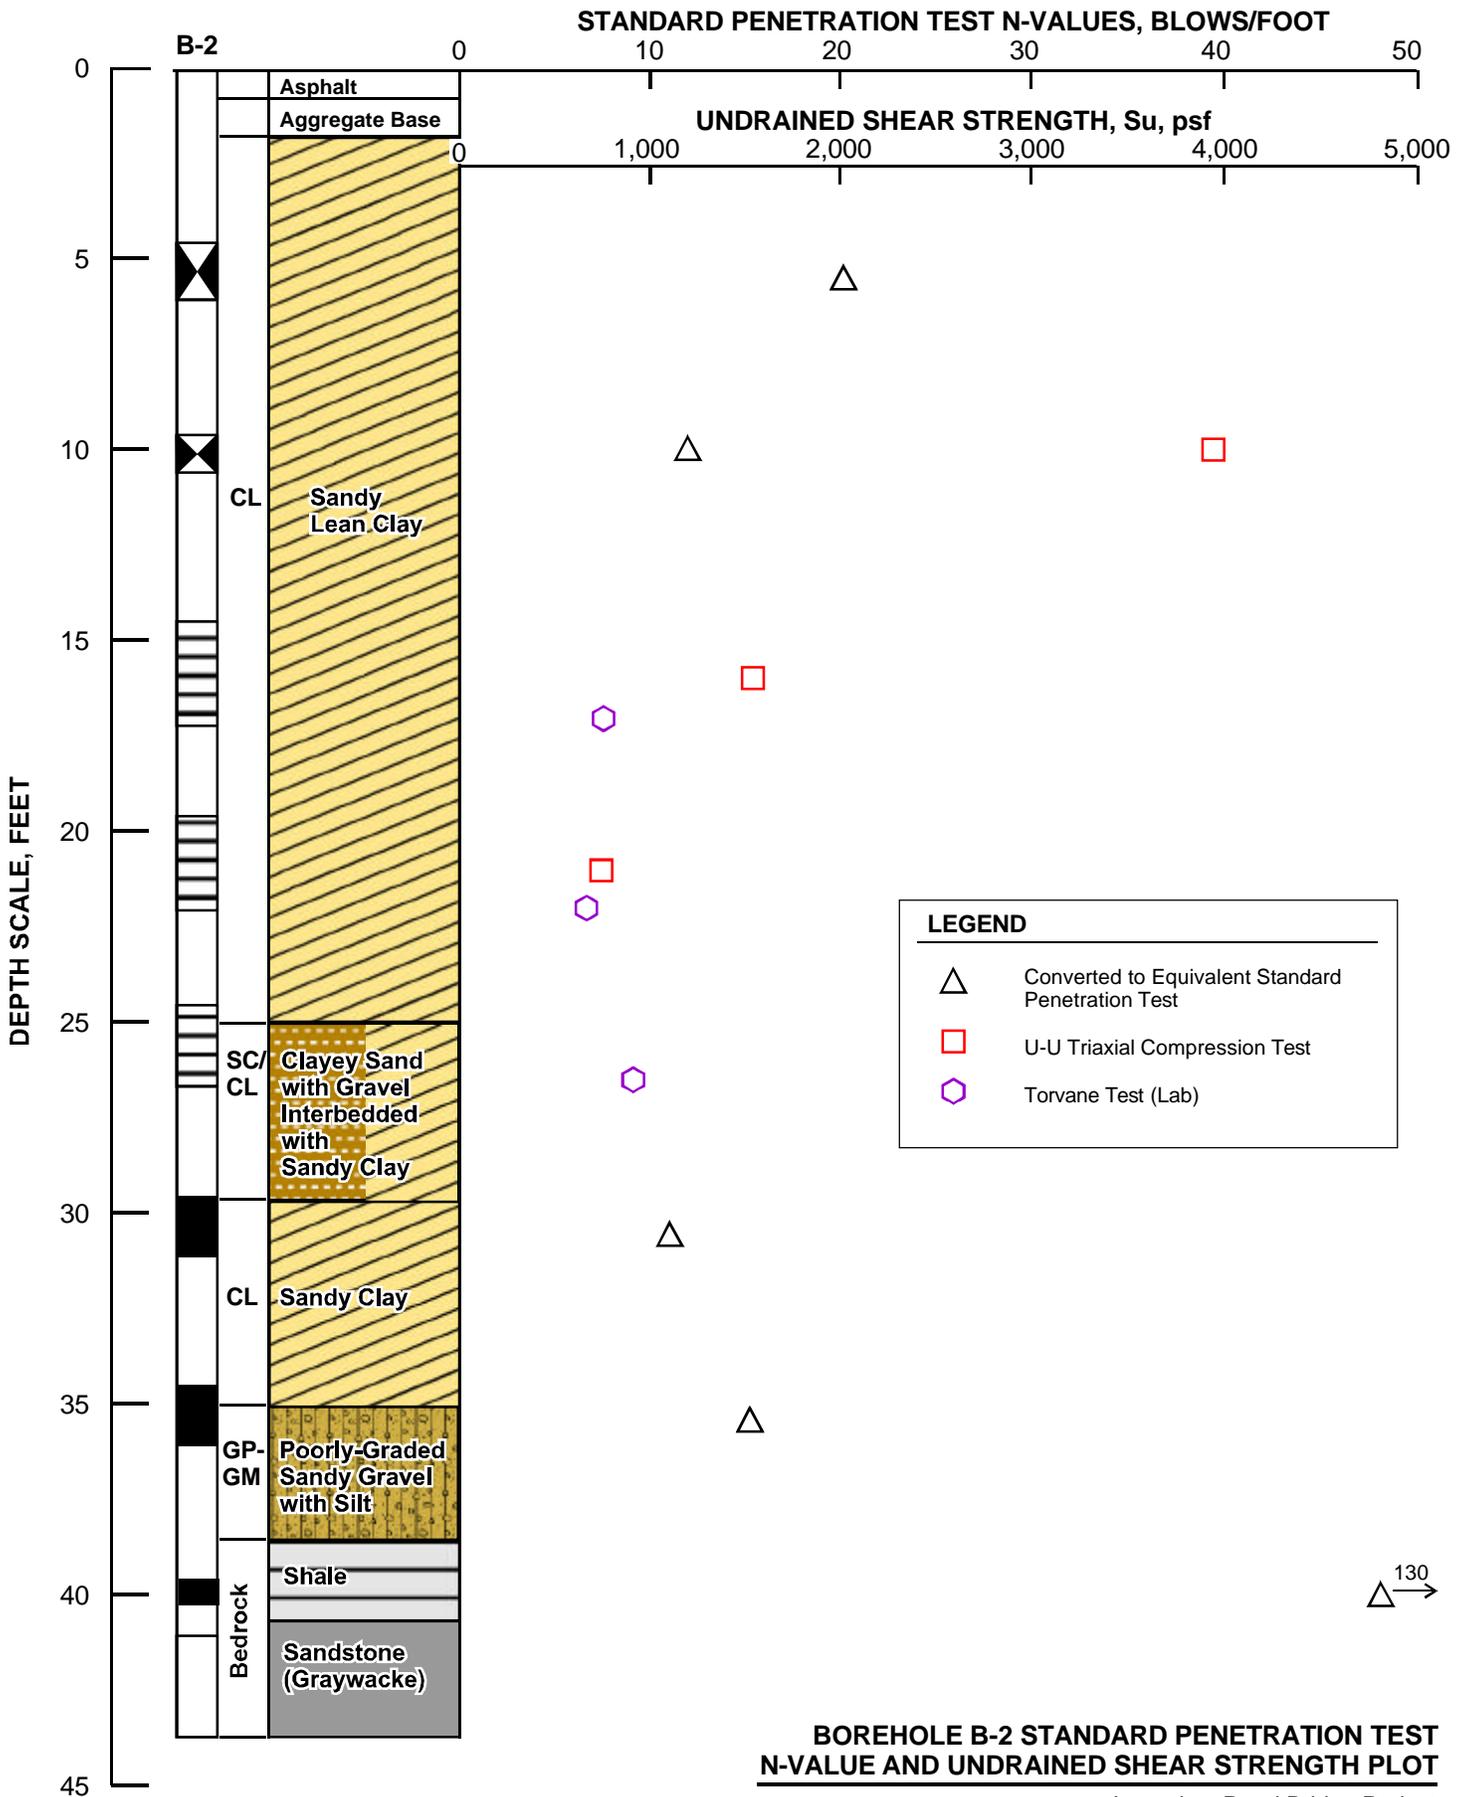
FIGURE 8

BOREHOLE B-2 STANDARD PENETRATION TEST N-VALUE AND UNDRAINED SHEAR STRENGTH PLOT

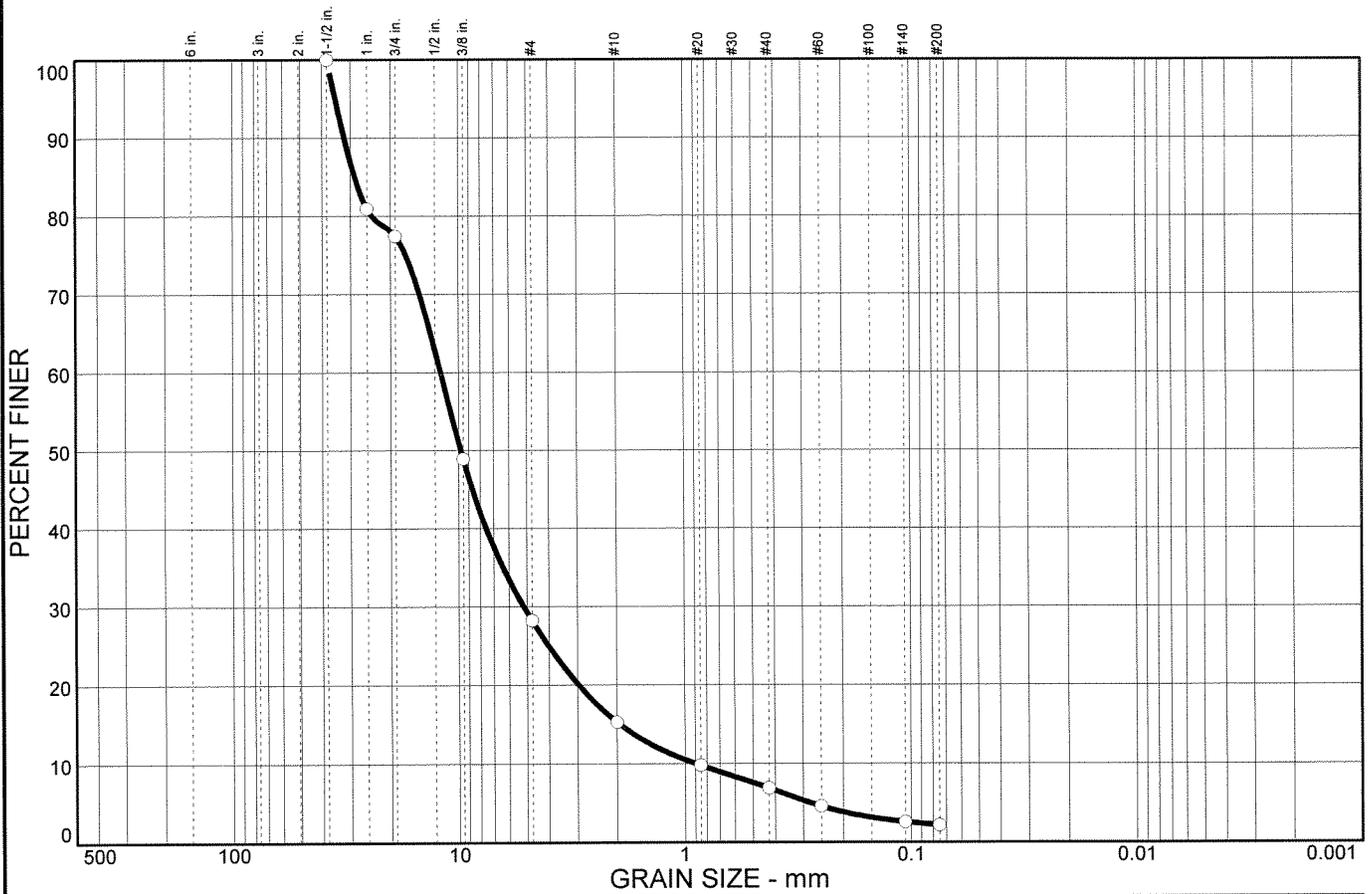
% COBBLES	% GRAVEL		% SAND			% FINES	
	CRS.	FINE	CRS.	MEDIUM	FINE	SILT	CLAY
0.0	22.6	49.2	12.9	8.4	4.7	2.2

SIEVE SIZE	PERCENT FINER	SPEC.* PERCENT	PASS? (X=NO)
1.5 in.	100.0		
1 in.	80.9		
3/4 in.	77.4		
3/8 in.	48.9		
#4	28.2		
#10	15.3		
#20	9.8		
#40	6.9		
#60	4.6		
#140	2.6		
#200	2.2

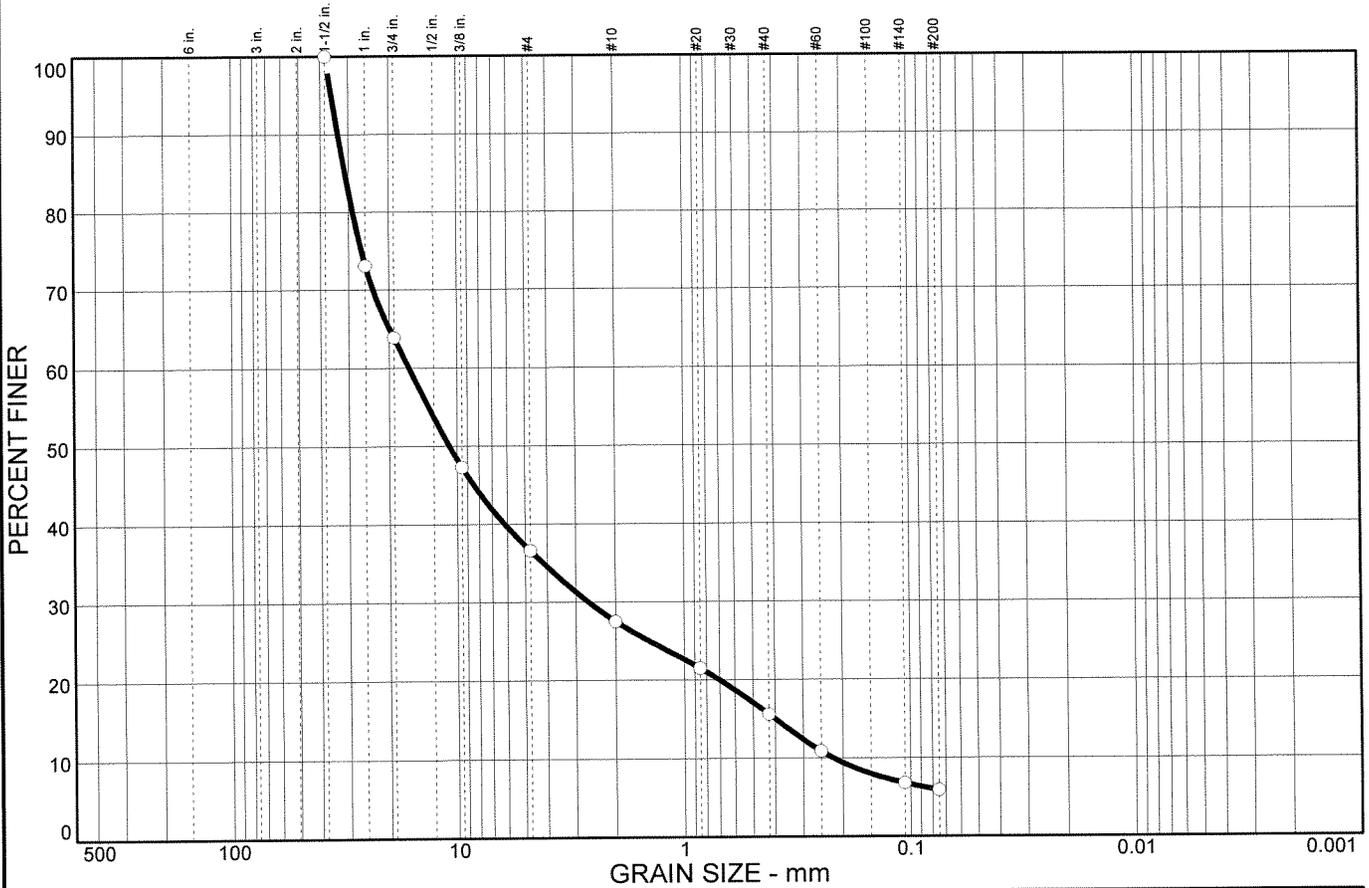
% COBBLES	% GRAVEL		% SAND			% FINES	
	CRS.	FINE	CRS.	MEDIUM	FINE	SILT	CLAY
0.0	36.1	27.3	9.1	11.9	9.7	5.9

SIEVE SIZE	PERCENT FINER	SPEC.* PERCENT	PASS? (X=NO)
1.5 in.	100.0		
1 in.	73.1		
3/4 in.	63.9		
3/8 in.	47.3		
#4	36.6		
#10	27.5		
#20	21.5		
#40	15.6		
#60	10.9		
#140	6.8		
#200	5.9
