**GEOTECHNICAL DATA REPORT
LAGUNITAS ROAD BRIDGE
PROJECT
ROSS, CALIFORNIA**

**Job No. 43-00067008.00
January 30, 2002**

Final Geotechnical Data Report
San Francisco District COE
IDC DACW07-00-D-0003
Lagunitas Road Bridge Project
Ross, California

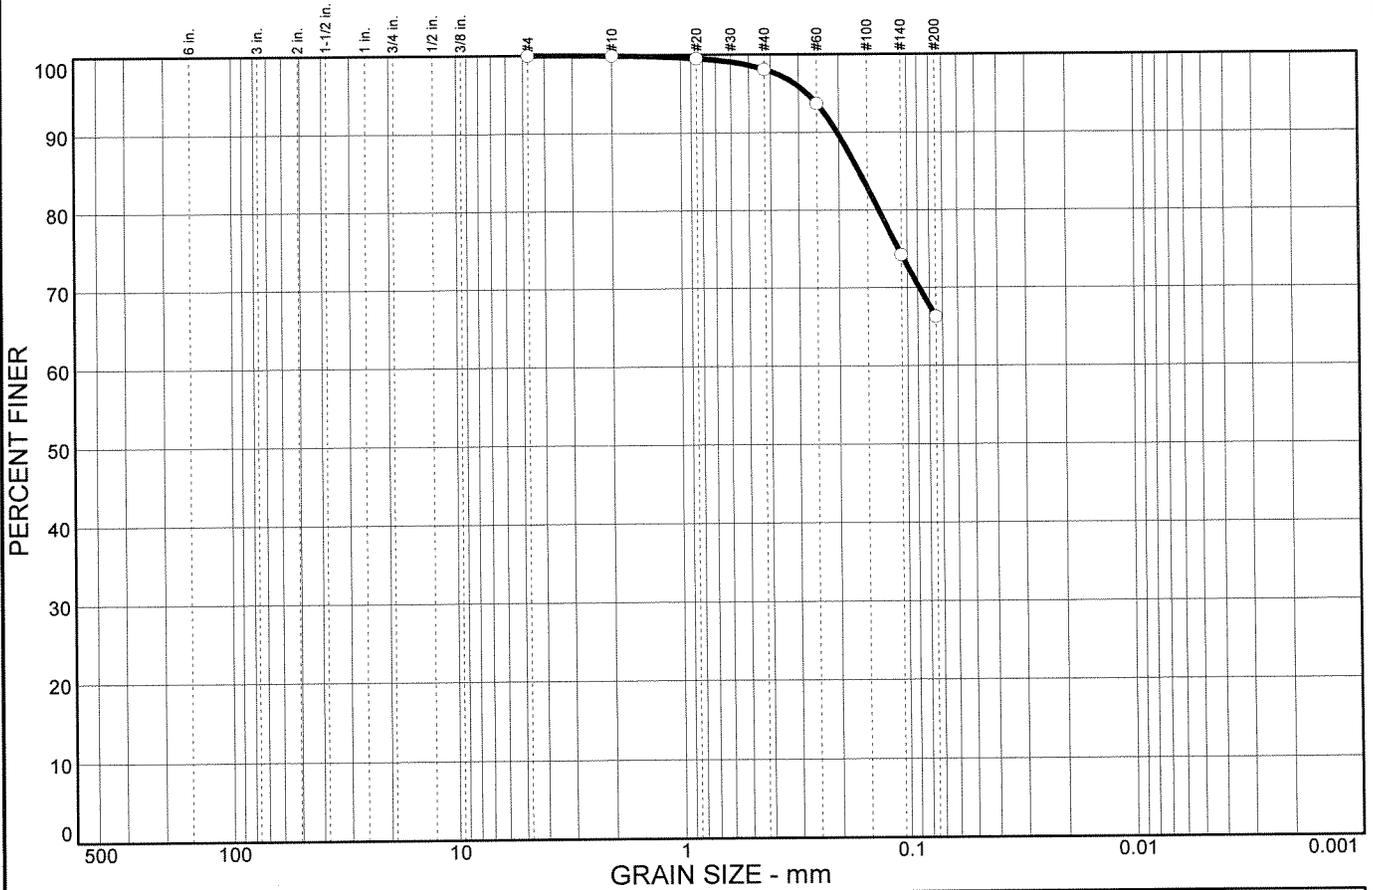
% COBBLES	% GRAVEL		% SAND			% FINES	
	CRS.	FINE	CRS.	MEDIUM	FINE	SILT	CLAY
0.0	0.0	0.0	0.1	1.8	31.8	66.3

SIEVE SIZE	PERCENT FINER	SPEC.* PERCENT	PASS? (X=NO)
#4	100.0		
#10	99.9		
#20	99.5		
#40	98.1		
#60	93.7		
#140	74.2		
#200	66.3

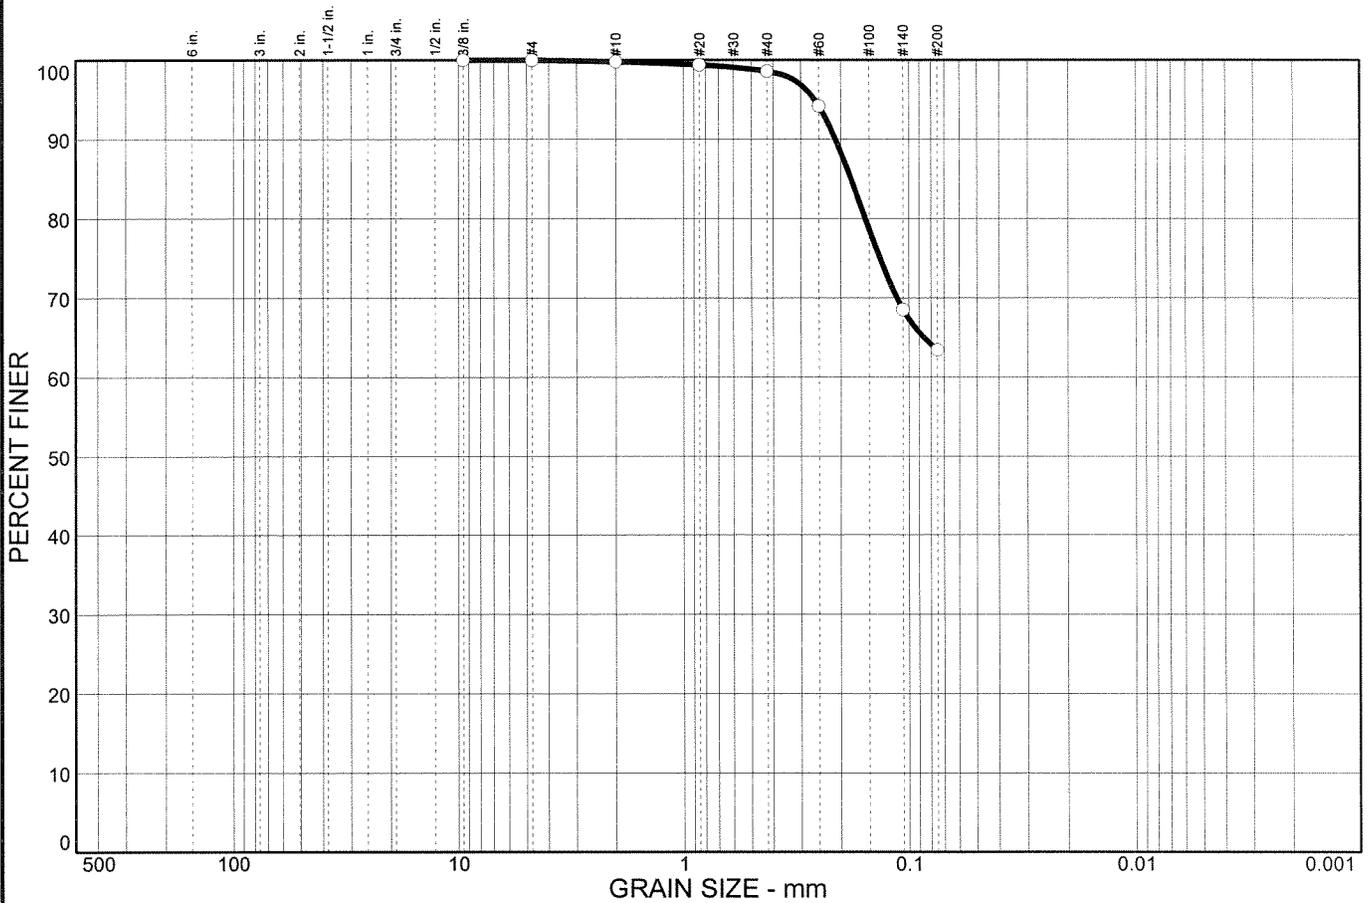
% COBBLES	% GRAVEL		% SAND			% FINES	
	CRS.	FINE	CRS.	MEDIUM	FINE	SILT	CLAY
0.0	0.0	0.0	0.2	1.2	35.2	63.4

SIEVE SIZE	PERCENT FINER	SPEC.* PERCENT	PASS? (X=NO)
3/8 in.	100.0		
#4	100.0		
#10	99.8		
#20	99.4		
#40	98.6		
#60	94.2		
#140	68.5		
#200	63.4

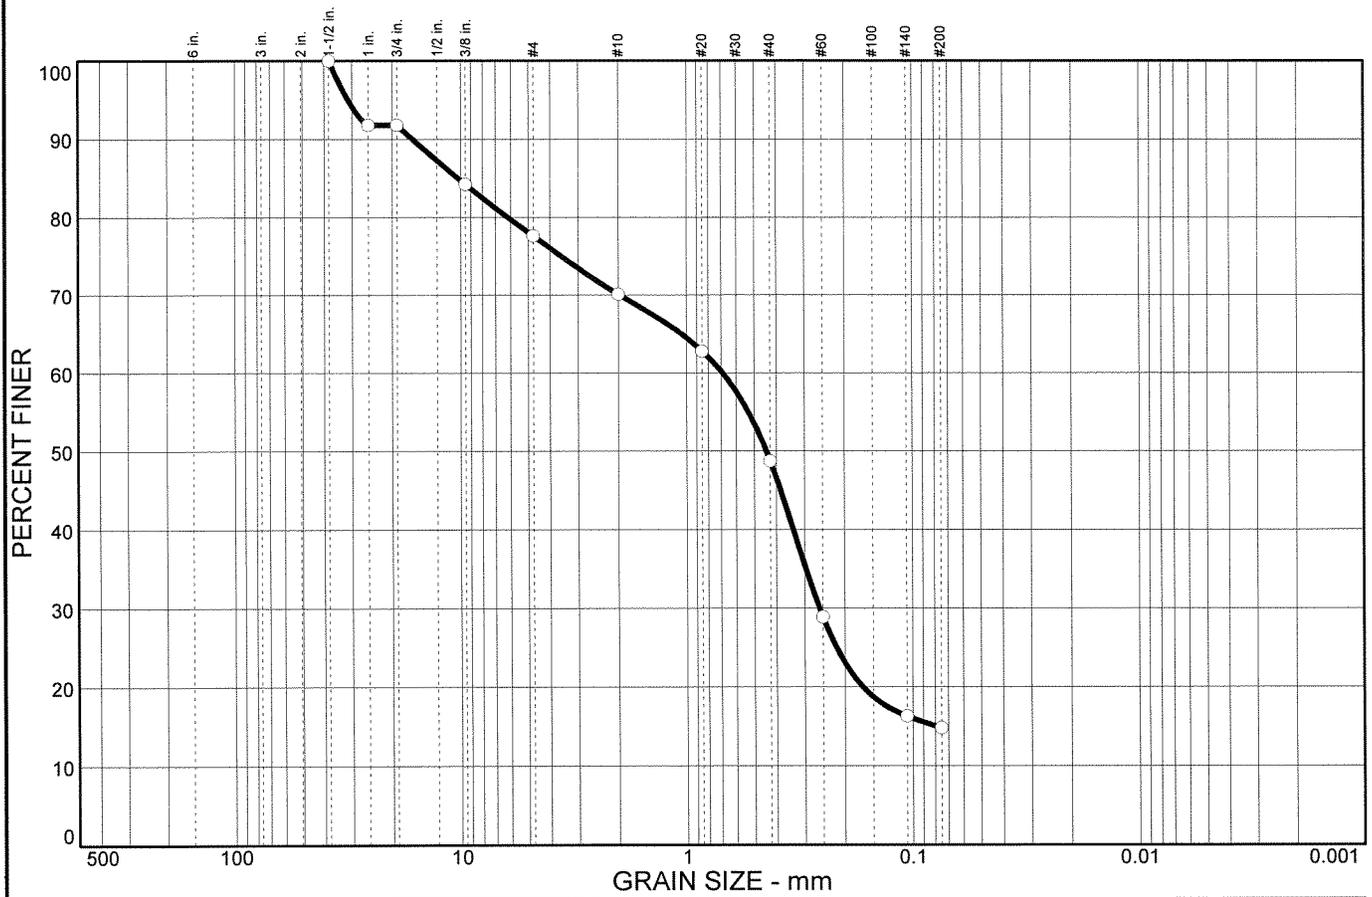
% COBBLES	% GRAVEL		% SAND			% FINES	
	CRS.	FINE	CRS.	MEDIUM	FINE	SILT	CLAY
0.0	8.2	14.2	7.5	21.4	33.9	14.8

SIEVE SIZE	PERCENT FINER	SPEC.* PERCENT	PASS? (X=NO)
1.5 in.	100.0		
1 in.	91.8		
3/4 in.	91.8		
3/8 in.	84.2		
#4	77.6		
#10	70.1		
#20	62.8		
#40	48.7		
#60	28.9		
#140	16.3		
#200	14.8

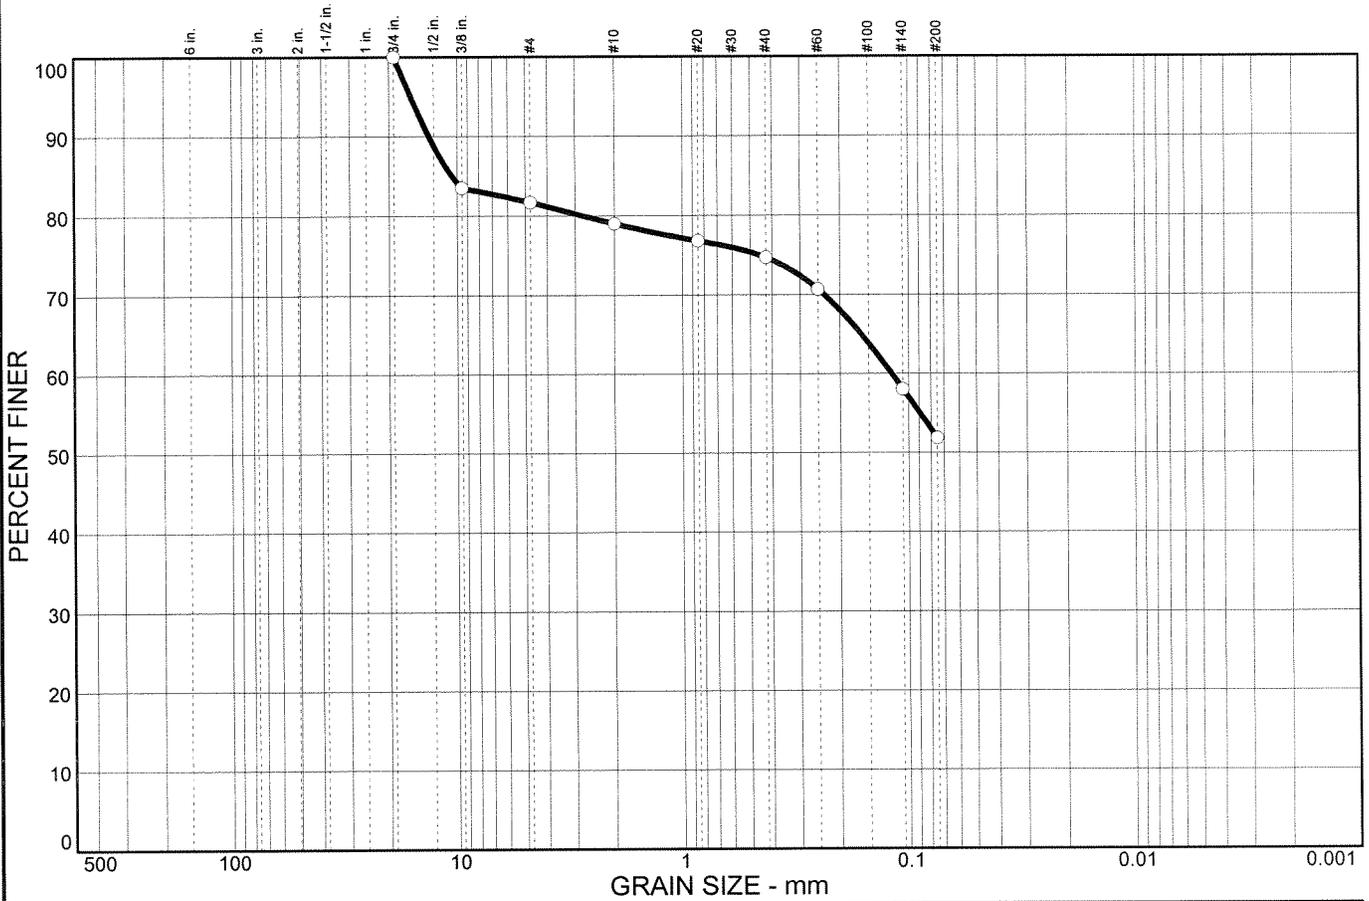
% COBBLES	% GRAVEL		% SAND			% FINES	
	CRS.	FINE	CRS.	MEDIUM	FINE	SILT	CLAY
0.0	0.0	18.3	2.7	4.3	22.9	51.8

SIEVE SIZE	PERCENT FINER	SPEC.* PERCENT	PASS? (X=NO)
3/4 in.	100.0		
3/8 in.	83.5		
#4	81.7		
#10	79.0		
#20	76.8		
#40	74.7		
#60	70.7		
#140	58.0		
#200	51.8

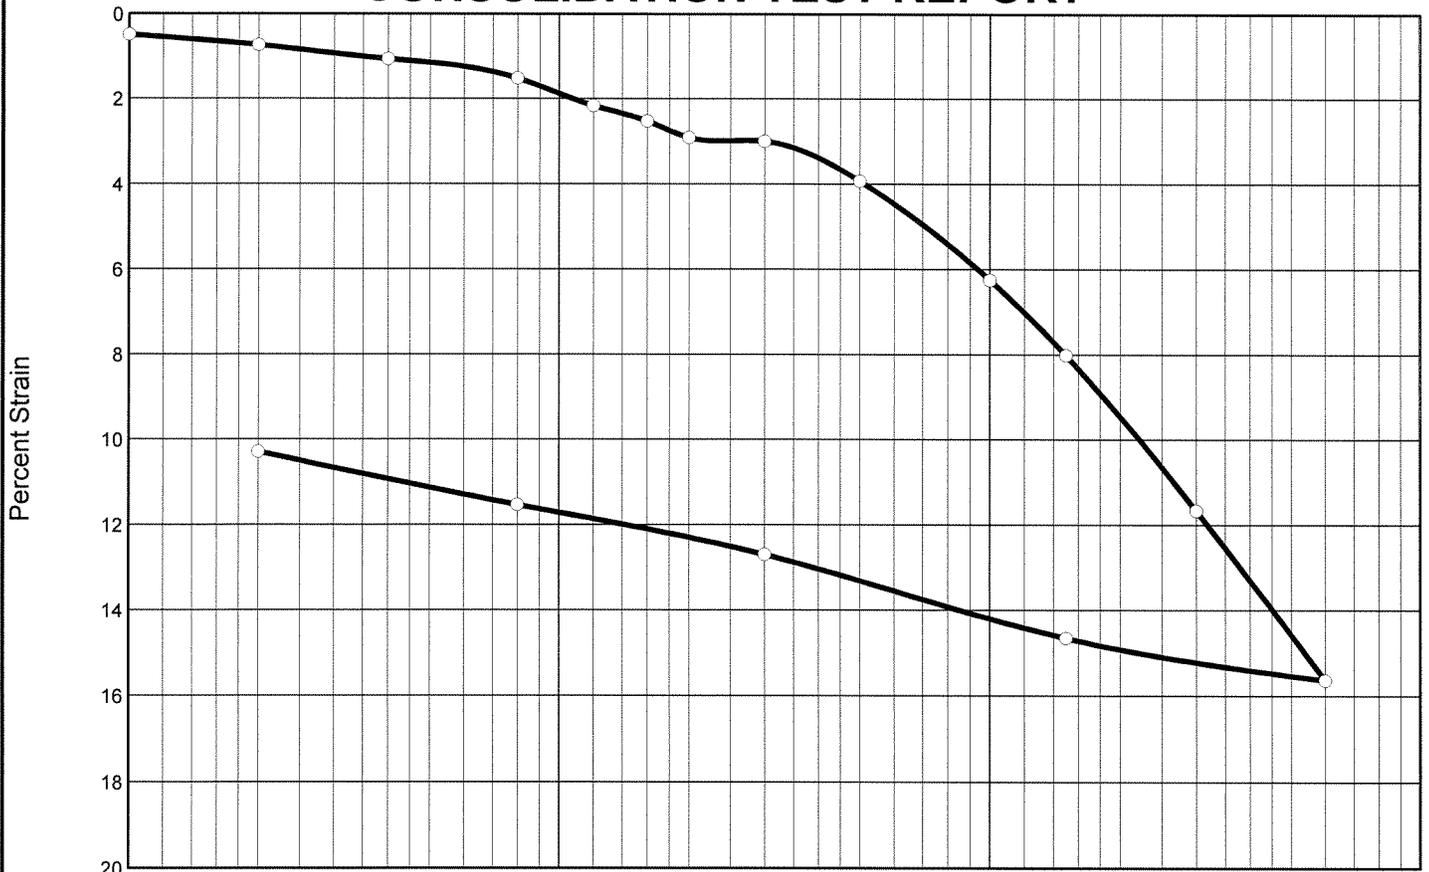
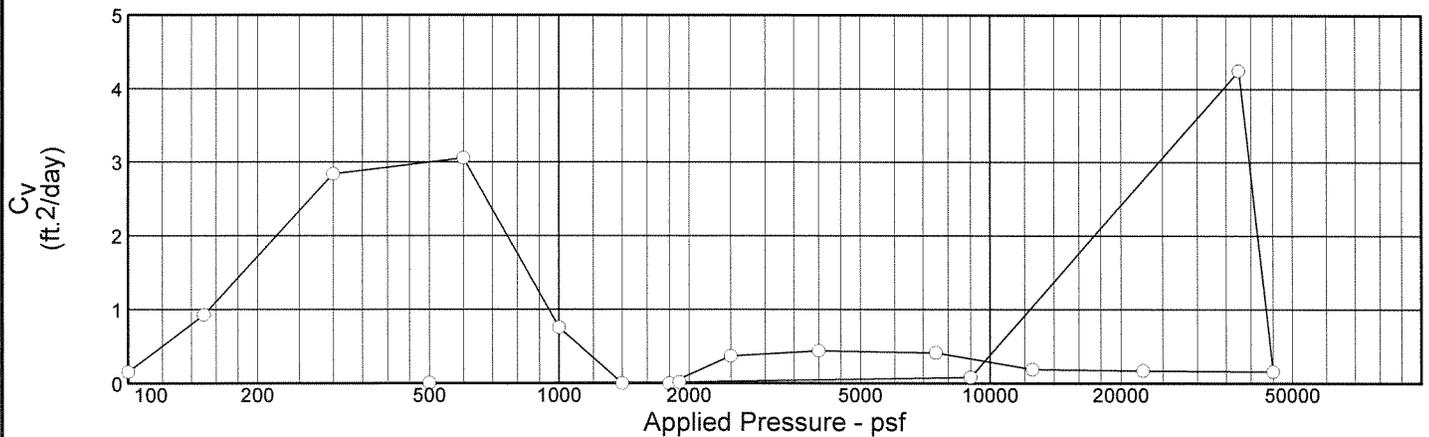
CONSOLIDATION TEST REPORT

Natural		Dry Dens. (pcf)	LL	PI	Sp. Gr.	USCS	AASHTO	Initial Void Ratio
Saturation	Moisture							
94.3 %	23.8 %	100.2	36	14	2.7			0.682

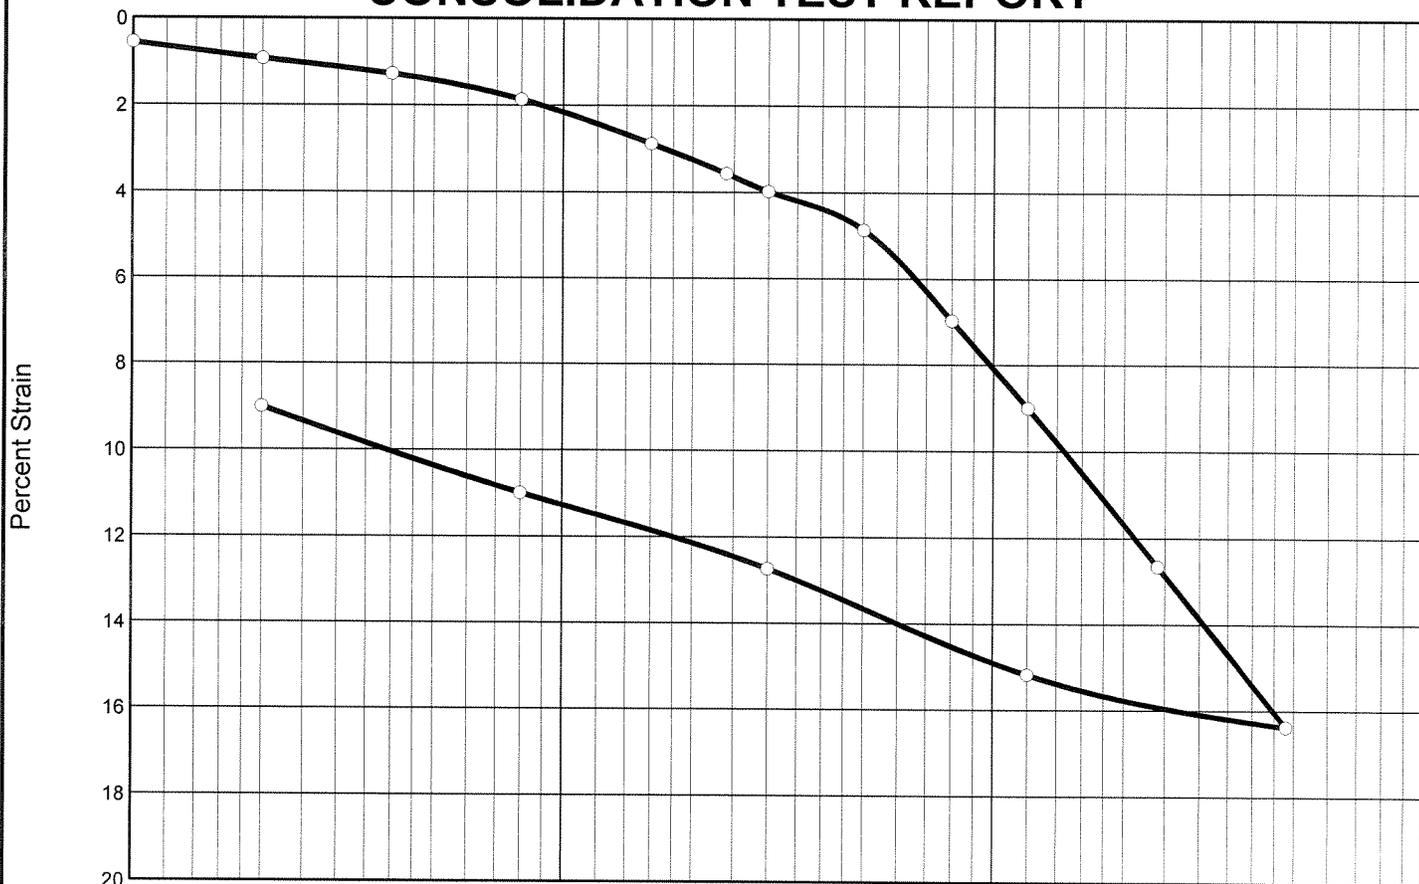
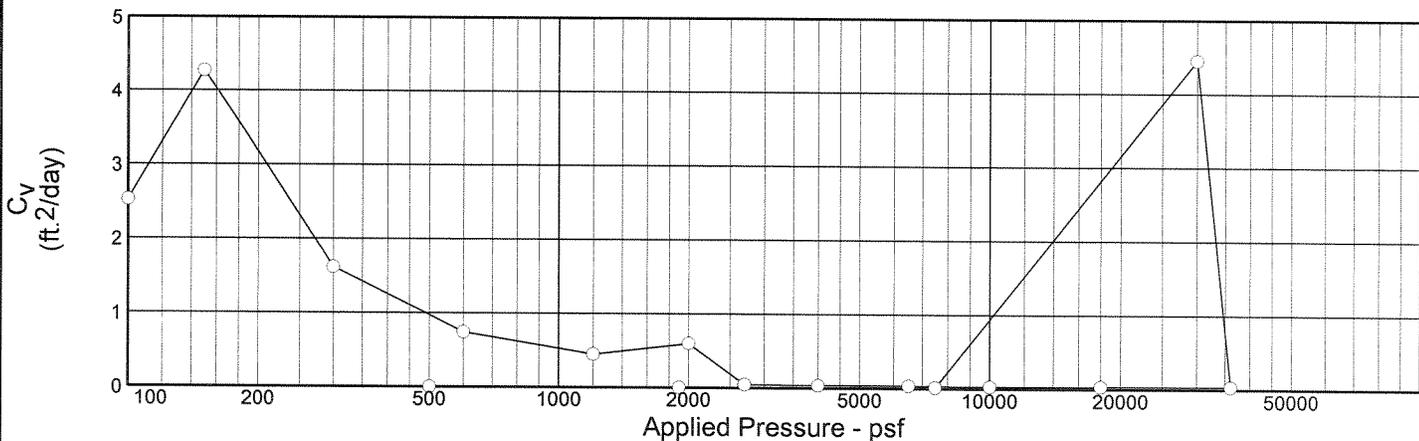
CONSOLIDATION TEST REPORT

Natural		Dry Dens. (pcf)	LL	PI	Sp. Gr.	USCS	AASHTO	Initial Void Ratio
Saturation	Moisture							
99.1 %	26.2 %	98.4	43	20	2.7	CL		0.712
