# CHARACTERIZATION OF SUSPENDED SEDIMENT PLUMES ASSOCIATED WITH KNOCKDOWN OPERATIONS AT REDWOOD CITY, CALIFORNIA

Submitted to the US Army Corps of Engineers, San Francisco District

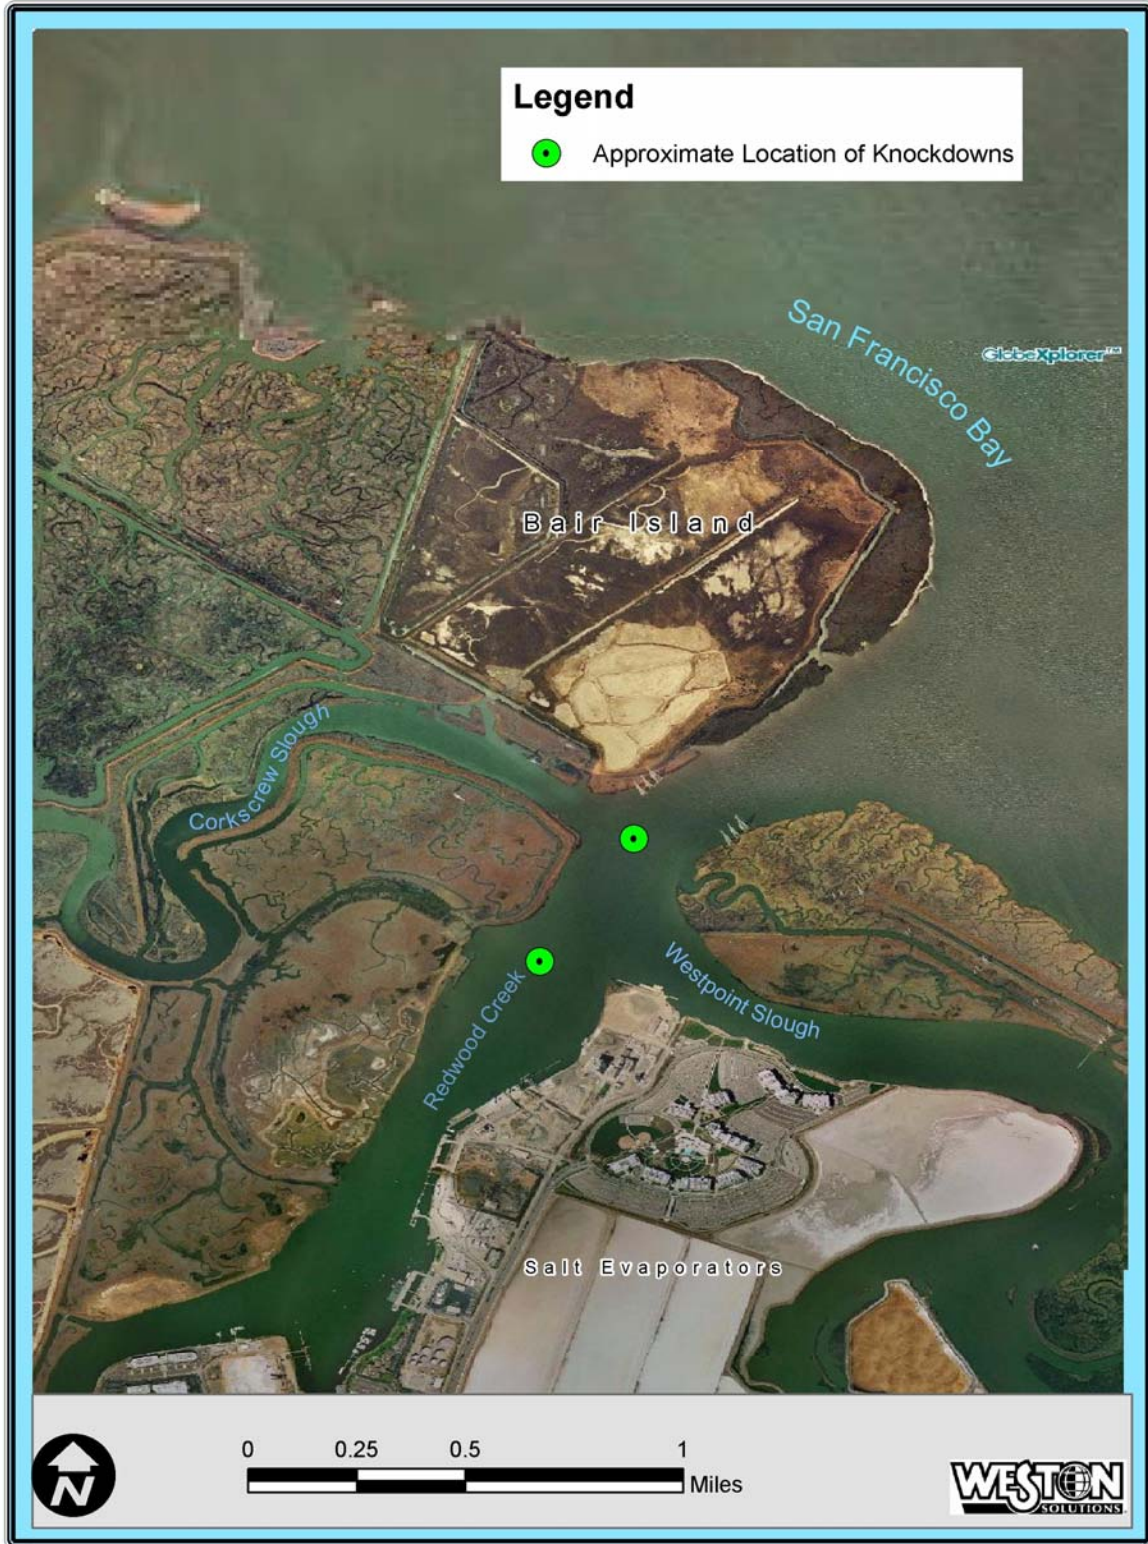
Figure 2. Aerial view of the study location showing the reach of Redwood Creek subject to knockdown and the points of confluence with Corkscrew Slough to the west and Westpoint Slough to the east.

The Redwood Creek navigation channel is approximately 6 km in length, extending in a general north-south direction from the San Francisco Bay to the Port facilities. The northern 4 km (2.5 mi) of the channel is 92 m (300 ft) wide and is maintained at a depth of 8.5 m (28 ft). The southernmost portion of Redwood Creek, adjacent to the Port facilities, has two turning basins, each approximately 325 m (1,066 ft) wide. The channel is bordered along most of its length by tidal flats. Mean tidal amplitude at the project site is 1.8 m (6.2 ft). Two sloughs intersect Redwood Creek: Corkscrew Slough from the west and Westpoint Slough from the east (Figure 2). Neither slough is maintained for navigation.

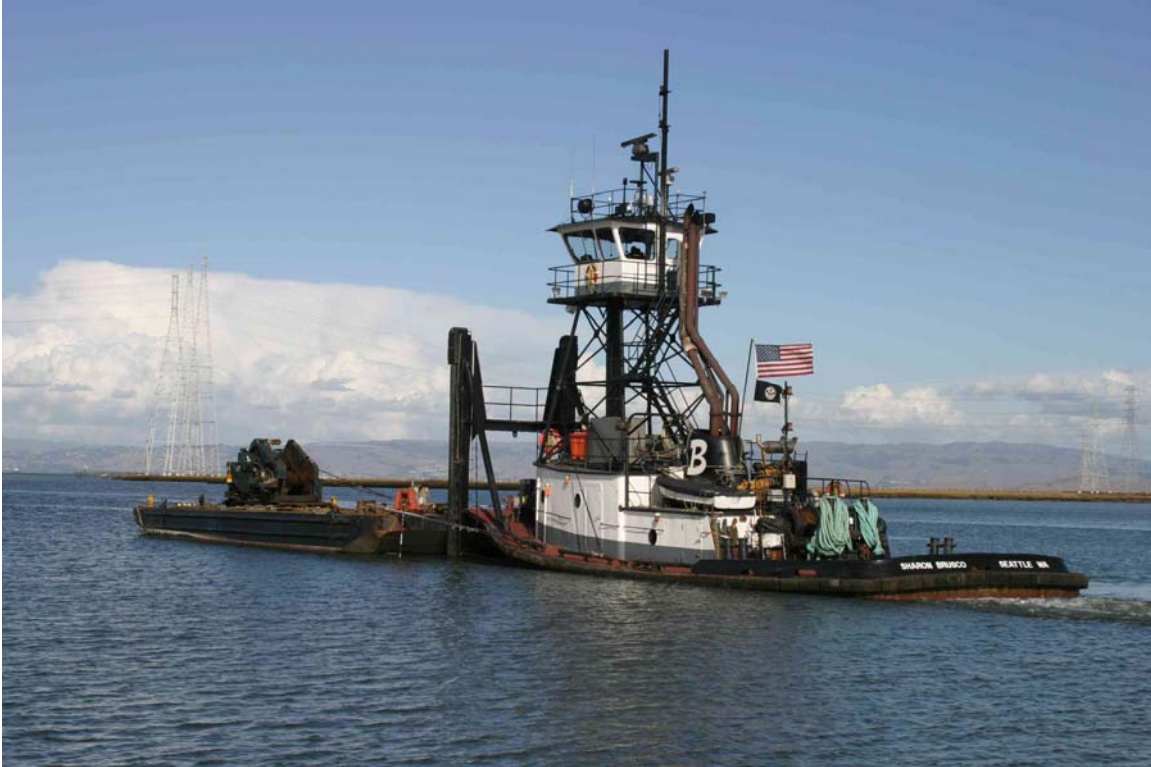
Figure 3. The Dutra Dredging Company T/V *Sharon Brusko* pushing the knockdown barge in Redwood Creek.

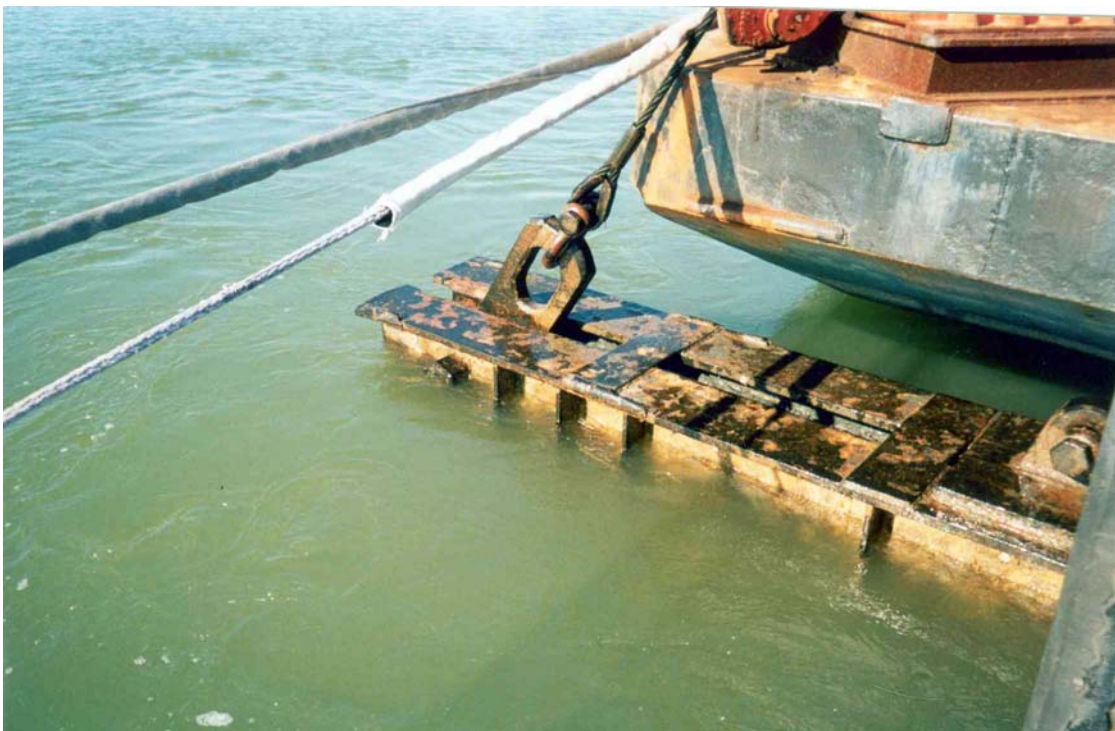
Figure 4. The knockdown bar suspended from the barge at the water surface.

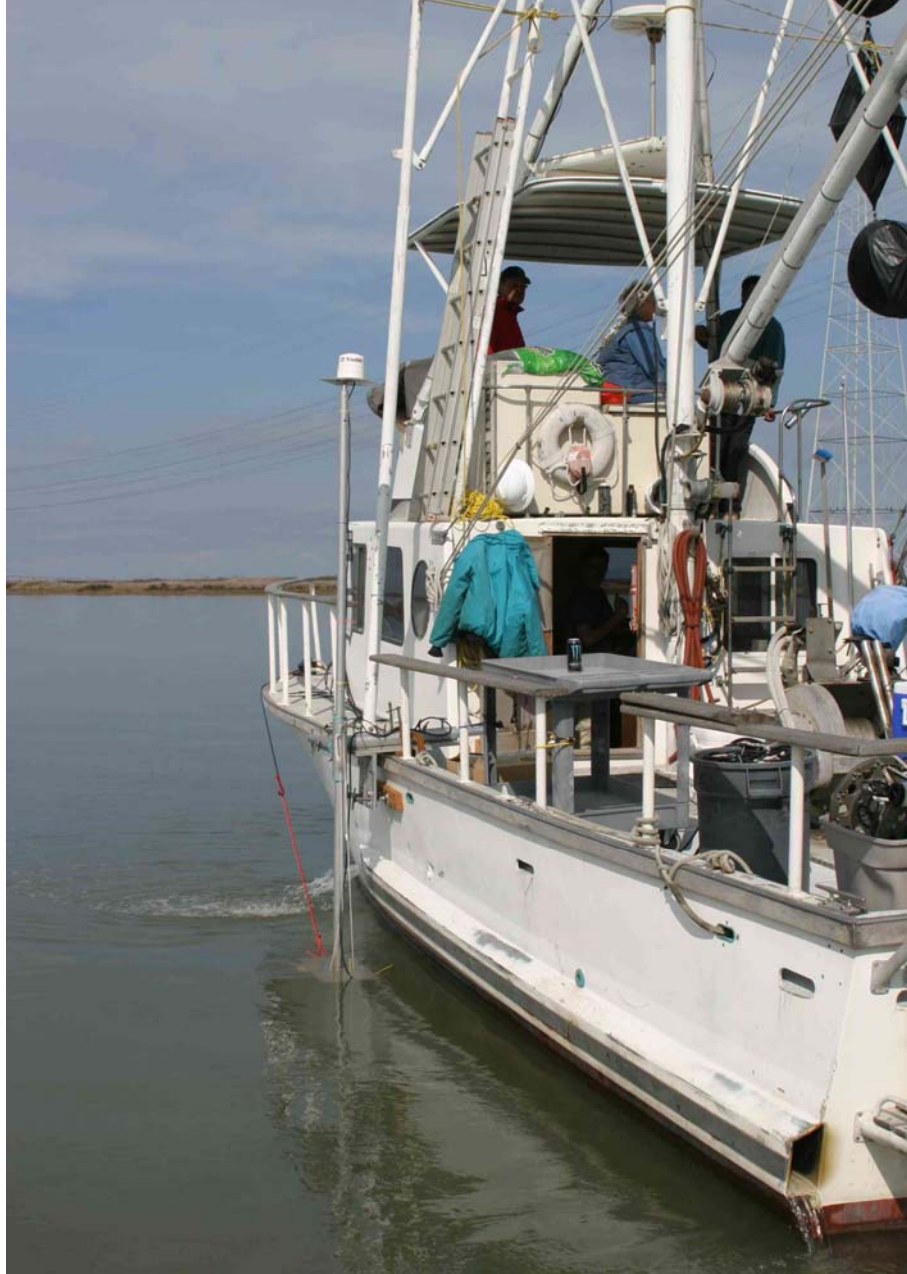
Figure 6. Survey vessel R/V Shearwater, showing ADCP-integrated DGPS mounted on the port side with transducer assembly riding just below the surface of the water.

Plume monitoring operations were conducted from the 44 ft survey vessel R/V *Shearwater* (Figure 6), equipped with a stern-mounted A-frame for deployment of water quality instrumentation. A Trimble NT300D differential global positioning system (DGPS) aboard the survey vessel provided navigation and position data to an accuracy of  $\pm 1.0$  m (3.2 ft). Vessel mobilization and gear testing occurred on 24 October and demobilization occurred when knockdown operations ceased on 28 October 2004. A Garmin GPS 76 placed on the T/V *Sharon Brusco* each day continuously recorded the tug's position accurate to 5 m (16 ft). These data were downloaded at the end of each day and used to determine the origin of the suspended sediment plume at selected times during all knockdown surveys.

Surveys were conducted with an RD Instruments 600kHz Workhorse Mariner Acoustic Doppler Current Profiler (ADCP) mounted amidships on the port side of the survey vessel (Figure 6). The ADCP transducer head was mounted 33 cm (13 in) below the water's surface. Data acquisition was performed by RD Instruments' WinRiver software running on a laptop computer. The ADCP was used to collect current velocity, direction, and acoustic backscatter data. Data were collected with a bin resolution of 0.5 m (1.6 ft) and a total of 35 vertical bins for all transects. The instrumentation package calculated and recorded vessel and current direction in three-directional axes to an accuracy of  $\pm 0.2$  cm/sec. Data were recorded for predetermined horizontal and vertical bins (vertical bin size = 0.5 m (1.6 ft)). Bottom depth and surface water temperatures were also recorded. An internal fluxgate compass allowed the instrument to correct ADCP current vectors for vessel speed and orientation. Navigation data received from the DGPS were collected synoptically and integrated during post-processing.

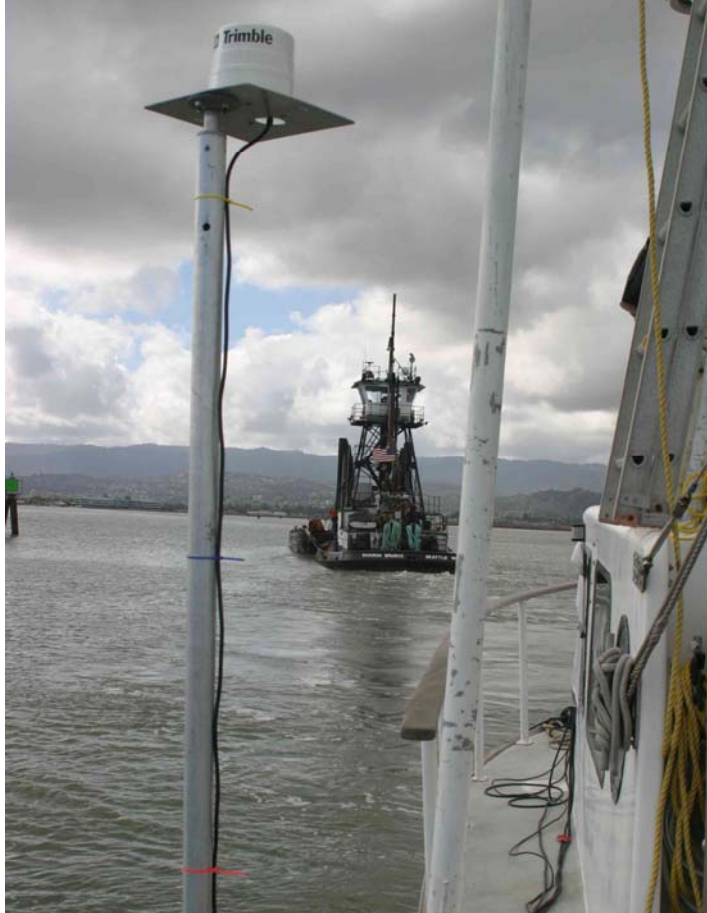
Figure 9. Running a parallel ADCP transect directly behind the knockdown barge.

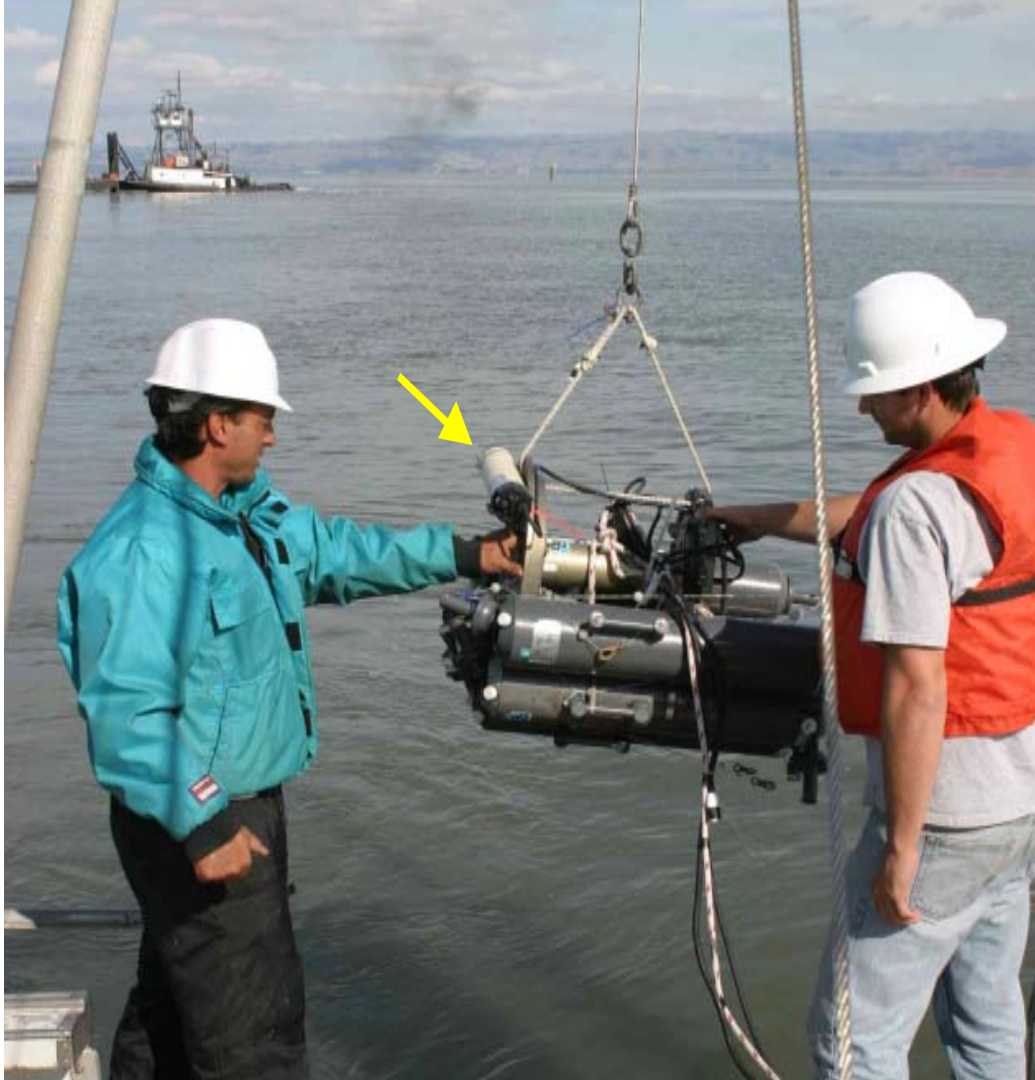
Figure 11. Modified rosette water sampler with OBS unit attached (indicated by arrow).

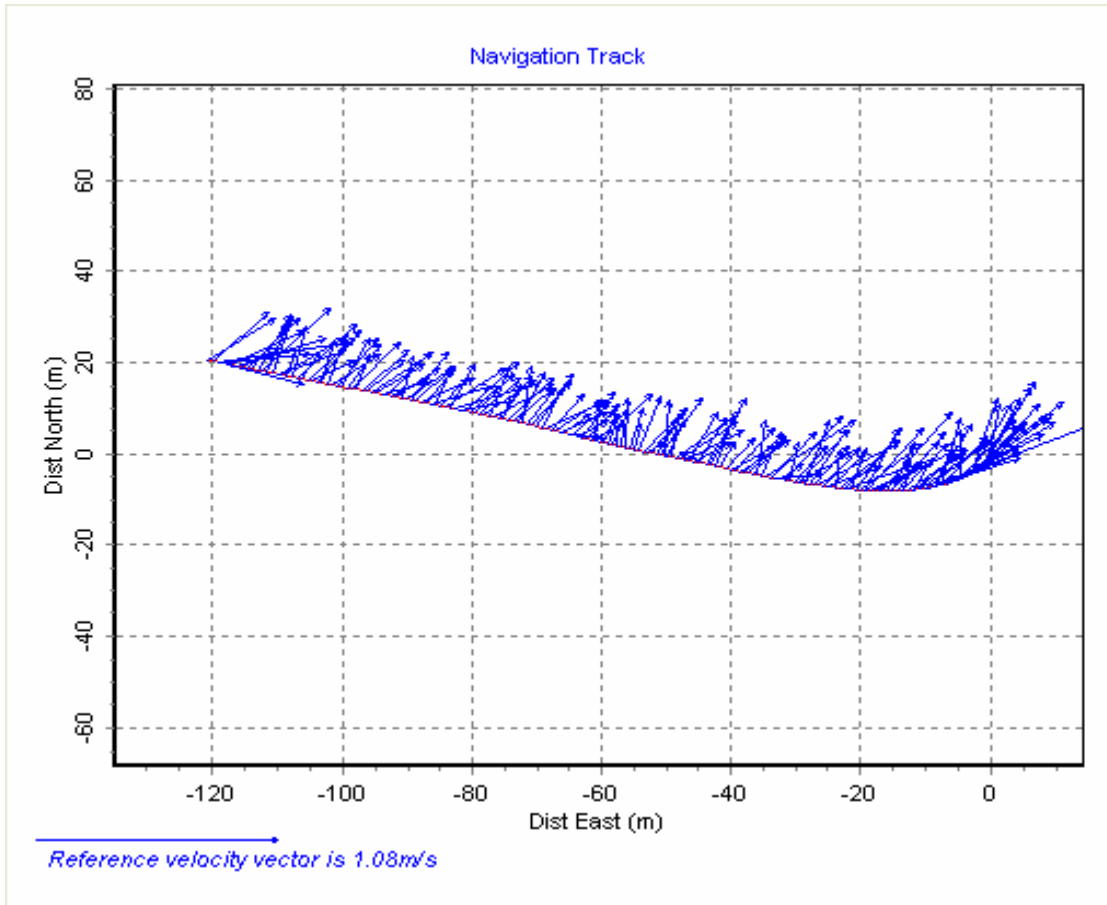
Figure 12. Current velocity and direction vectors for a transect across Redwood Creek during an ebbing tide.

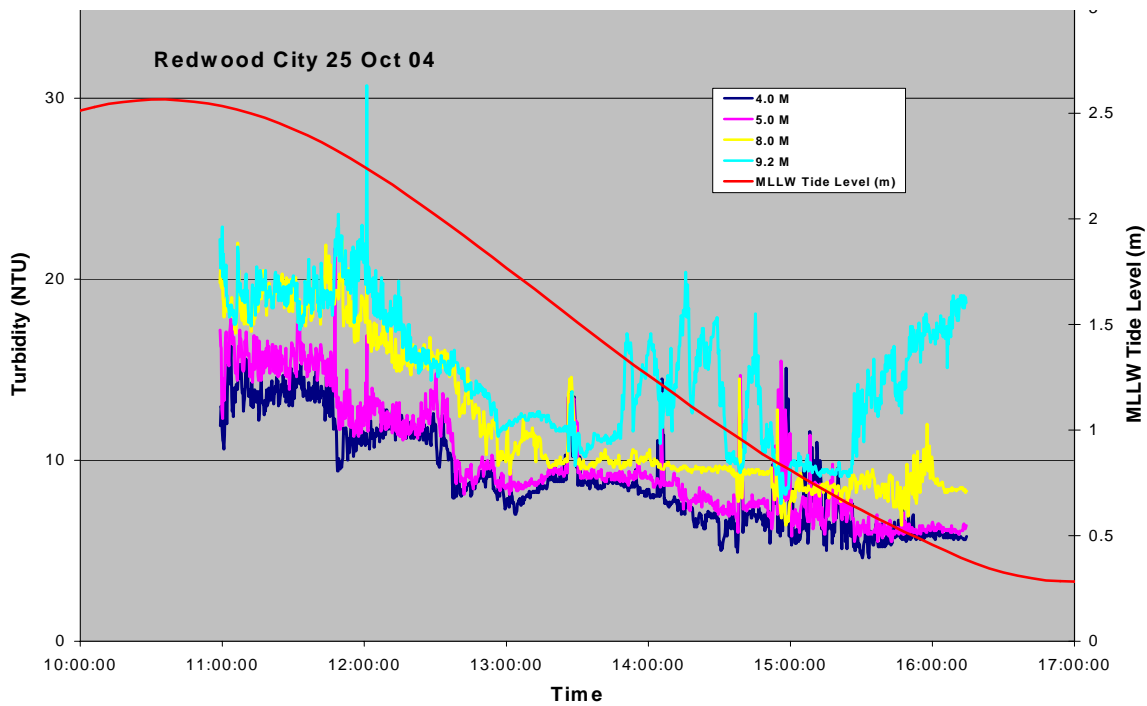
Figure 18. Ambient turbidity conditions at the mid-reach moored buoy.

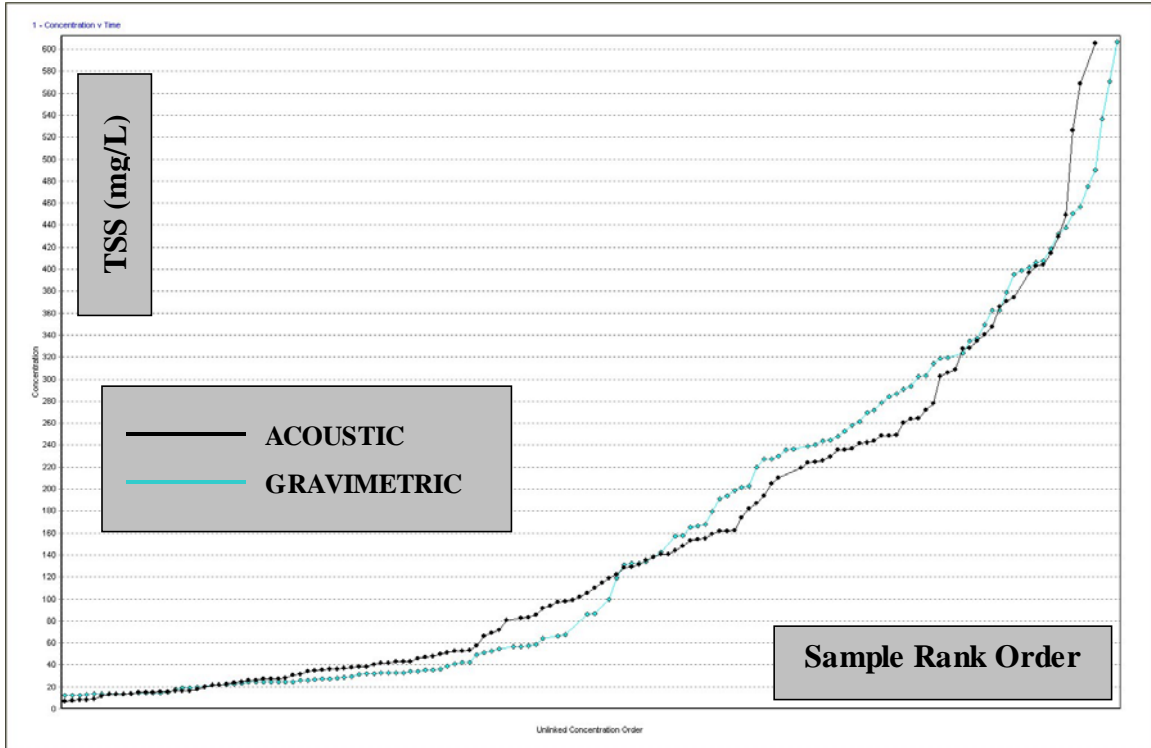
Figure 33. Comparison of gravimetric and acoustic estimates of TSS concentration for the entire population of samples taken in Redwood Creek in rank order.

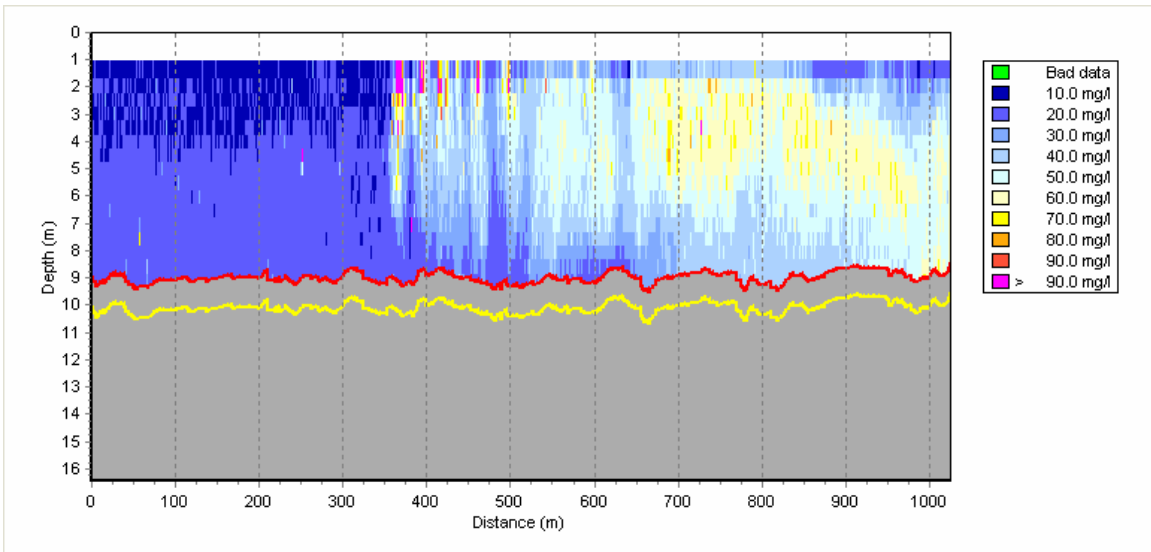
Figure 35. Vertical profile of ambient TSS concentrations across Redwood Creek during an ebbing tide.

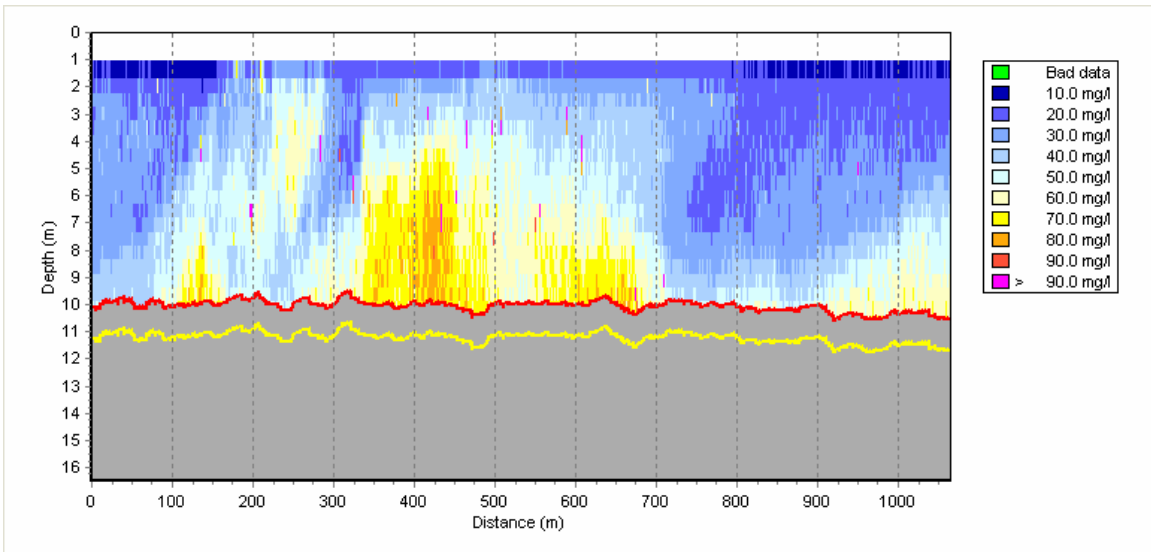
Figure 36. Vertical profile of ambient TSS concentrations across Redwood Creek during a flooding tide.
