# **Results of a Submerged Oil Assessment of Sediments Located Within the Port of Oakland Federal Maintenance Channel**

Prepared for

Pacific EcoRisk  
2250 Cordelia Road  
Fairfield, CA 94534

**January 2008**

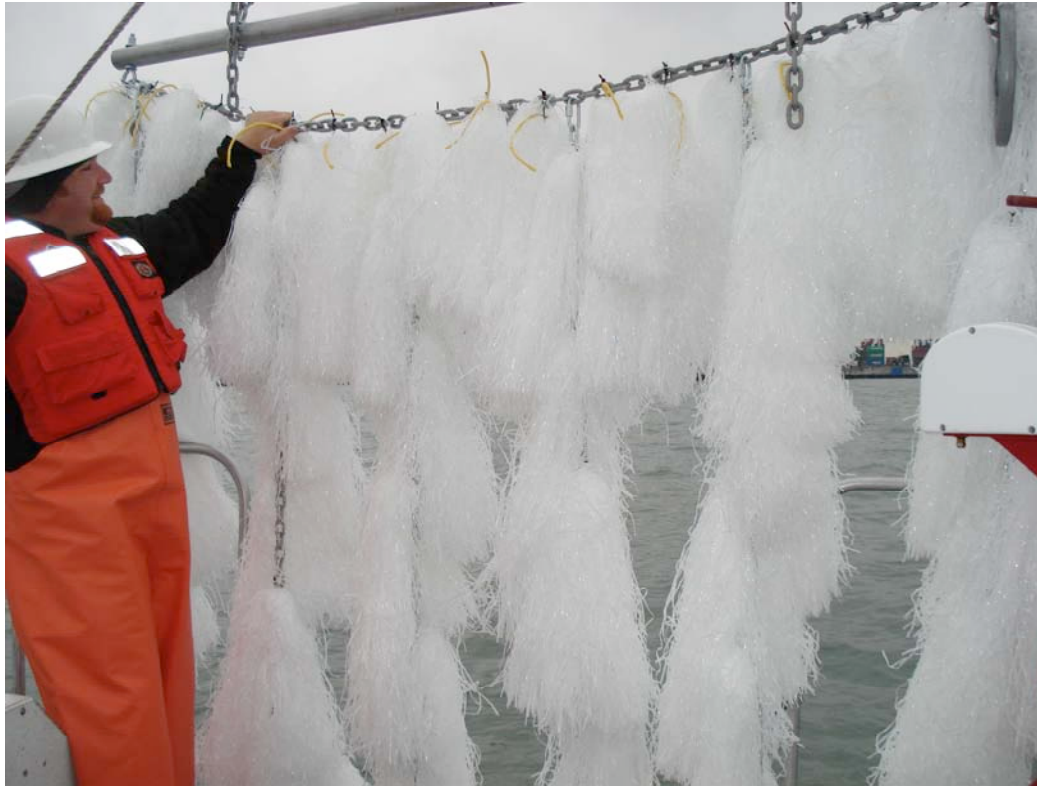
**Figure 2-1. Oil Snare Apparatus**

- A towing vessel will drag a weighted mopping beam aligned perpendicular to the direction of travel;
- The towing vessel will travel along a pre-defined transect within the area to be dredged using a DGPS navigation system with data logger accurate to +/- 1 meter;

- Sorbent pom-poms will be attached to the mopping beam to ensure continuous coverage along the mopping beam;
- Towing cables or chains of adequate strength and length to ensure the mopping beam will remain in contact with the bottom during dragging will be used; and

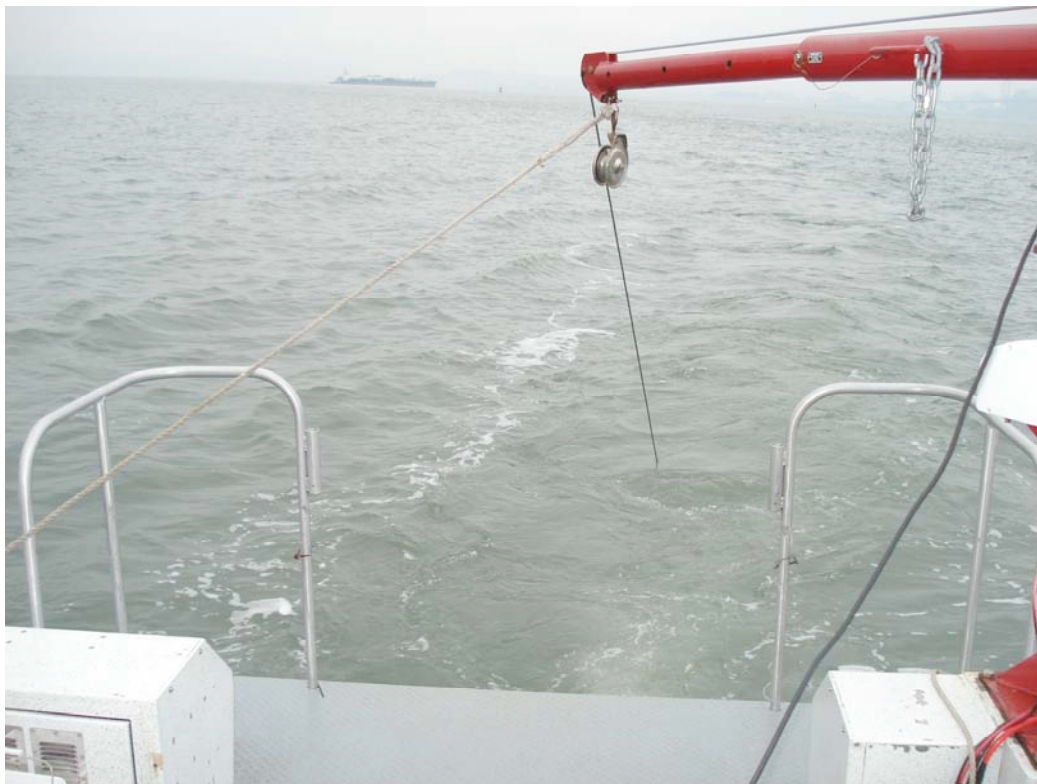
**Figure 2-2. Performance of Transect 1 Run**

Briefly, the results of the oil assessment of transect T-1 indicated that there was no oil or tar present. A summary of the transect run and results are presented in Table 1; documentation of the results are presented in Figures 1-1 through 1-10.

Data	Start of Transect Run	End of Transect Run
Latitude/Northing	37° 48.389	37° 48.490
Longitude/Easting	122° 20.561	122° 20.378
Measured Water Depth MLLW (ft)	49.6	19.7
Mud Present on Beam	NA	YES
Visual Oil/Tar Present	NA	NO
Petroleum Odor Present	NA	NO

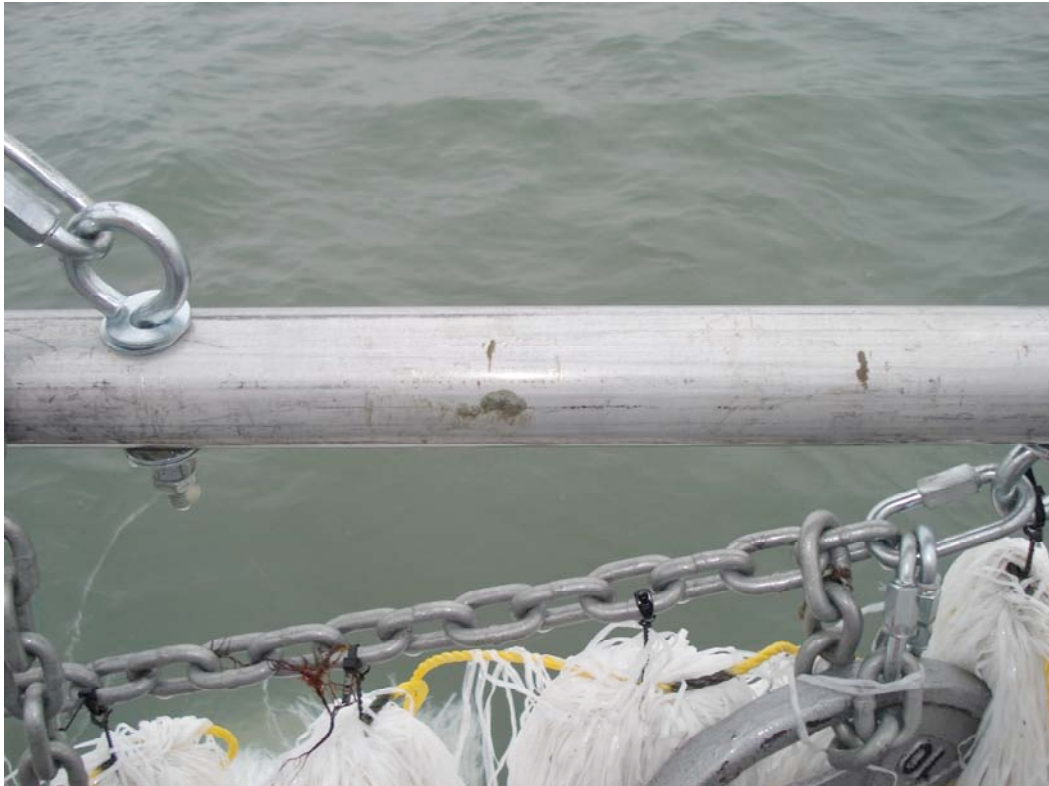
**Figure 2-3. Transect 1: Evidence of Beam Reaching Surficial Sediment**

Pom-pom Condition	<input checked="" type="radio"/> no oil	lightly oiled	heavily oiled
Comments:	271 yds off Berth 37 pom-poms clean mud on pom poms - washed off macro algae present no oil sheen observed 1,9 ft Berth 37 inside dn 53.2-54 ft

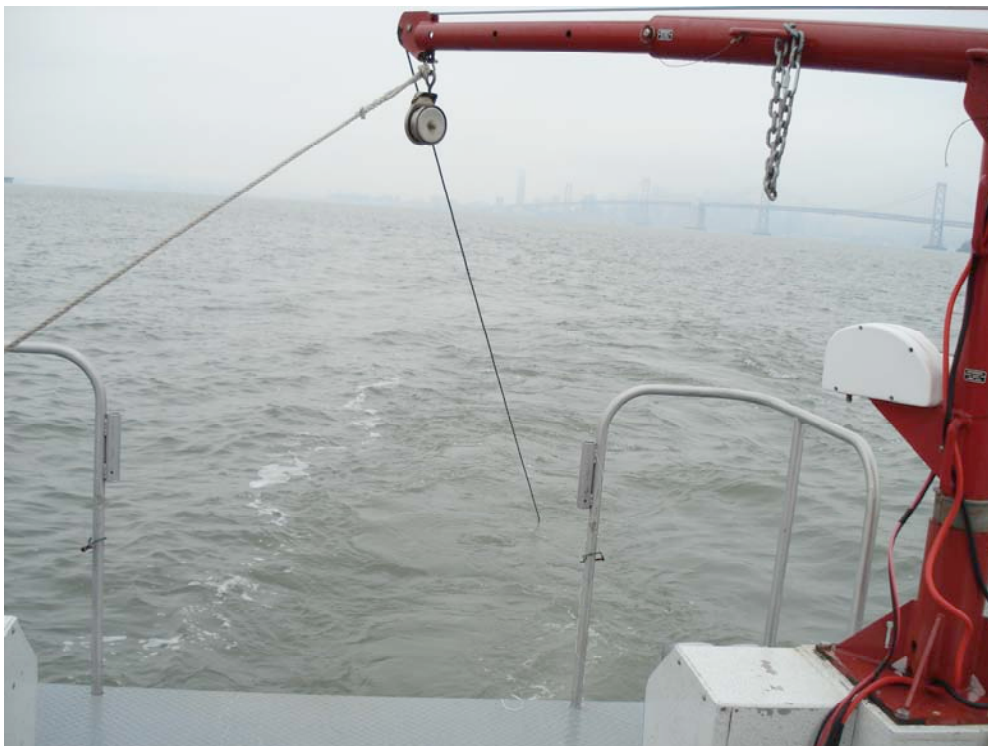
**Figure 2-12. Performance of Transect 2 Run**

Briefly, the results of the oil assessment of transect T-2 indicated that there was no oil or residual tar present. A summary of the transect run and result are presented in Table 2-1; documentation of the results are presented in Figures 1-11 through 1-19.

Data	Start of Transect Run	End of Transect Run
Latitude/Northing	37° 48.540	37° 48.629
Longitude/Easting	122° 20.645	122° 20.402
Measured Water Depth MLLW (ft)	18.5	10.5
Mud Present on Beam	NA	YES
Visual Oil/Tar Present	NA	NO
Petroleum Odor Present	NA	NO

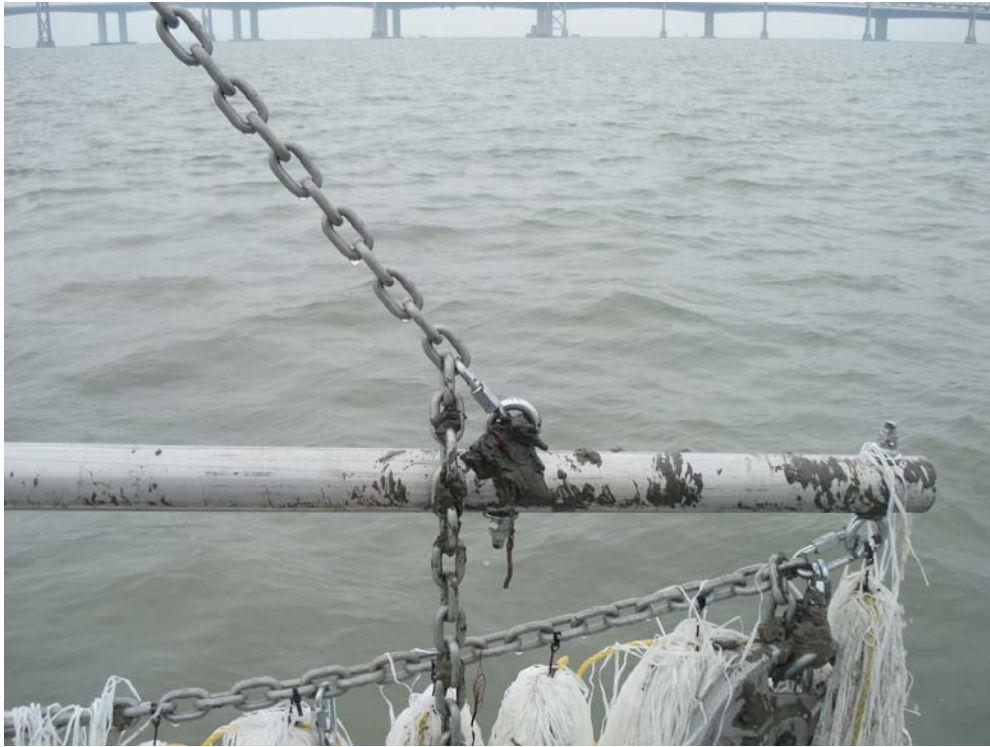
**Figure 2-13. Transect 2: Evidence of Beam Reaching Surficial Sediment**

Pom-pom Condition	no oil	lightly oiled	heavily oiled
Comments:	1.7 kt pom pom w/mud - washed off macro algae present no oil sheen observed
