Appendix D

Ecosystem Benefit Modeling Appendix

Watsonville Slough Ecosystem Restoration Project
San Francisco District

Continuing Authorities Program (CAP), Section 1135

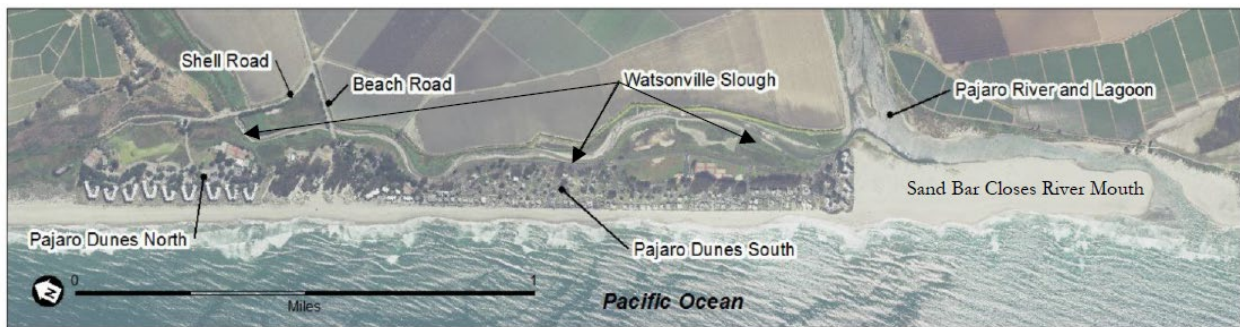
Figure 1: Map of the project area extents, showing the confluence of the Watsonville Slough and the Pajaro River at the Pajaro Lagoon (Source: Technical Memo from ESA, 2018).

The Watsonville Slough CAP study area is located at the confluence of the Watsonville Slough with the Pajaro River, in southern Santa Cruz County. The study area is bordered inland by low-lying, active agricultural fields and on the ocean side by the Pajaro Dunes Community. The project area is bounded by Shell Road at the upstream end, and the Pajaro River and Lagoon at the downstream end (Figure 1).

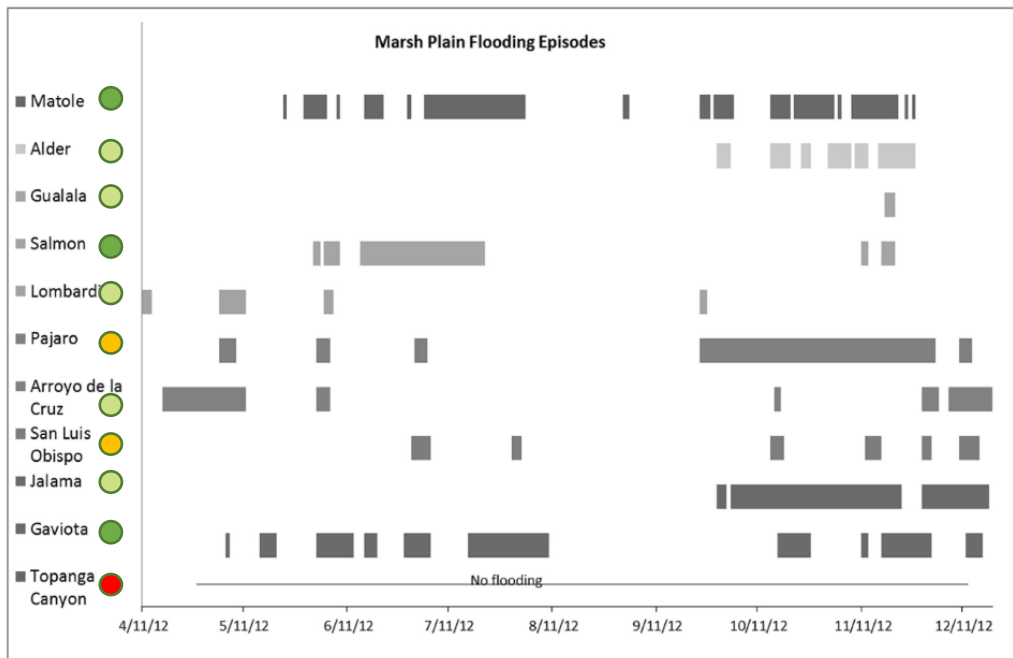
Figure 7. Periods of marsh plain inundation for 10 BBEs during 2012. Summer flooding in Matole, Salmon Creek, and Gaviota were correlated with higher CRAM scores and presence of sensitive plant species. Ponding in the winter occurred in estuaries with a range of CRAM scores. Colored dots beside the estuary name reflect the overall CRAM score for the estuary: green is “Optimal”, chartreuse is “Good”, amber is “Fair”, and red is “Poor”. Adapted from Clark and O’Connor 2019.
