County of San Mateo
Maintenance Area

North Bayside of
San Mateo County
Maintenance Area

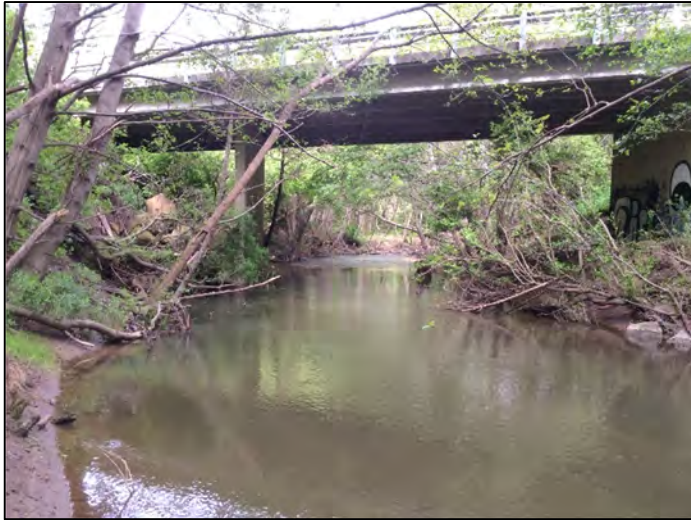
Photo 1. Pescadero Creek at the upstream side of Pescadero Creek Road bridge near Cloverdale Road. (April 2017)

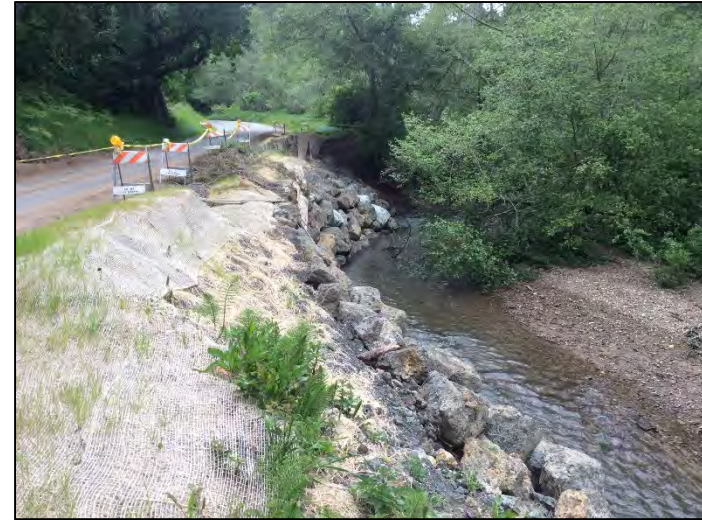
Photo 2. Gazos Creek in Pescadero. Photo shows a recent slip-out that occurred along Gazos Creek Road. (April 2017)

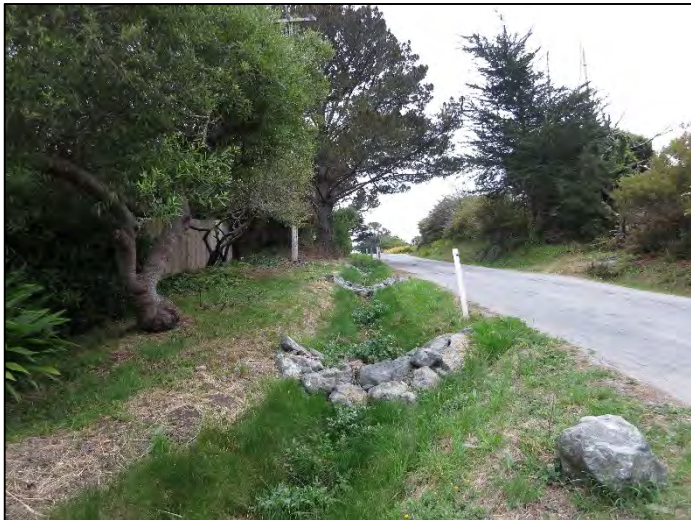
Photo 3. LID ditch along Farallone Avenue in Montara (May 2015)

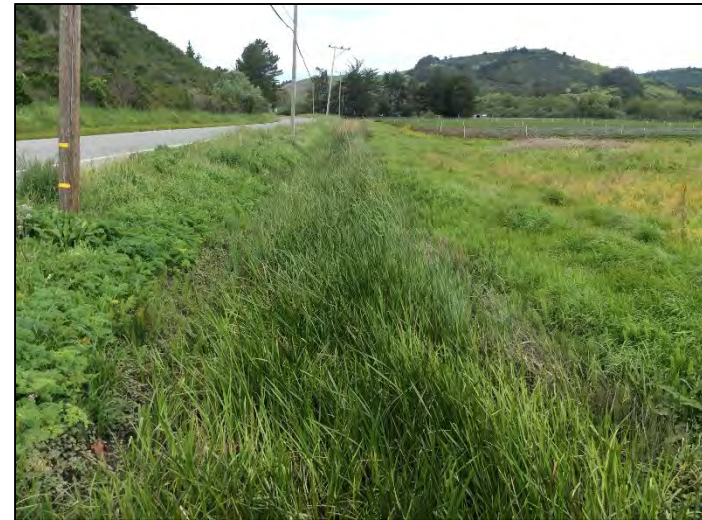
Photo 4. Earthen ditch adjacent to Cloverdale Road in Pescadero. (April 2017)

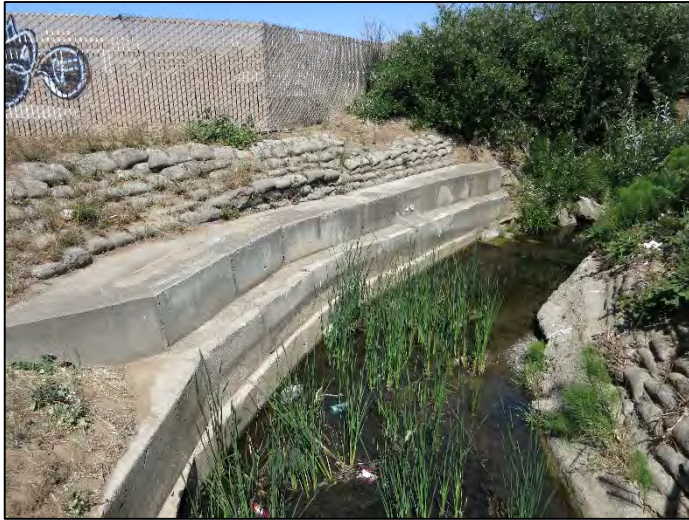
Photo 5. Belmont Creek downstream from Old County Road in Belmont, an example of a modified earthen channel (May 2015)

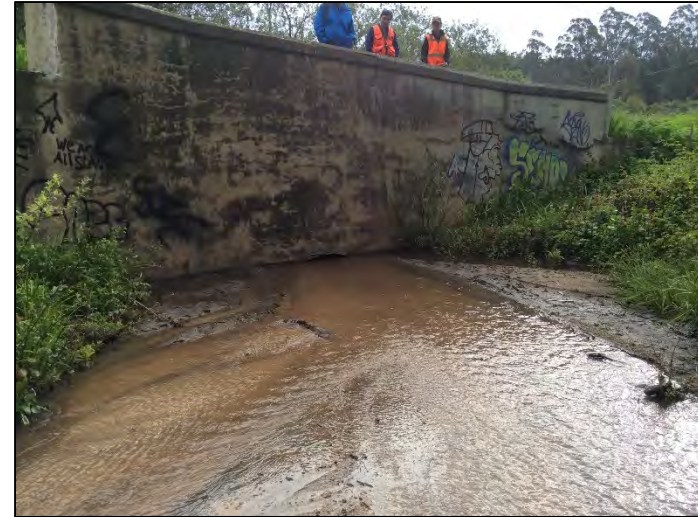
Photo 6. Upstream side of George Street bridge where substantial sediment accumulation has occurred and is blocking the culvert (April 2017)

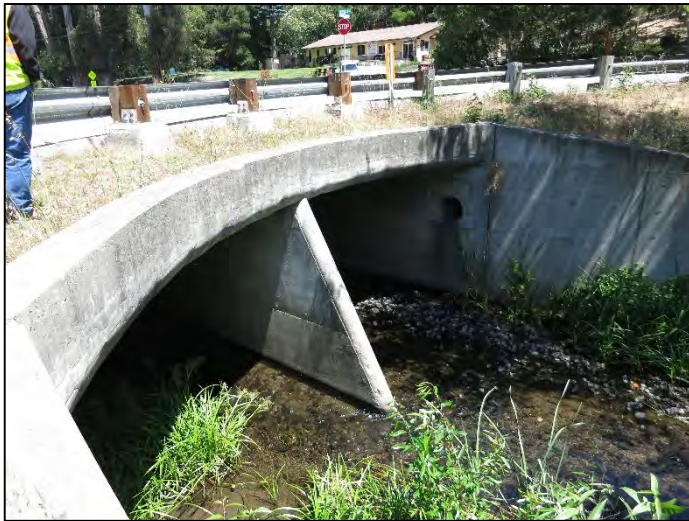
Photo 7. A concrete box culvert section of San Mateo Creek near Crystal Springs Road near its intersection with Polhemus Road (May 2017)

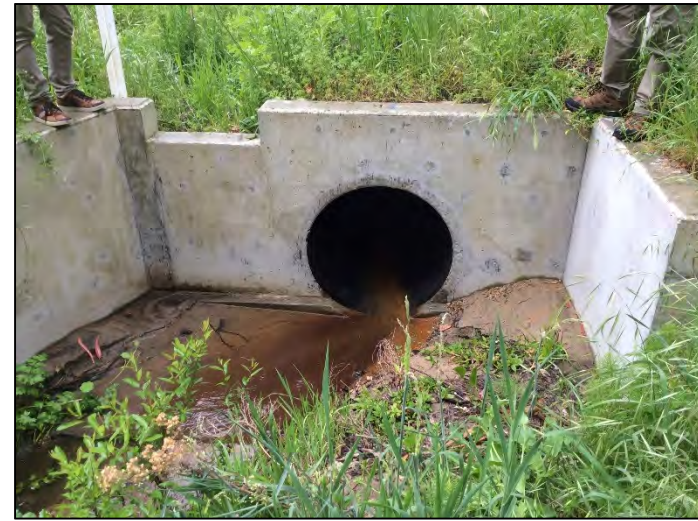
Photo 8. Culvert near George Street bridge that drains to Montara Creek. (April 2017)

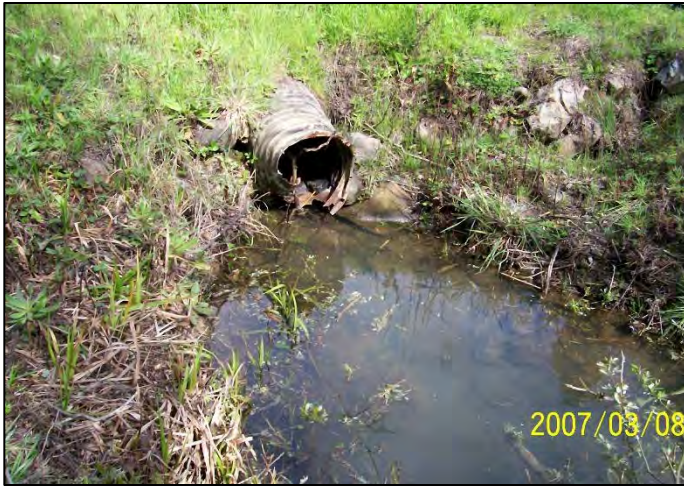
Photo 1. Deteriorated corrugated metal pipe (CMP) culvert located at Pigeon Point Road that requires replacement. (March 2007)

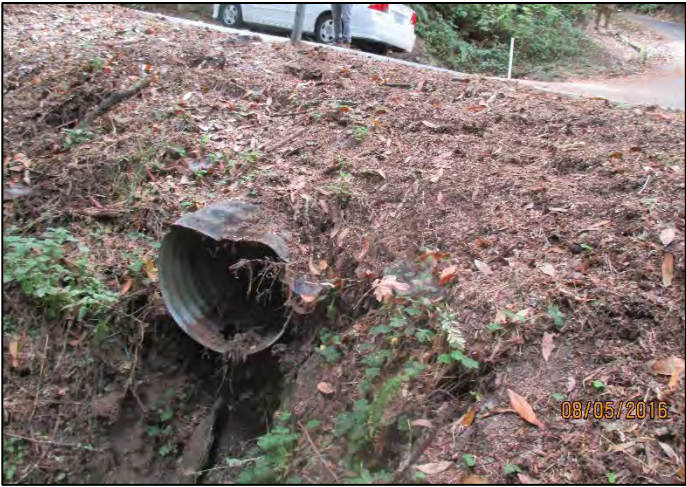
Photo 2. Deteriorated CMP culvert on Alpine Creek that requires replacement. (August 2016)

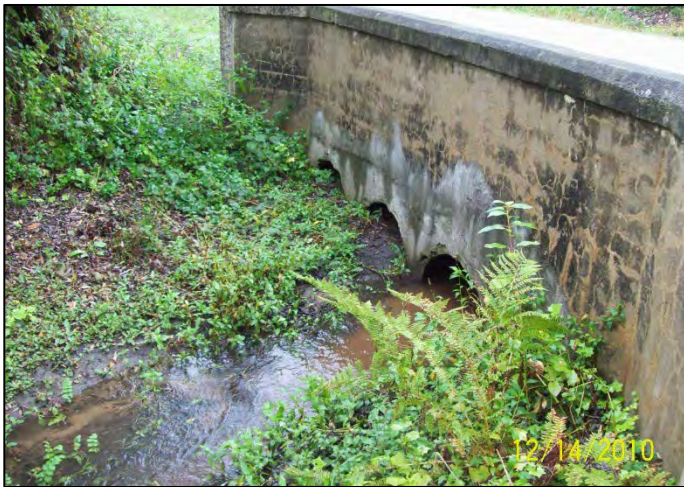
Photo 3. George Street bridge. Sediment and vegetation removal needed in the future. Bridge could also benefit from paint removal. (December 2010)

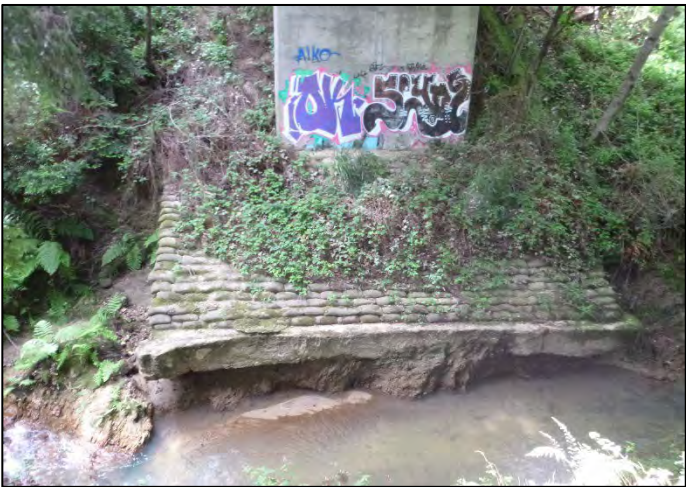
Photo 4. Scouring evident at the base of Cloverdale Road bridge. Erosion protection improvements are needed.

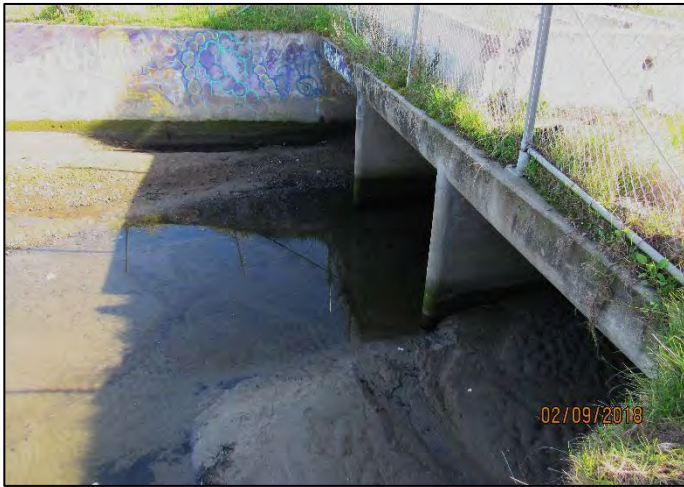
Photo 5. Sediment removal needed at the San Bruno Creek and Walnut Street crossing. (February 2018)

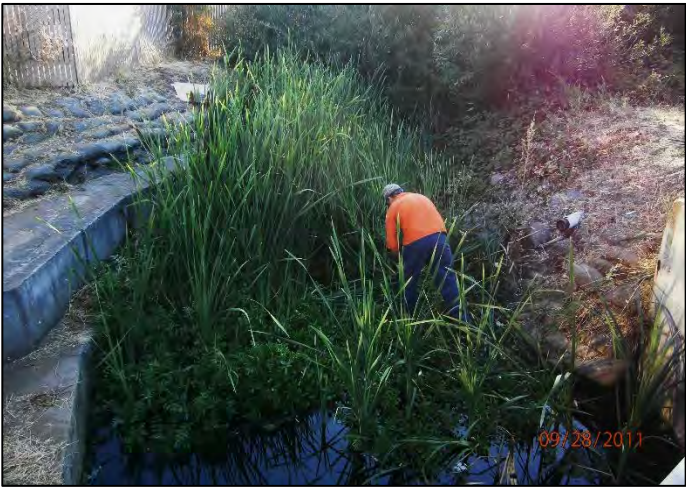
Photo 6. Sediment with vegetation growing on top of it in Belmont Creek at Old County Road. (September 2011)

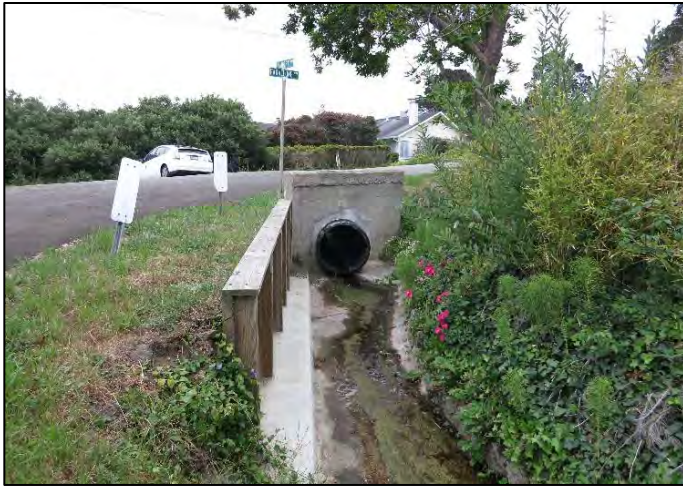
Photo 7. Paved ditch downstream of Farallone Avenue and Kanoff Street in Montara. Ditch is routinely maintained with a Vac-Con truck. (May 2015)

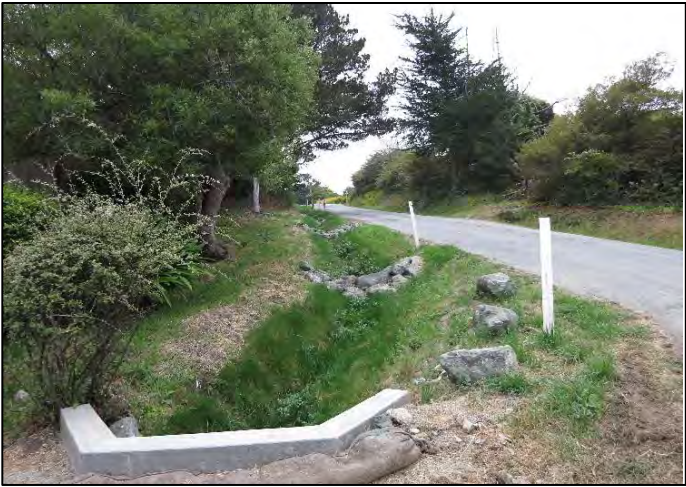
Photo 8. LID enhancements consisting of turf reinforcement mat, native grass sod, and rock check-dams that were recently installed along Farallone Avenue in Montara. (May 2015)

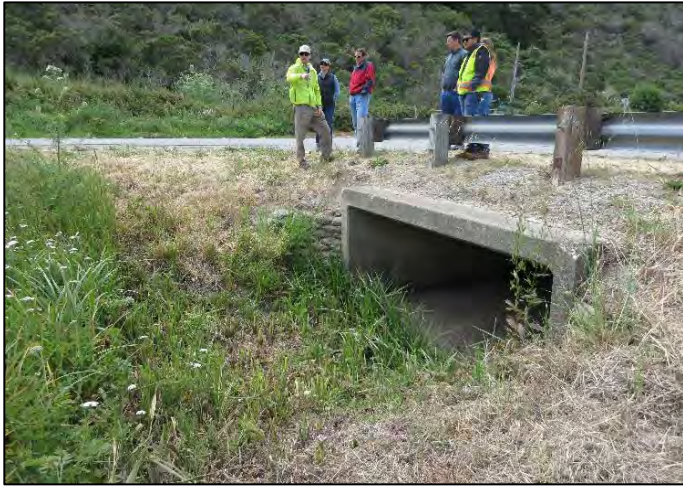
Photo 9. Concrete box culvert at Cloverdale Road and Butano Cutoff Road in Pescadero. Potential need for sediment and vegetation removal in the future. (May 2015)

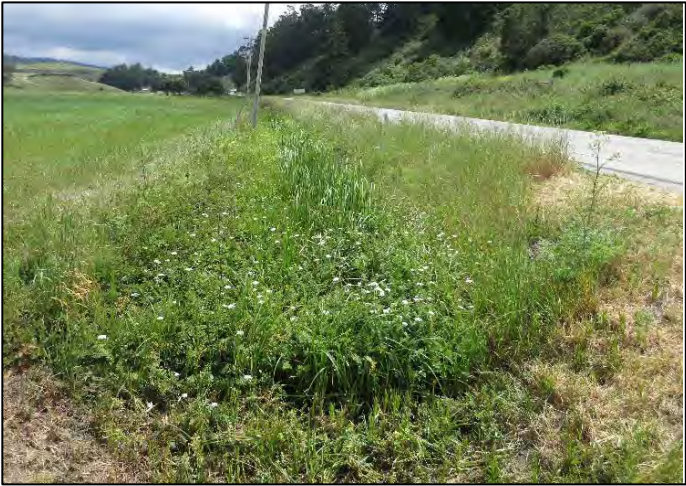
Photo 10. Unpaved ditch along Cloverdale Road in Pescadero. Potential need for sediment and vegetation removal in the future. (May 2015)

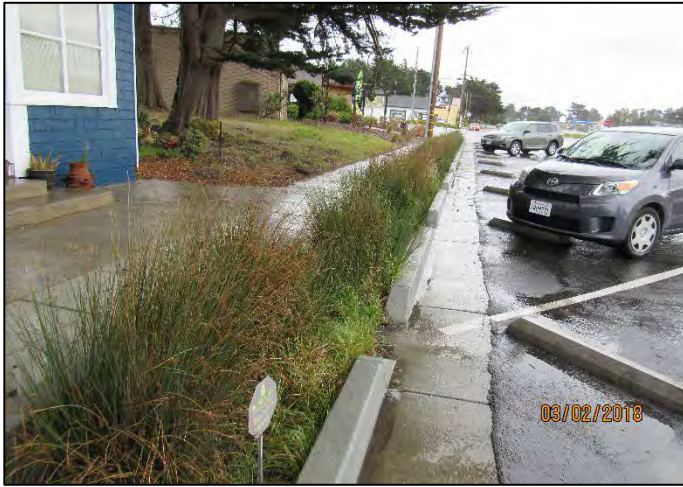
Photo 11. Bioretention swale along Carlos Street in Moss Beach that requires periodic vegetation removal, light sediment clearing, and planting. (March 2018)

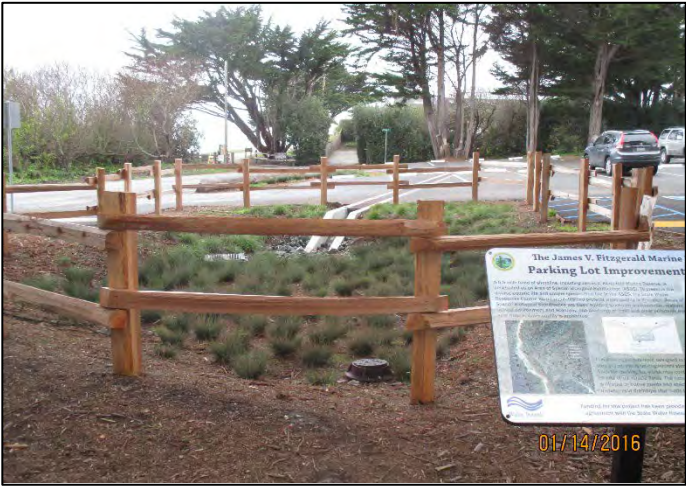
Photo 12. Bioretention swale at the Fitzgerald Marine Reserve parking lot, which requires periodic vegetation removal, light sediment clearing and revegetation. (January 2016)

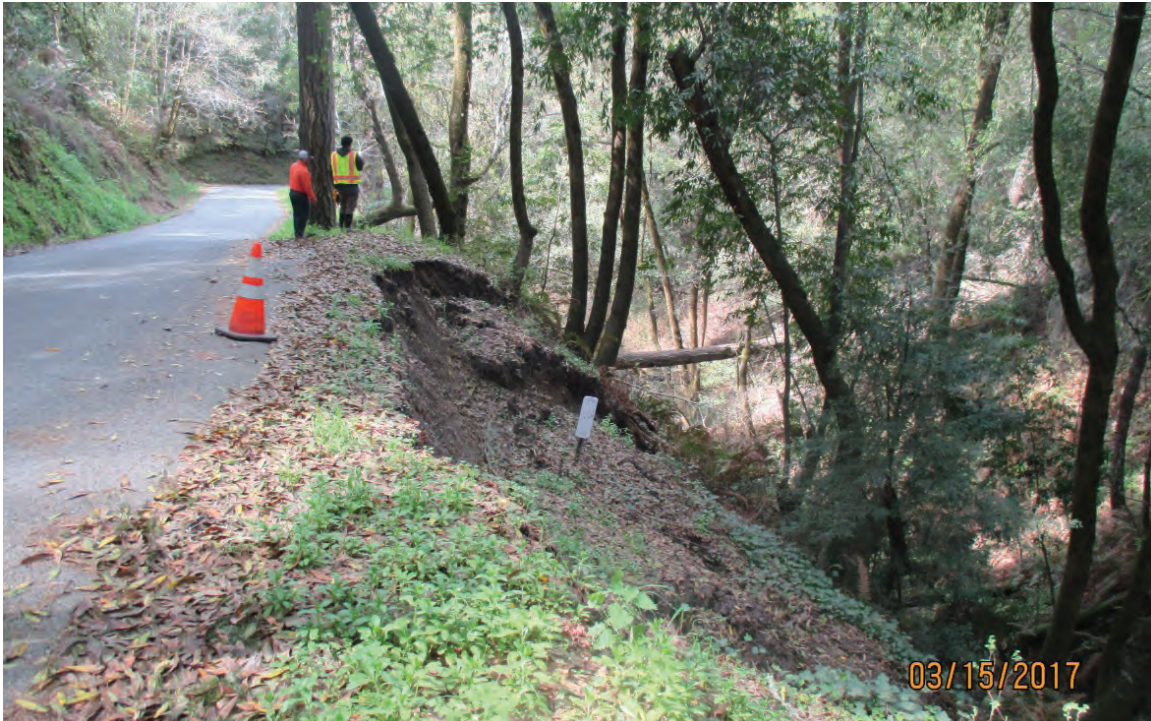
Photo 1. Example slope failure above unnamed tributary to Alpine Creek. This site was addressed in the County's 2017 emergency permit application. (March 2017)

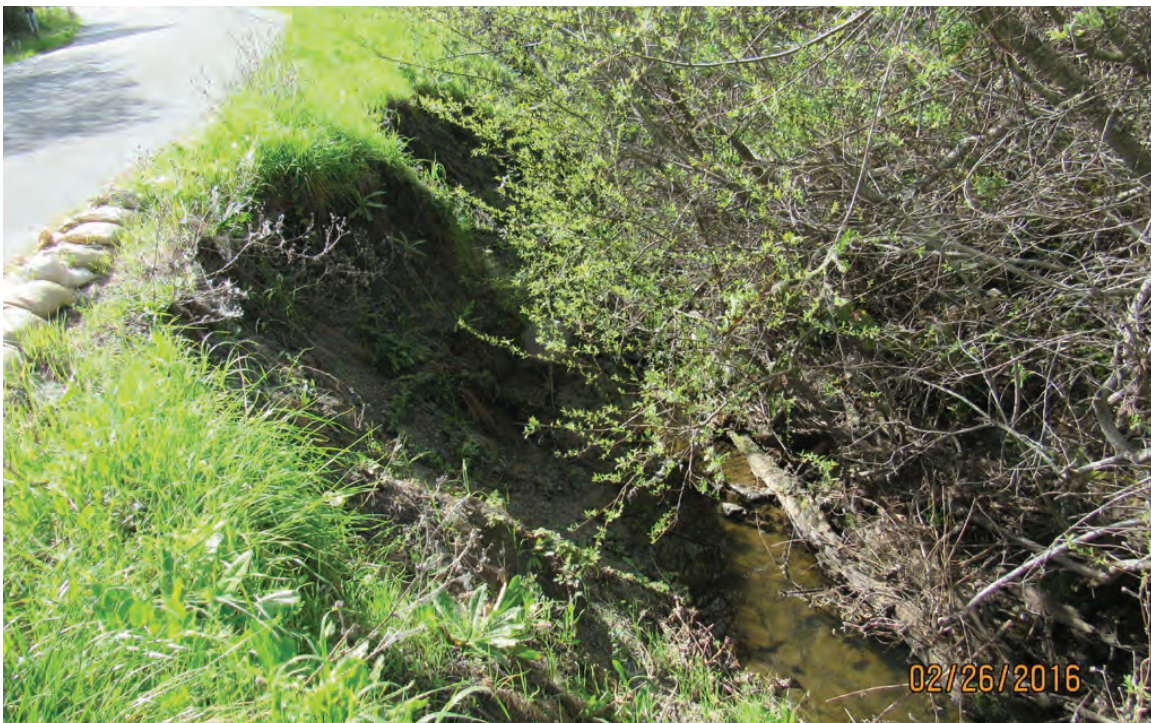
Photo 2. Bank failure along Lower Bear Gulch Road and adjacent to Clear Creek, an intermittent tributary to San Gregorio Creek. (February 2016)

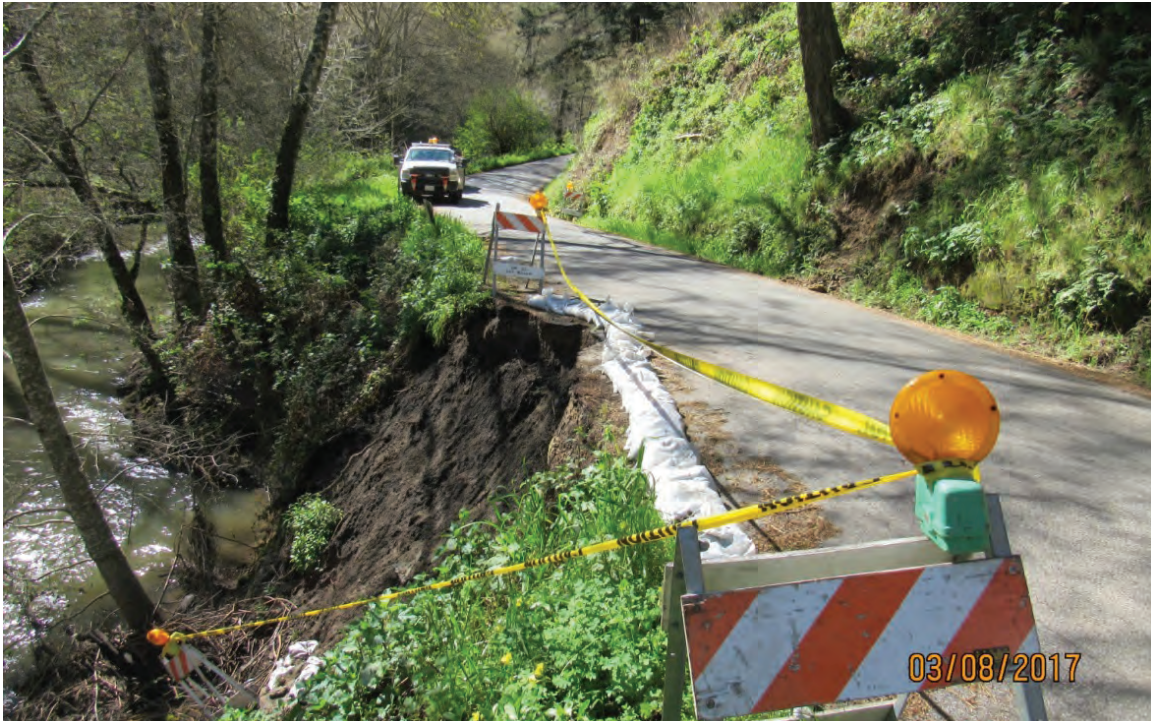
Photo 3. Example slope failure along Gazos Creek and Gazos Creek Road. This site was addressed in the County's 2017 emergency permit application. (March 2017)

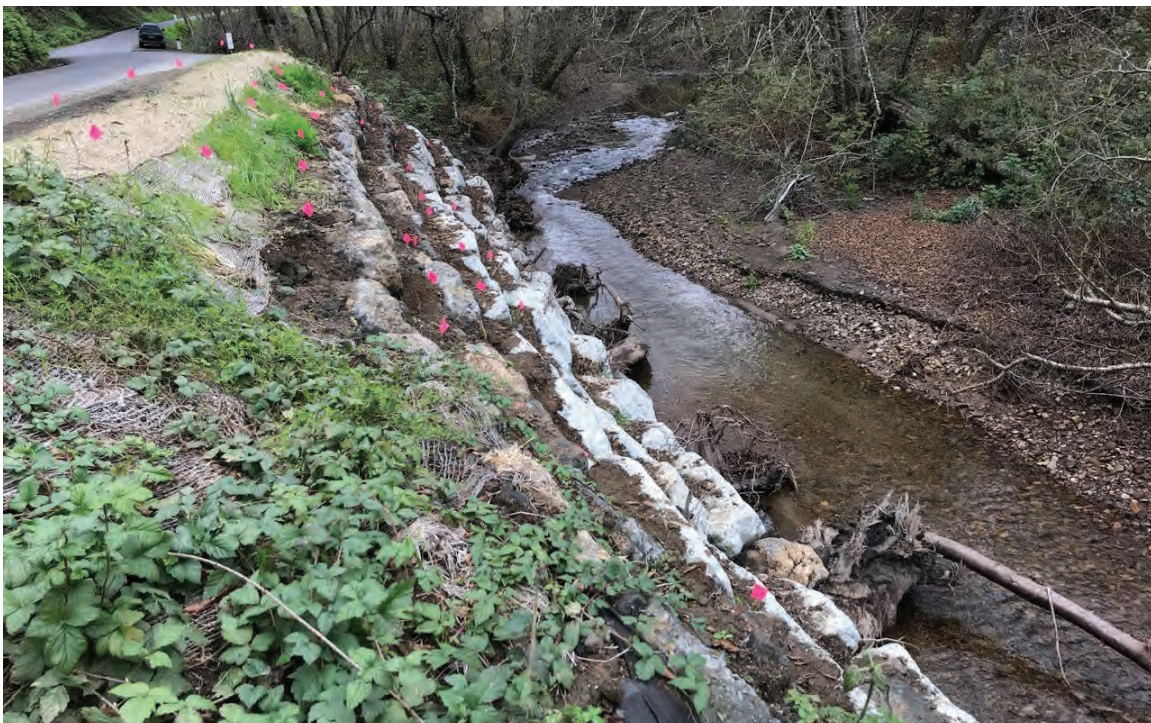
Photo 4. Completed bank stabilization site along Gazos Creek and Gazos Creek Road.

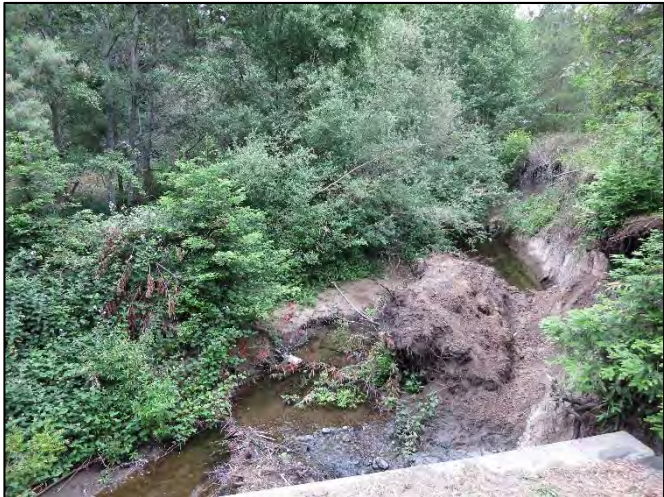
Photo 2. Example area that underwent hazardous tree removal in La Honda Creek (near Entrada Way). Photo shows mass of soil and redwood roots in middle portion of channel. (May 2015)
