\\h2o-server\GIS_Server\PROJECTS\14003_ContraCosta_SMP\mxd\Permitting\USACE\Figures_2-5_SMP_Channels.mxd 4/23/2019 PG

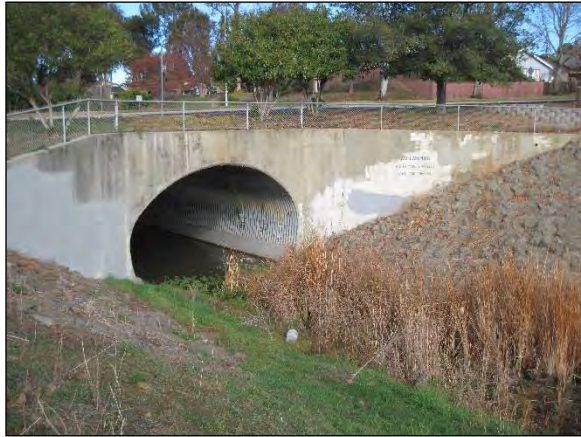
Photo 1. Concrete culvert at a Rodeo Creek road crossing, looking downstream at Viewpoint Blvd. (January 2014)

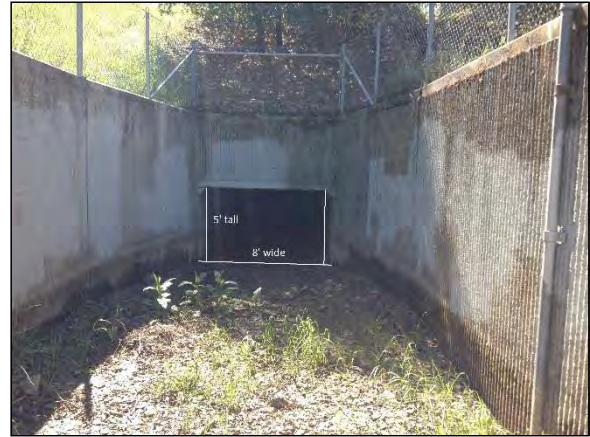
Photo 2. Pine Creek box culvert (downstream end). No flow present at time of survey. (April 2014)

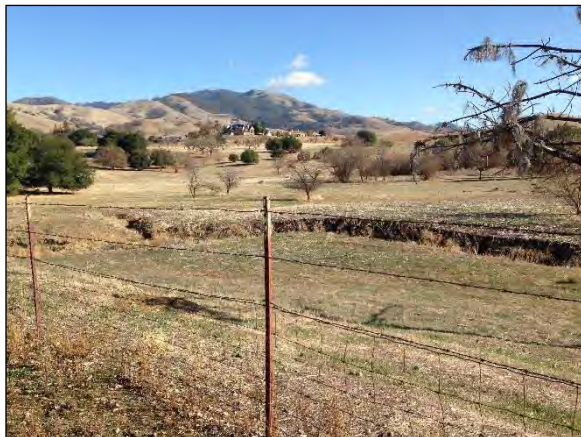
Photo 3. Pine Creek Basin looking southeast from Trails End Drive. (January 2014)

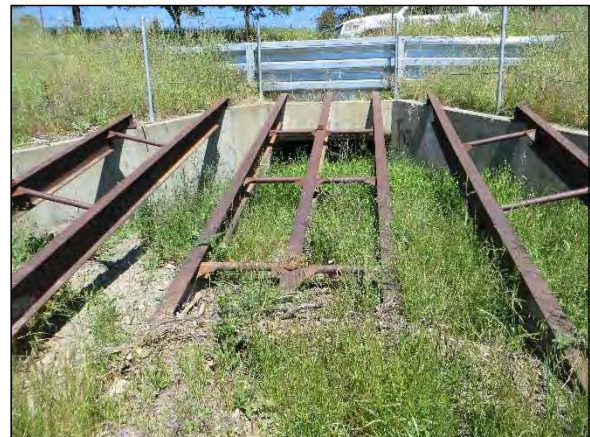
Photo 4. Metal trash rack covering entrance of upstream end of Pine Creek box culvert. (April 2014)

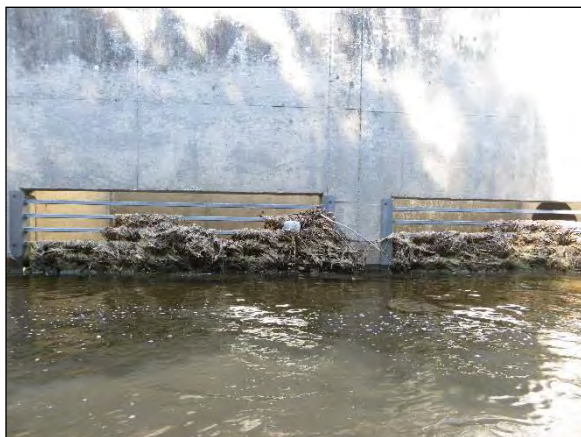
Photo 5. Old San Ramon Creek trash rack. (April 2014)

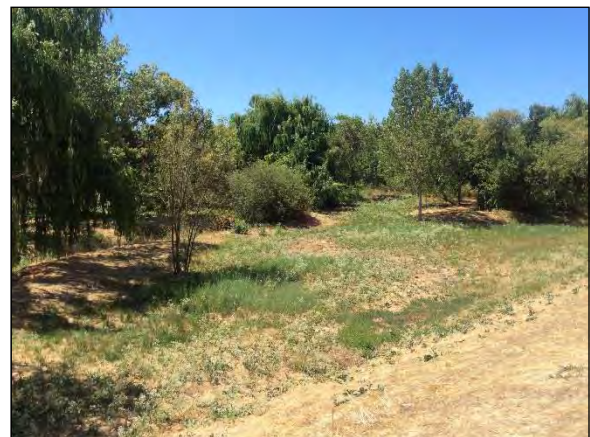
Photo 6. Viano Basin looking south from access road in Martinez. (July 2015)

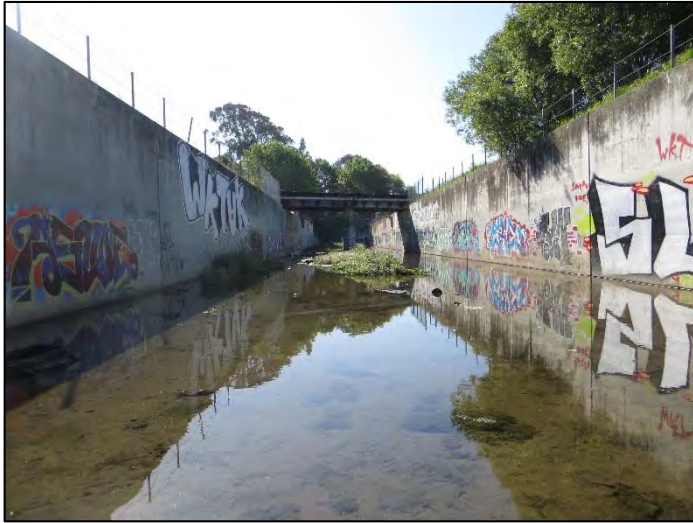
Photo 1. U-shaped concrete channel. View of San Pablo Creek looking upstream near Parr Boulevard in Richmond. (April 2014)

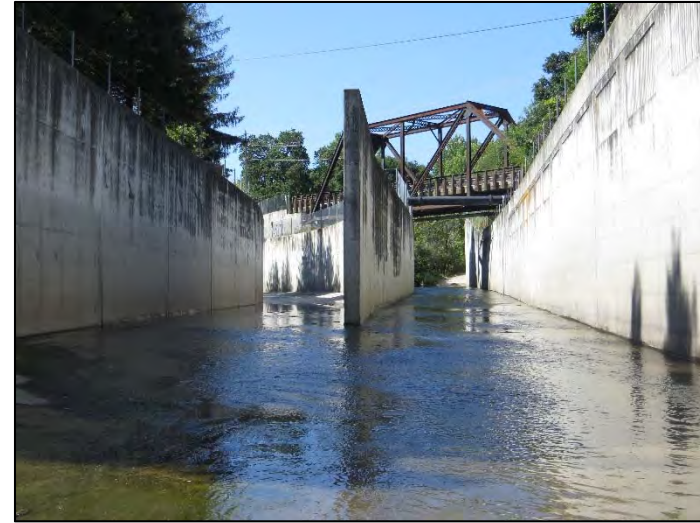
Photo 2. Confluence of two u-shaped concrete channels. View of Walnut Creek channel and San Ramon Bypass looking upstream toward Iron Horse Trail bridge, south of Ygnacio Valley Road. (April 2014)

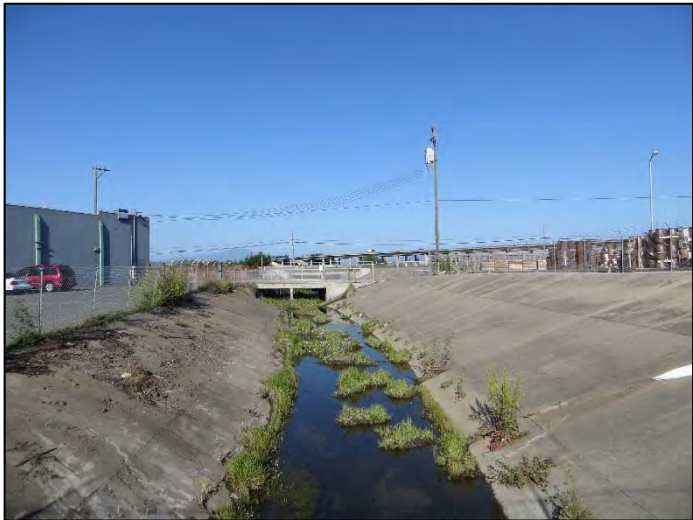
Photo 3. Concrete trapezoidal channel. View of Rheem Creek looking downstream from pedestrian crossing approximately 150 feet upstream of Giant Road. (April 2014)

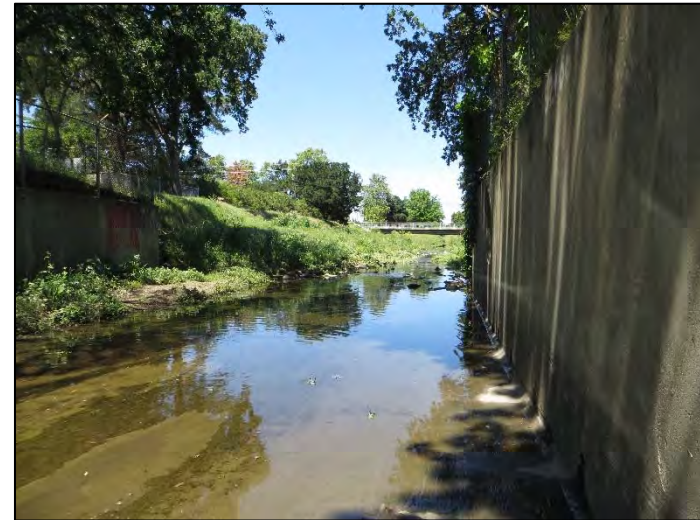
Photo 4. Concrete u-shaped channel. View of Grayson Creek looking downstream, near transition to earthen trapezoidal channel and Viking Drive crossing (seen in distance). (April 2014)

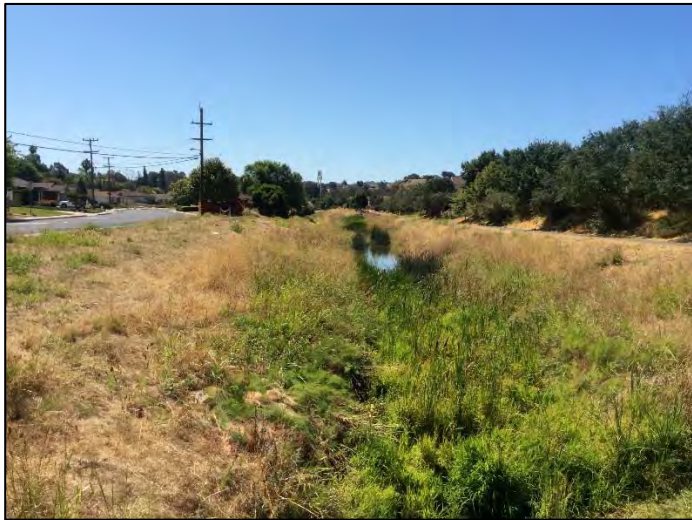
Photo 1. Earthen trapezoidal channel. View of Rodeo Creek looking upstream from 7th Avenue. (July 2015)

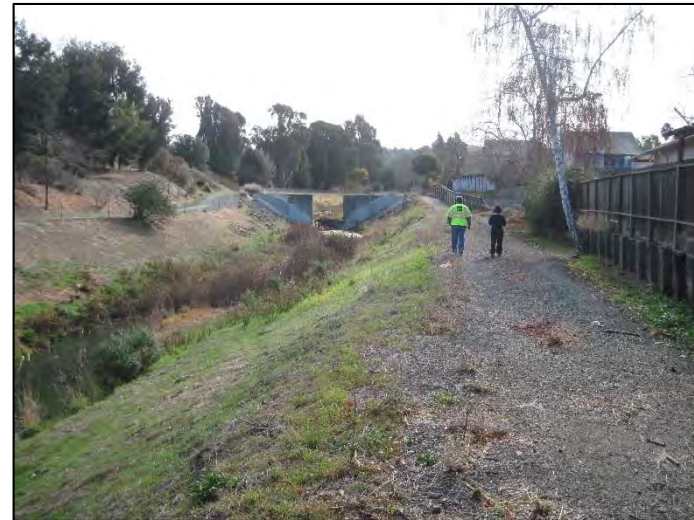
Photo 2. Earthen trapezoidal channel. View of Rodeo Creek looking upstream from near Viewpoint Blvd. crossing. Concrete weir seen in channel in distance. (January 2014)

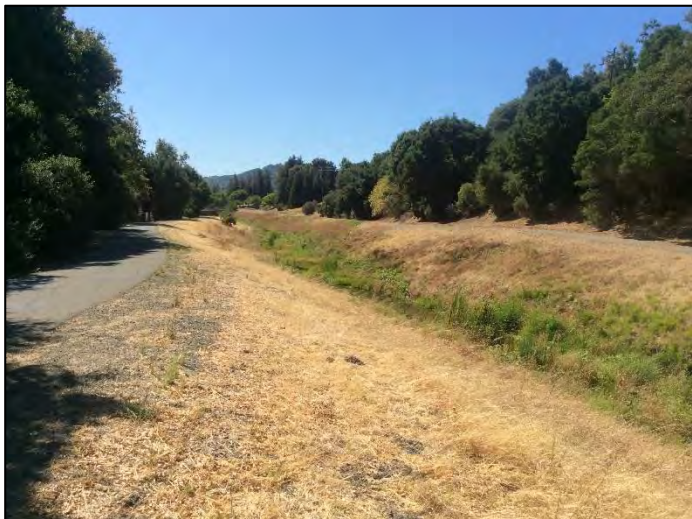
Photo 3. Earthen trapezoidal channel. View of Pinole Creek looking upstream west of Collins Elementary School in Pinole. (July 2015)

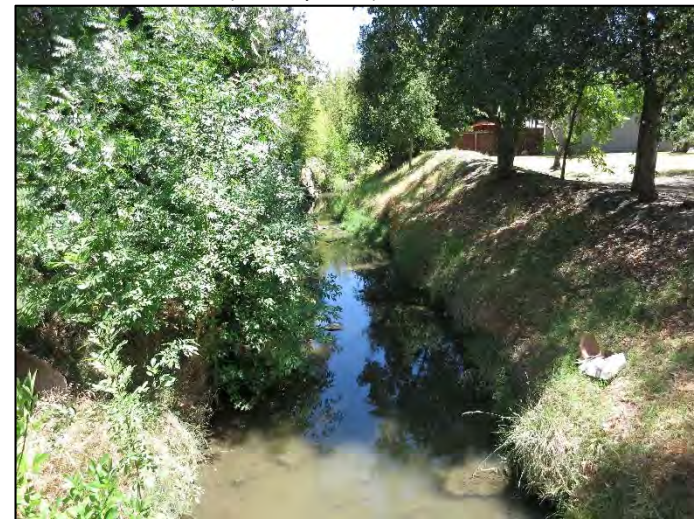
Photo 4. Earthen v-shaped channel. View of East Grayson Creek looking upstream from Boyd Road in Pleasant Hill. (August 2015)
