NAPA RIVER LEFT BANK TULOCAY TO IMOLA LEVEE SYSTEM

**NAPA RIVER/NAPA CREEK FLOOD PROTECTION PROJECT
NAPA, CALIFORNIA
NLD SYSTEM ID NO. 5305000100; SEGMENT ID NO. 5304000090**

**PERIODIC INSPECTION REPORT NO. 1
SEPTEMBER 2020**

**US Army Corps
of Engineers®
San Francisco District**

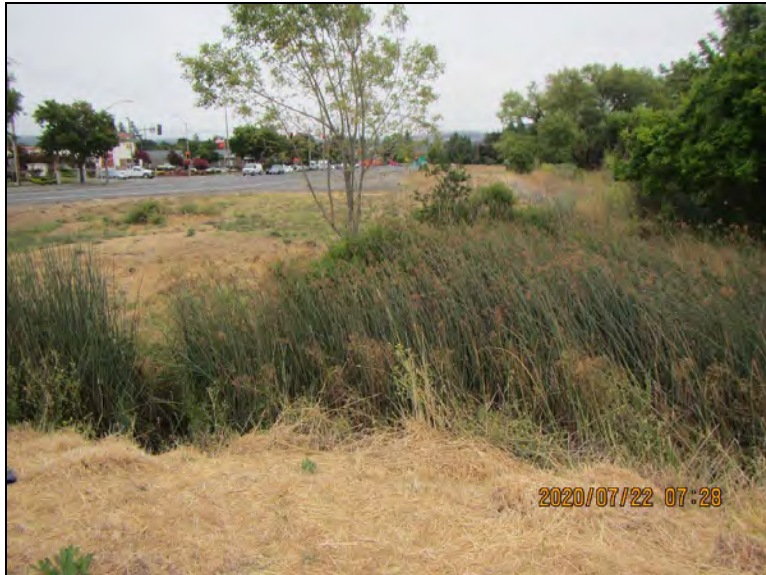
Inspect ID: NLT3_2020_a_0001 **Title:** USACE_CESPN_NLT3_2020_a_0001_1.jpg
Rated Item: 3. Encroachments **Caption:** Rating: Acceptable; Remarks: Upstream end of levee segment.; Action: No action required at this time.

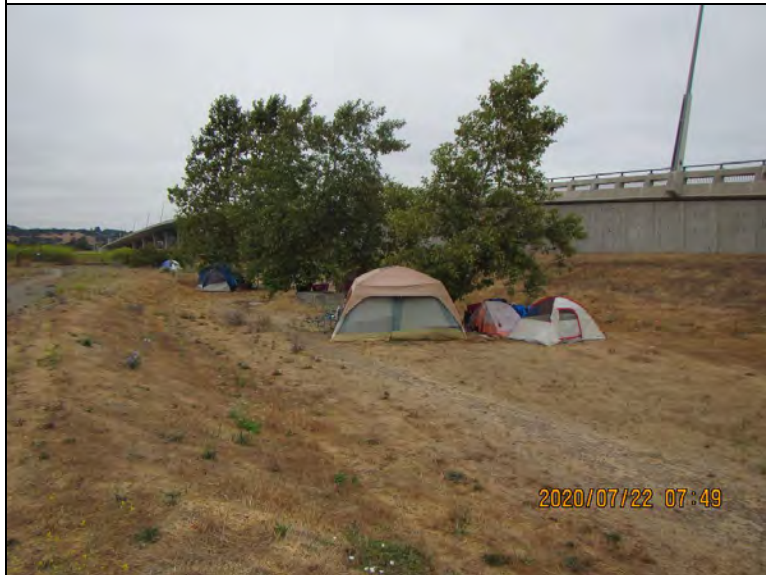
Inspect ID: NLT3_2020_a_0006 **Title:** USACE_CESPN_NLT3_2020_a_0006_1.jpg
Rated Item: 3. Encroachments **Caption:** Rating: Minimally Acceptable; Remarks: Homeless encampment within 15 feet of landside toe.; Action: No action required at this time.

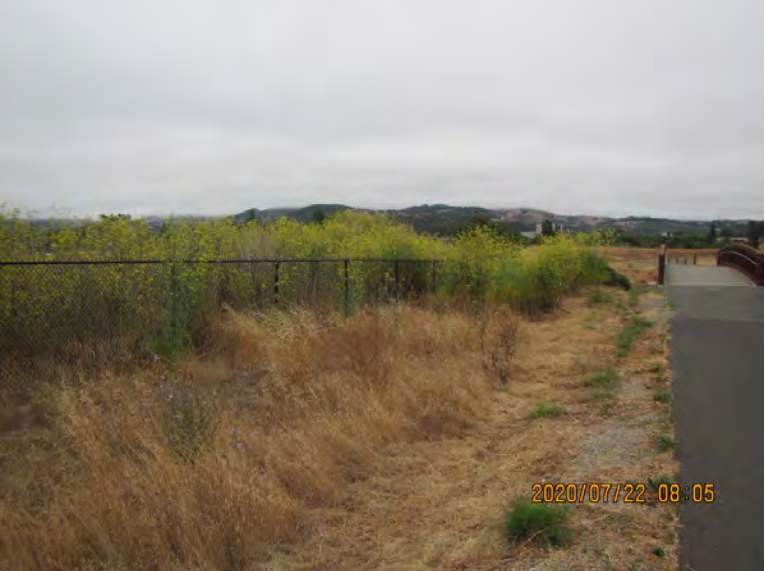
<p>Inspect ID: NLT3_2020_a_0012 Title: USACE_CESPN_NLT3_2020_a_0012_1.jpg Rated Item: 3. Encroachments Caption: Rating: Acceptable; Remarks: Fence and gate across levee slope and crown.; Action: Ensure access is obtained and maintained for flood fighting, maintenance and inspection activities.</p>

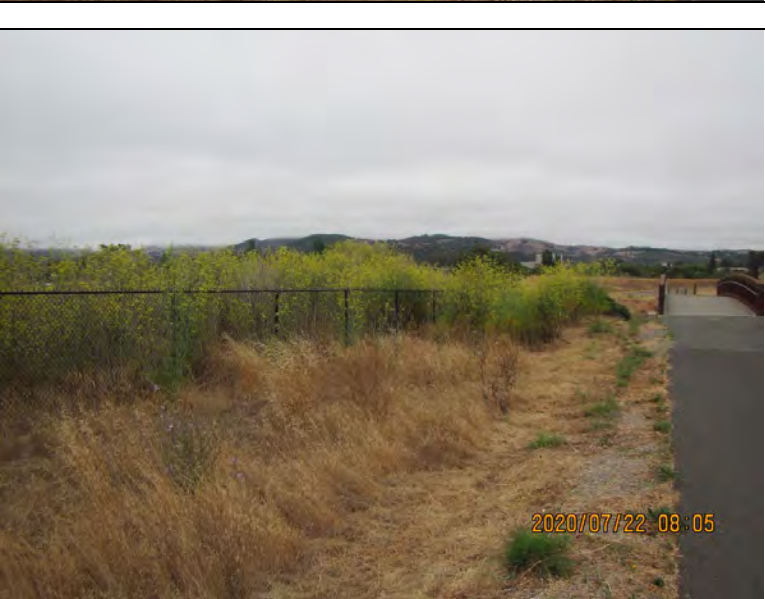
<p>Inspect ID: NLT3_2020_a_0013 Title: USACE_CESPN_NLT3_2020_a_0013_1.jpg Rated Item: 3. Encroachments Caption: Rating: Acceptable; Remarks: Fenceline within 15 feet of landside slope.; Action: Ensure access is obtained and maintained for flood fighting, maintenance and inspection activities.</p>

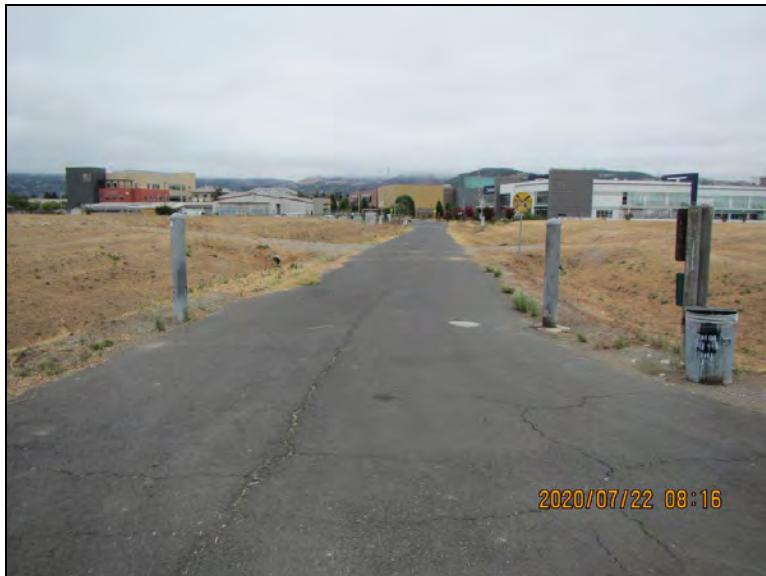
Inspect ID: NLT3_2020_a_0016 **Title:** USACE_CESPN_NLT3_2020_a_0016_1.jpg
Rated Item: 3. Encroachments **Caption:** Rating: Acceptable; Remarks: Access road on landside slope.; Action: No action required at this time.

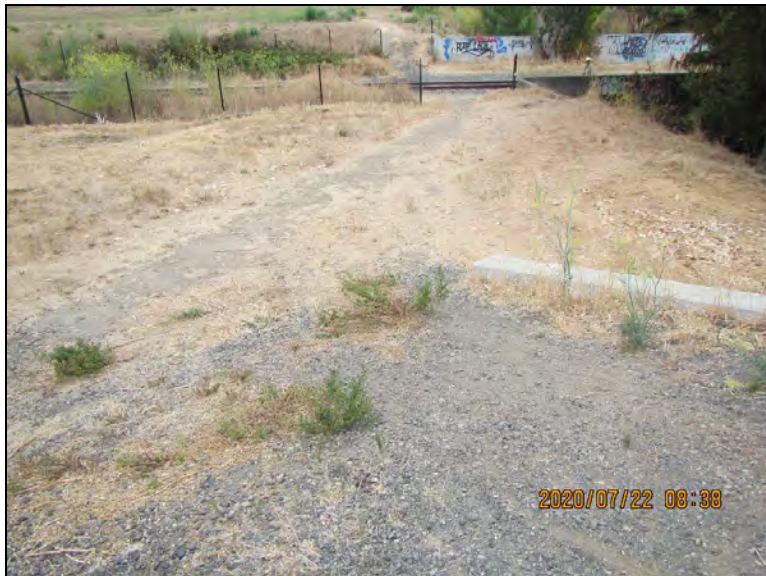
Inspect ID: NLT3_2020_a_0022 **Title:** USACE_CESPN_NLT3_2020_a_0022_1.jpg
Rated Item: 3. Encroachments **Caption:** Rating: Acceptable; Remarks: Downstream end of levee segment.; Action: No action required at this time.

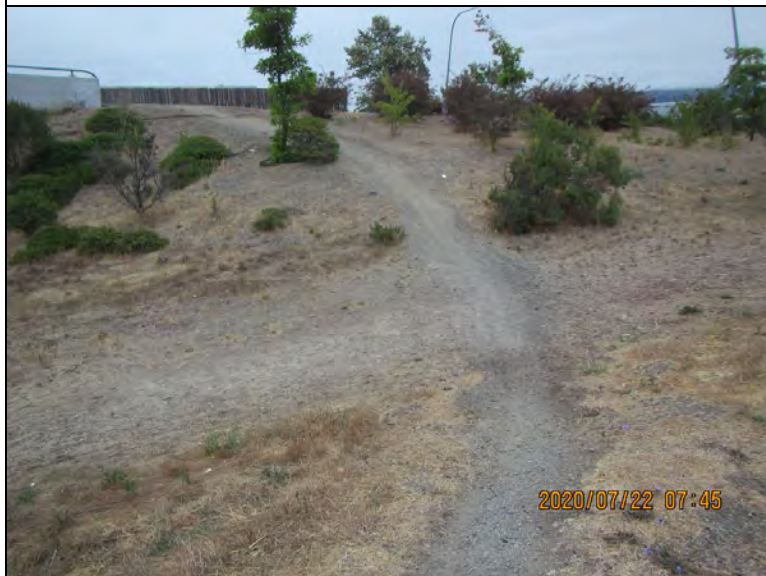
Inspect ID: NLT3_2020_a_0005 **Title:** USACE_CESPN_NLT3_2020_a_0005_1.jpg
Rated Item: 6. Erosion/ Bank Caving **Caption:** Rating: Minimally Acceptable; Remarks: Foot path on landside slope of levee.; Action: Fill and compact to reestablish levee cross section.
