Levee Inspection Report

Name of System: Alameda Zone 03A, Line B - Ward Creek (wDCR)
 Name of Segment: Alameda Zone 03A, Line B - Ward Creek (wDCR)
 NLD System ID: 5305001100 NLD Segment ID: 5304001100

Segment Type: Non-Federally Constructed, local O&M
 Levee Sponsor (Name and Organization): Alameda County Flood Control and Conservation District
 Inspection Report Prepared by: Patrick Sing, PE Date(s) of Inspection: 09/03/2020 - 09/03/2020

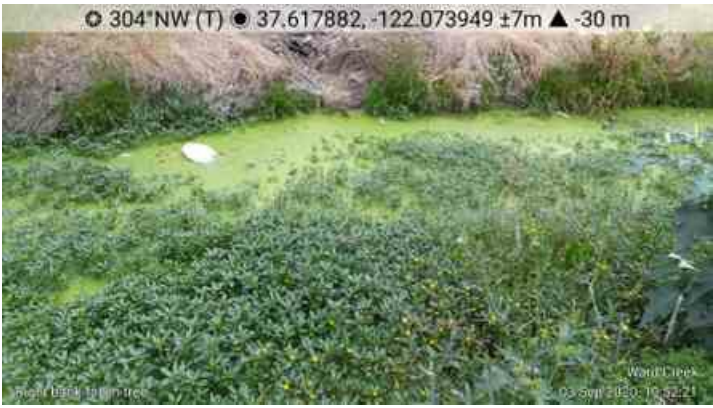
<p>Inspect ID: 2020-0029 Title: 5304001100_CESPN_2020_A_0029_1_20201204T164128.jpg Rated Item: 2. Shoaling (sediment deposition) Caption: Minimally Acceptable - Algae and minor shoaling was observed within the channel adjacent to the levee embankment at the downstream end of the segment. The sponsor should remove the shoal before it grows in size and becomes a serious impediment to flow within the channel. (O&M Manual Station 0+79)</p>
