PUBLIC NOTICE

Project: Reclamation District 768 Levee Repair – 10 year Permit

NUMBER: 400235N

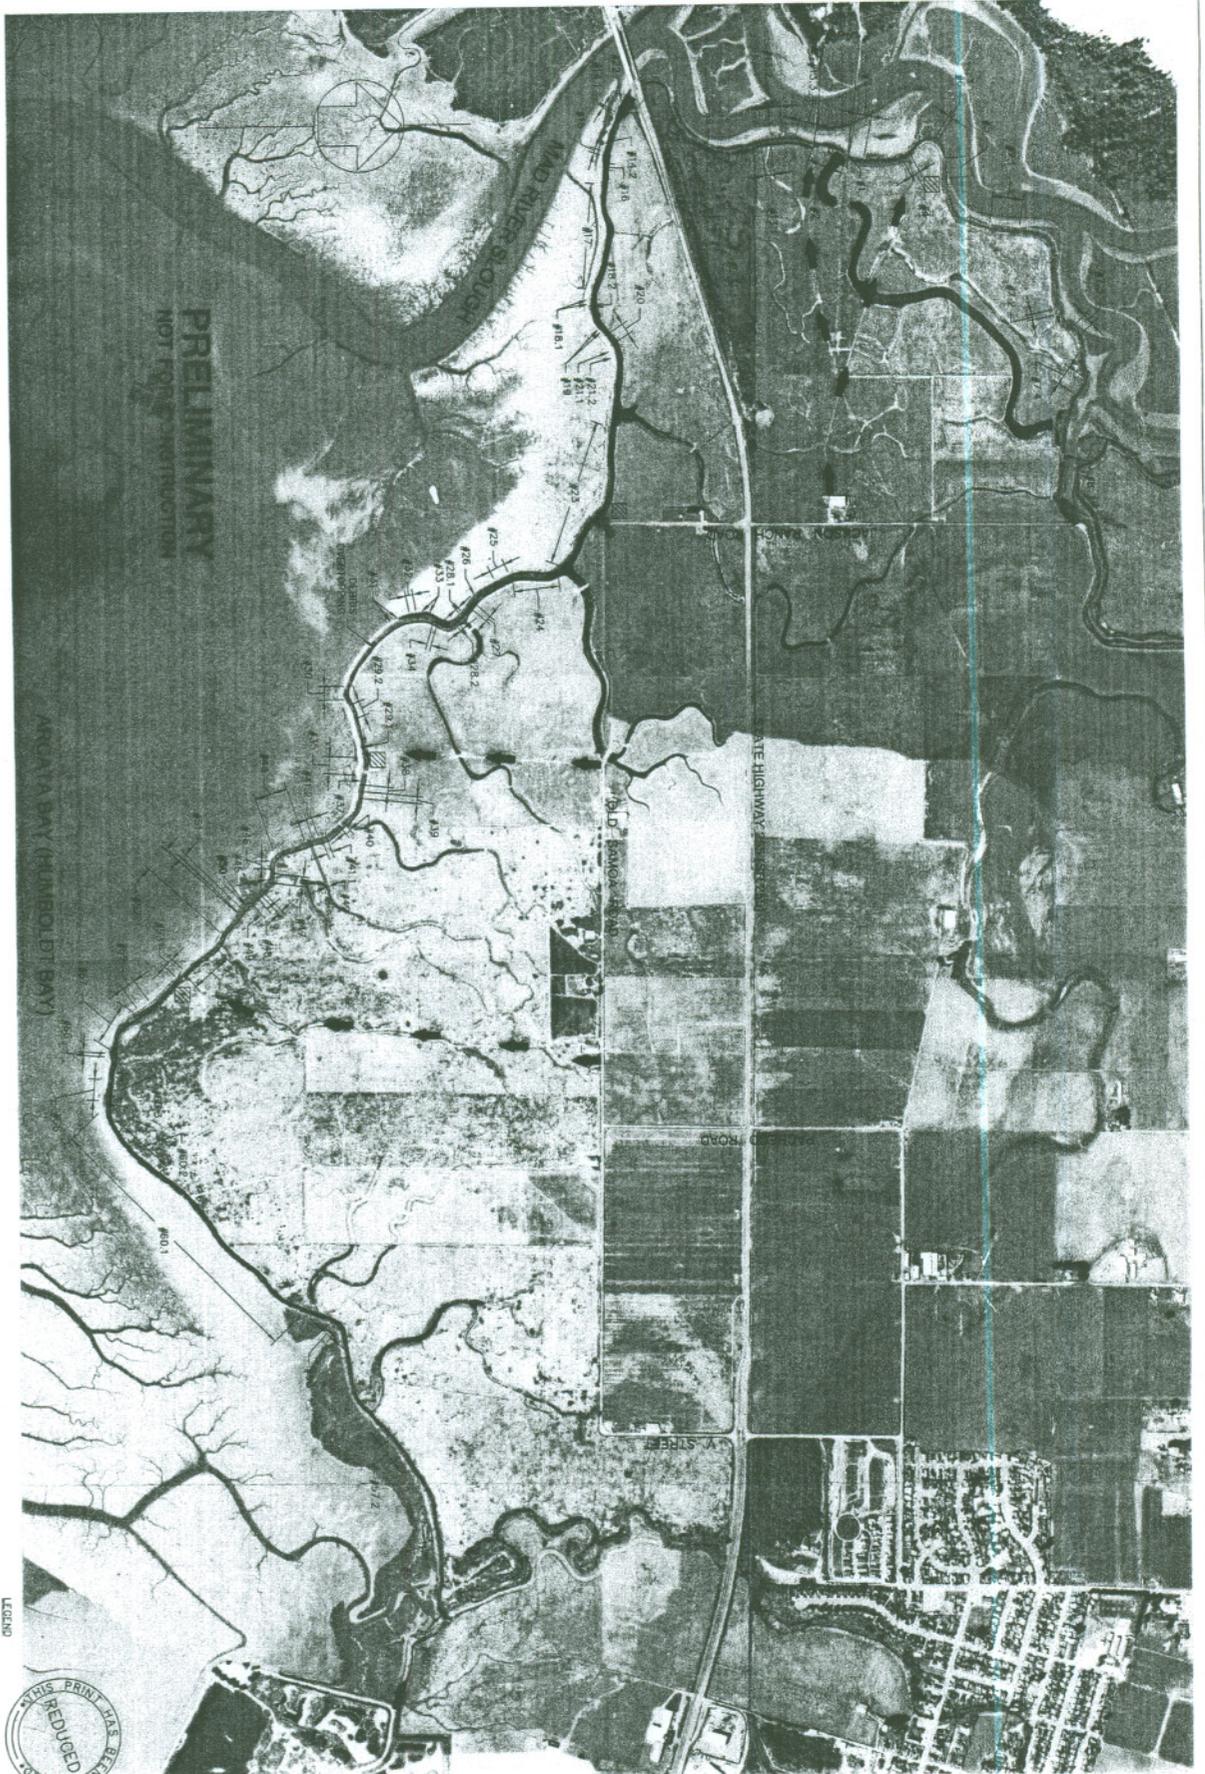
RECLAMATION DISTRICT #768
LEVEE REPAIR MAP

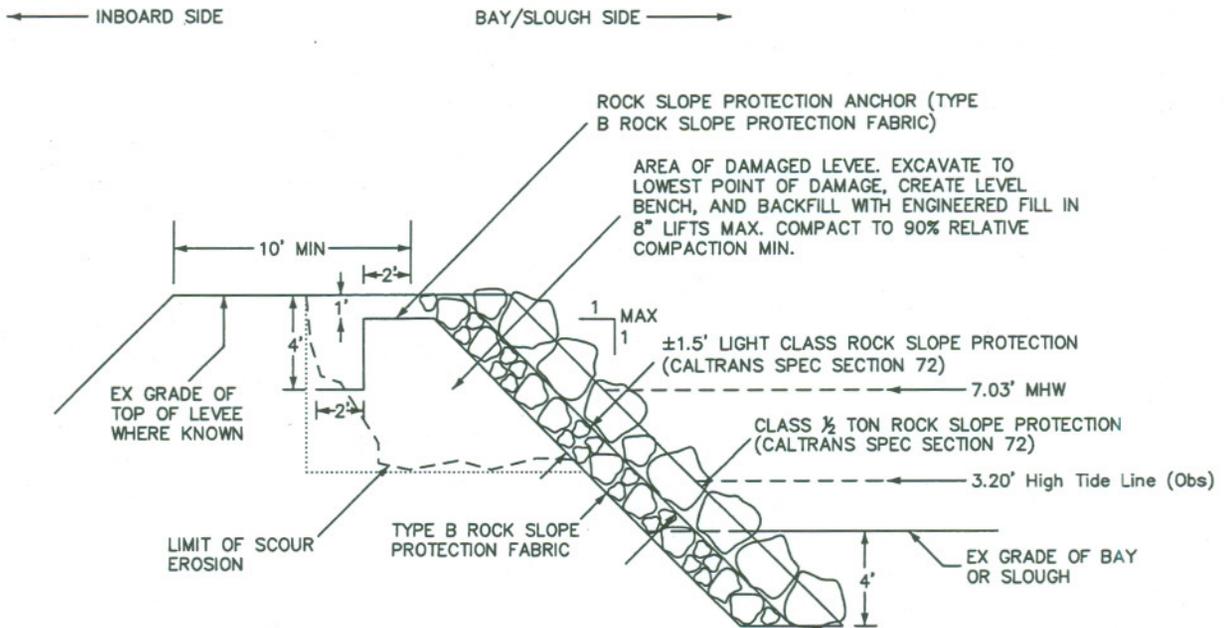
- NOTES:
1. HYDROSEED ALL NONTIDAL DISTURBED EARTH SURFACES.
 2. REMOVE ALL DEBRIS FROM AREA OF REPAIR PRIOR TO WORK.

TIDAL INFLUENCED LEVEE REPAIR

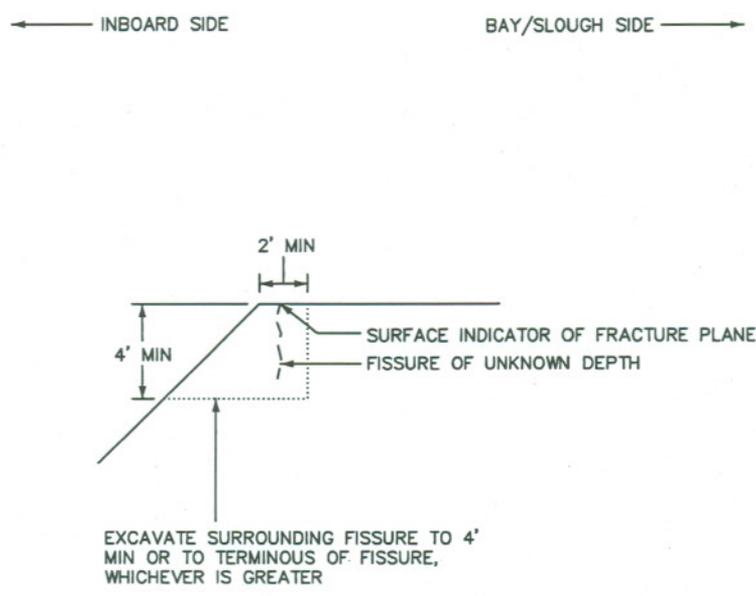
Figure 6

- NOTES:**
1. HYDROSEED ALL NONTIDAL DISTURBED EARTH SURFACES.
 2. BACKFILL EXCAVATED AREA WITH ENGINEERED FILL IN 8" LIFTS MAX. COMPACT TO 90% RELATIVE COMPACTION MIN.
 3. AREAS WHERE NONTIDAL LEVEE SLOPE IS GREATER THAN OR EQUAL TO 1:1, INSTALL COCONUT/STRAW EROSION BLANKETS ON ALL DISTURBED EARTH SURFACES.

NONTIDAL FISSURE REPAIR
CROSS-SECTION
 SCALE: 1/8 INCH = 1'±

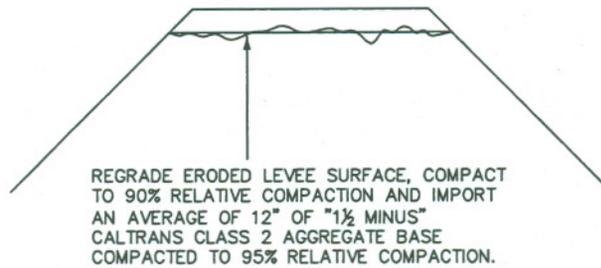
1. HYDROSEED ALL NONTIDAL DISTURBED EARTH SURFACES EXCLUDING IMPORTED AGGREGATE BASE.
2. REMOVE ALL DEBRIS AND CLEAR AND GRUB PRIOR TO WORK.

TOP OF LEVEE EROSION REPAIR
CROSS-SECTION

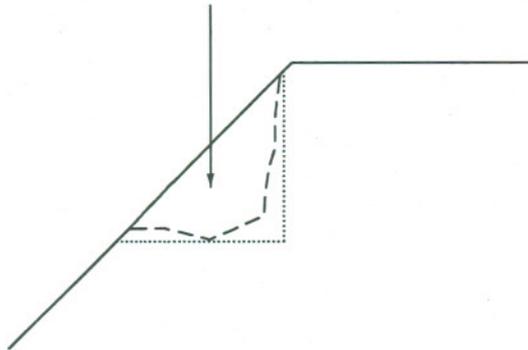
← INBOARD SIDE BAY/SLOUGH SIDE →

AREA OF DAMAGED LEVEE. EXCAVATE TO LOWEST POINT OF DAMAGE, CREATE LEVEL BENCH, AND BACKFILL WITH ENGINEERED FILL IN 8" LIFTS MAX. COMPACT TO 90% RELATIVE COMPACTION MIN.

1. HYDROSEED ALL NONTIDAL DISTURBED EARTH SURFACES.
2. REMOVE ALL DEBRIS AND CLEAR AND GRUB PRIOR TO WORK.
3. AREAS WHERE NONTIDAL LEVEE SLOPE IS GREATER THAN OR EQUAL TO 1:1, INSTALL COCONUT/STRAW EROSION BLANKETS ON ALL DISTURBED EARTH SURFACES.

NONTIDAL LEVEE REPAIR
CROSS-SECTION

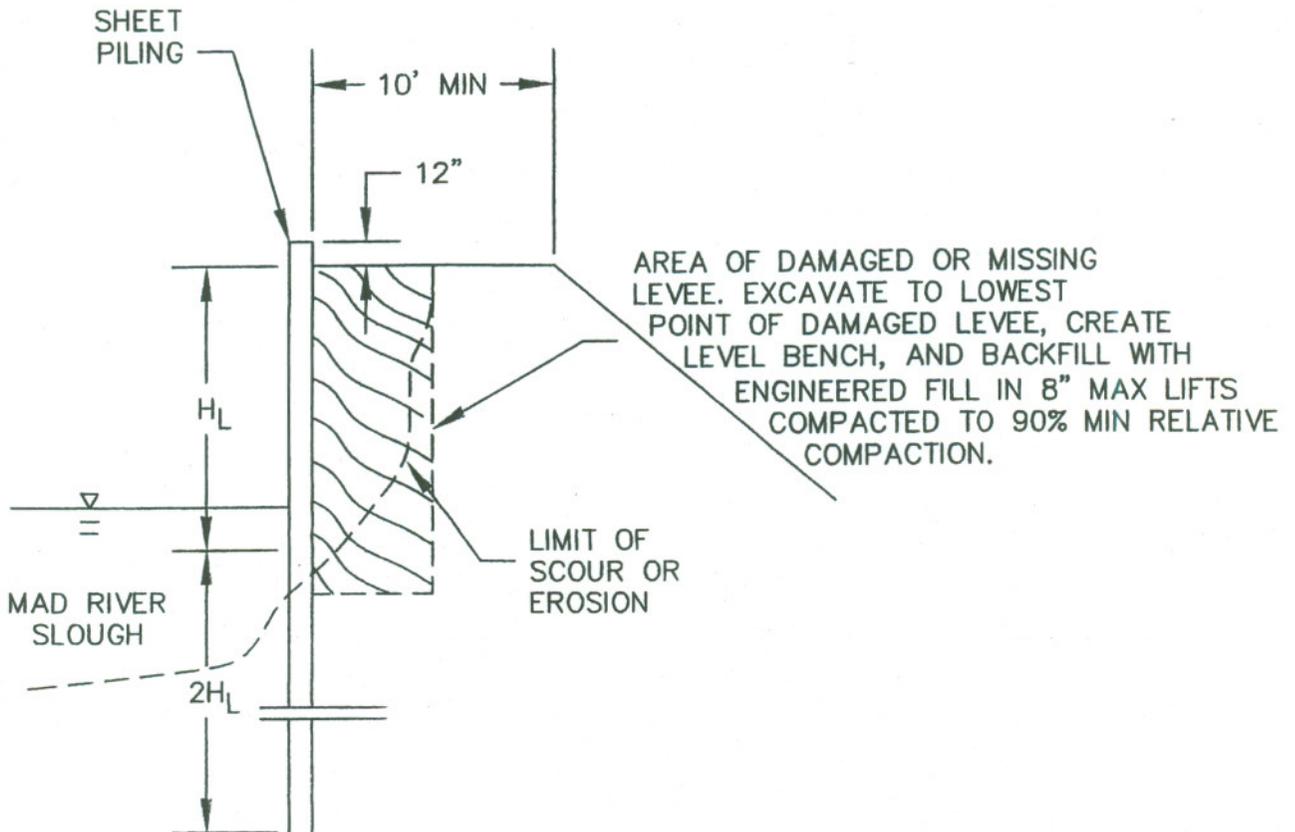
LEVEE REPAIR W/ SHEET PILING
SCALE: 1/8" = 1'

1. HYDROSEED ALL NON-TIDAL DISTURBED EARTH SURFACES.
2. REMOVE ALL DEBRIS AND CLEAR AND GRUB PRIOR TO WORK.
3. THIS IS NOT A FINAL DESIGN. SHEET PILES WILL BE DESIGNED TO CURRENT ARMY CORP OF ENGINEERS STANDARDS WHICH MAY INCLUDE ADDITIONAL APPURTENANCES SUCH AS TIE-BACK RODS, VERTICAL BRACING AND HORIZONTAL BRACING, AND MAY REQUIRE DIFFERENT GRADING THAN SHOWN IN THIS DETAIL.

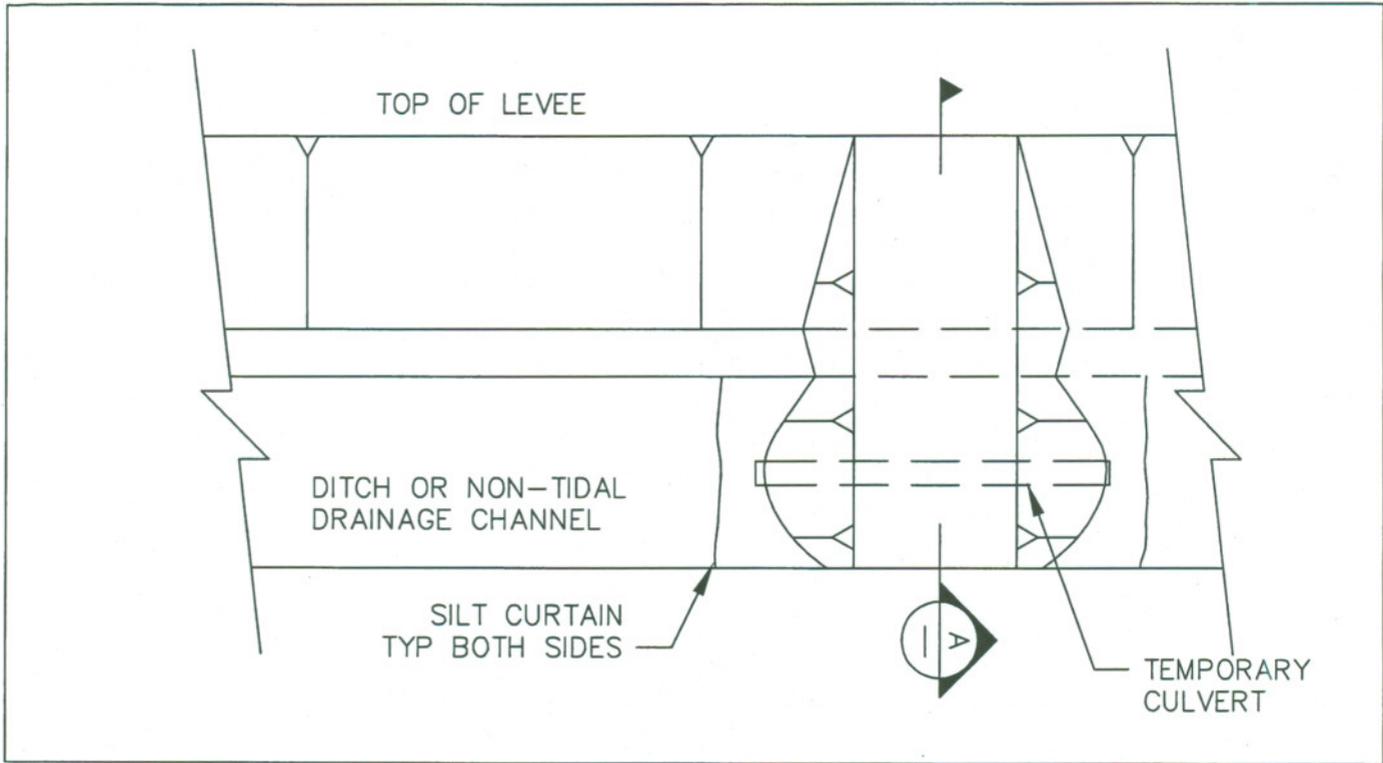
1 PLAN - TEMPORARY DITCH CROSSING - CULVERT
SCALE: NTS

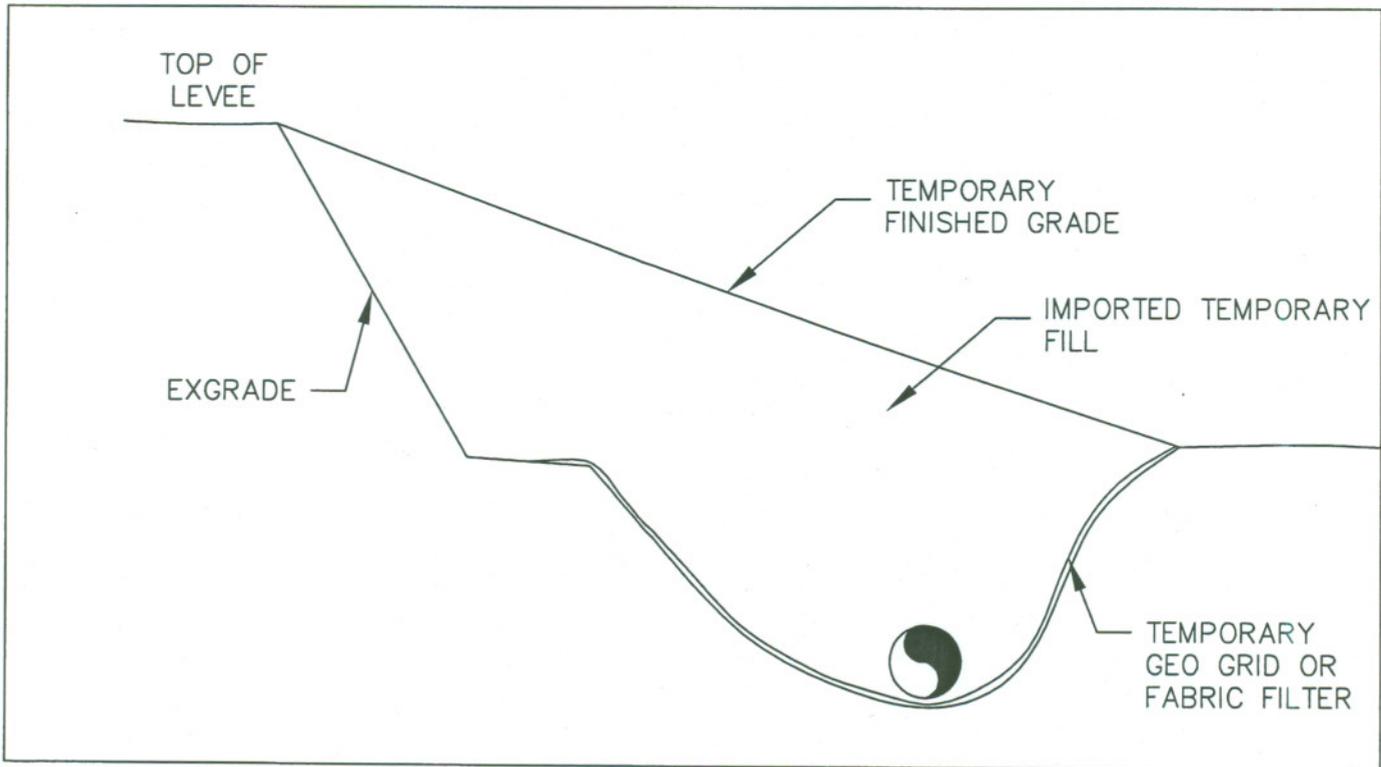
A SECTION
SCALE: NTS

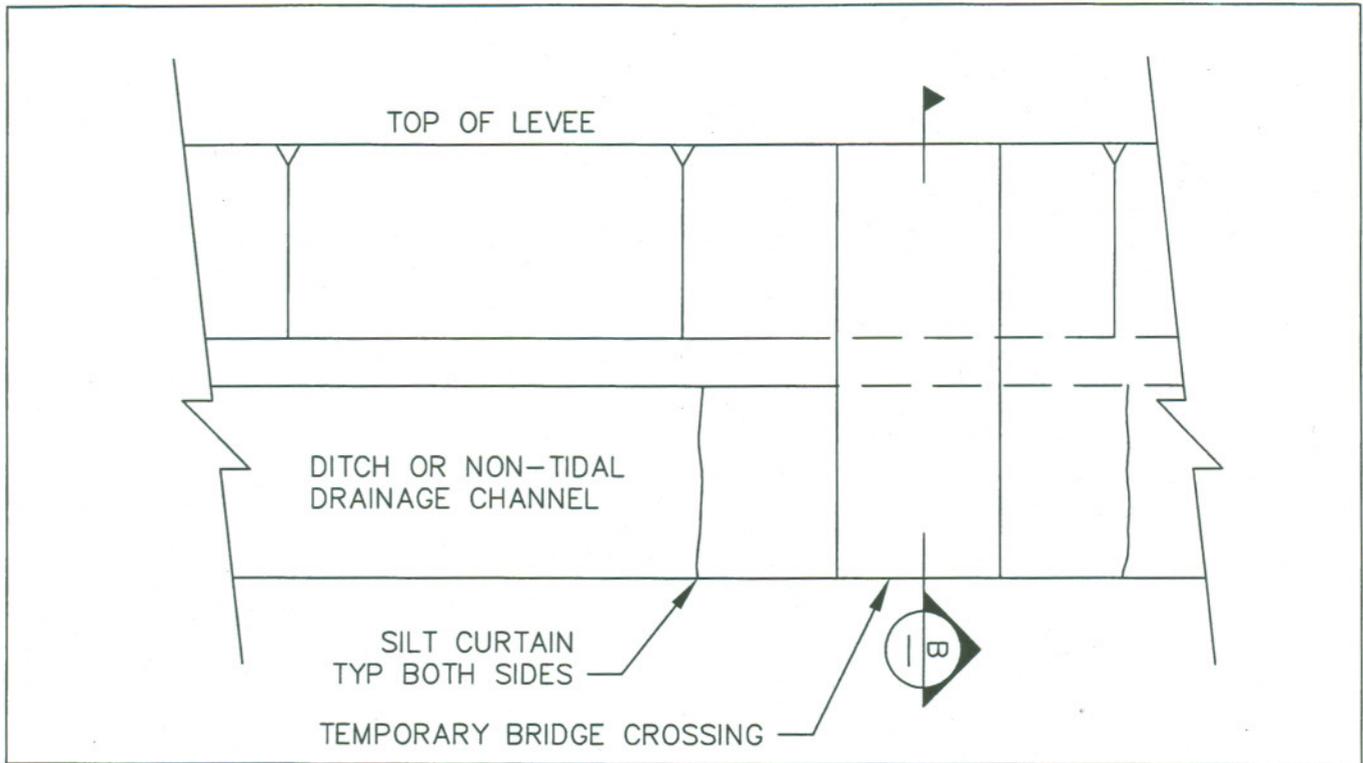
2 PLAN - TEMPORARY DITCH CROSSING - BRIDGE
SCALE: NTS

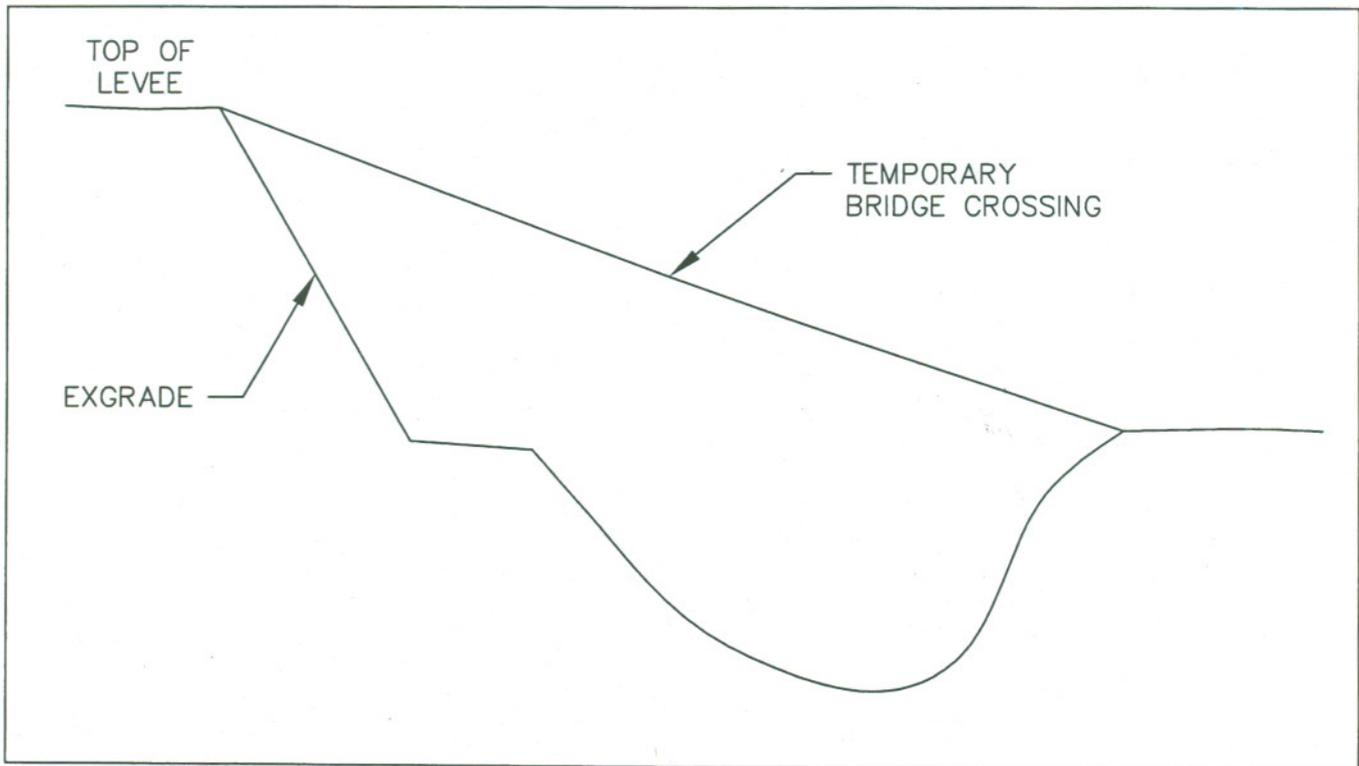
B SECTION
SCALE: NTS
