**US Army Corps
of Engineers®**
San Francisco District

Appendix I

Geotechnical Engineering

DRAFT

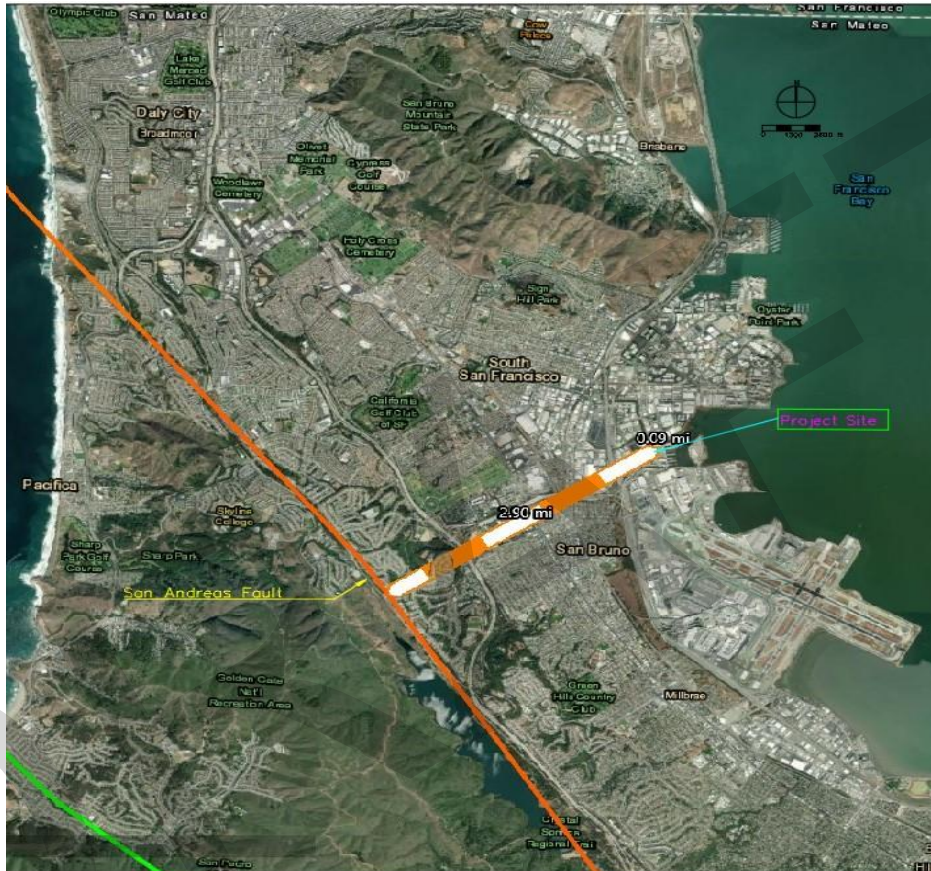
The Major Bay Area Faults are shown on Figure 3. The closest active fault to the project site is the San Andreas fault, located approximately 3 miles southwest of the site. The site is not located within a state designated Alquist-Priolo Earthquake Fault Zone or a Santa Clara County fault rupture hazard zone. No known surface expression of active faults is believed to cross the site, and therefore fault rupture hazard is not anticipated.

Figure 3 - Major Faults near the project Site

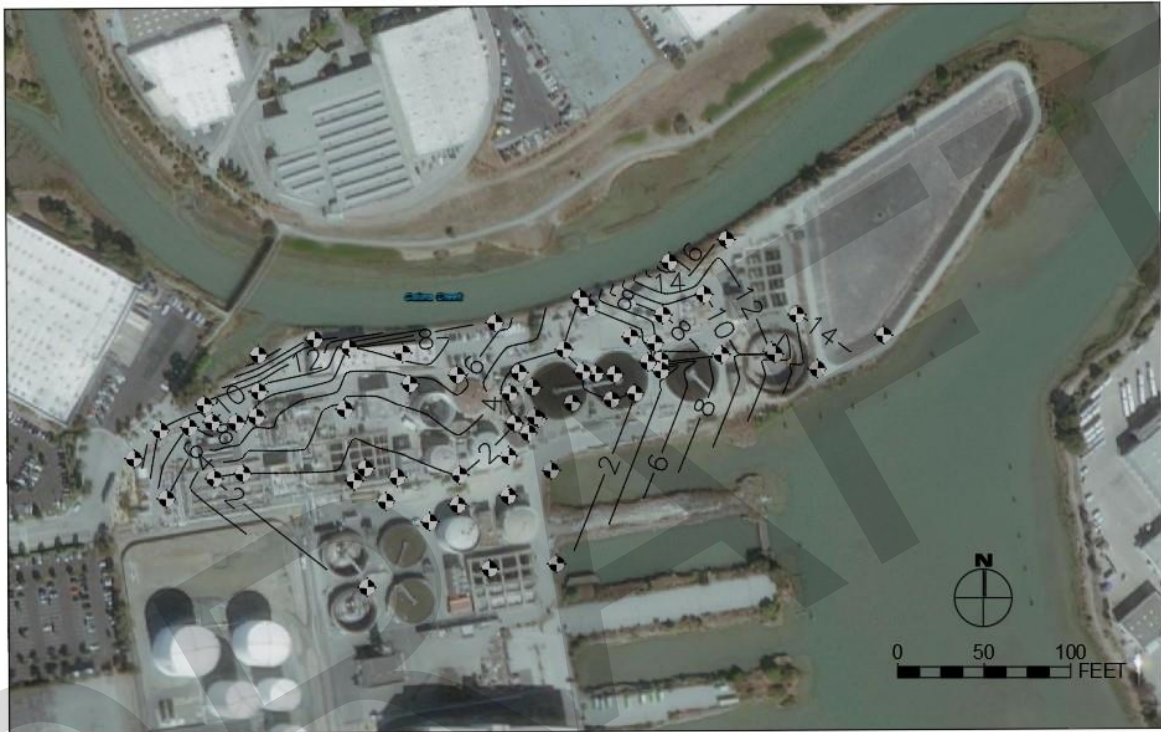
Bay Mud thickness is judged to be the most important geotechnical aspect affecting the cost of proposed alternatives. The thickness of the Bay Mud was estimated based on the data collected from standard penetration testing (SPT) explorations previously conducted by Fugro and others, and engineering judgment. The interpretation is shown on Figure 8.

BAY MUD THICKNESS CONTOUR MAP

Figure 8- Preliminary Bay Mud Contour Map

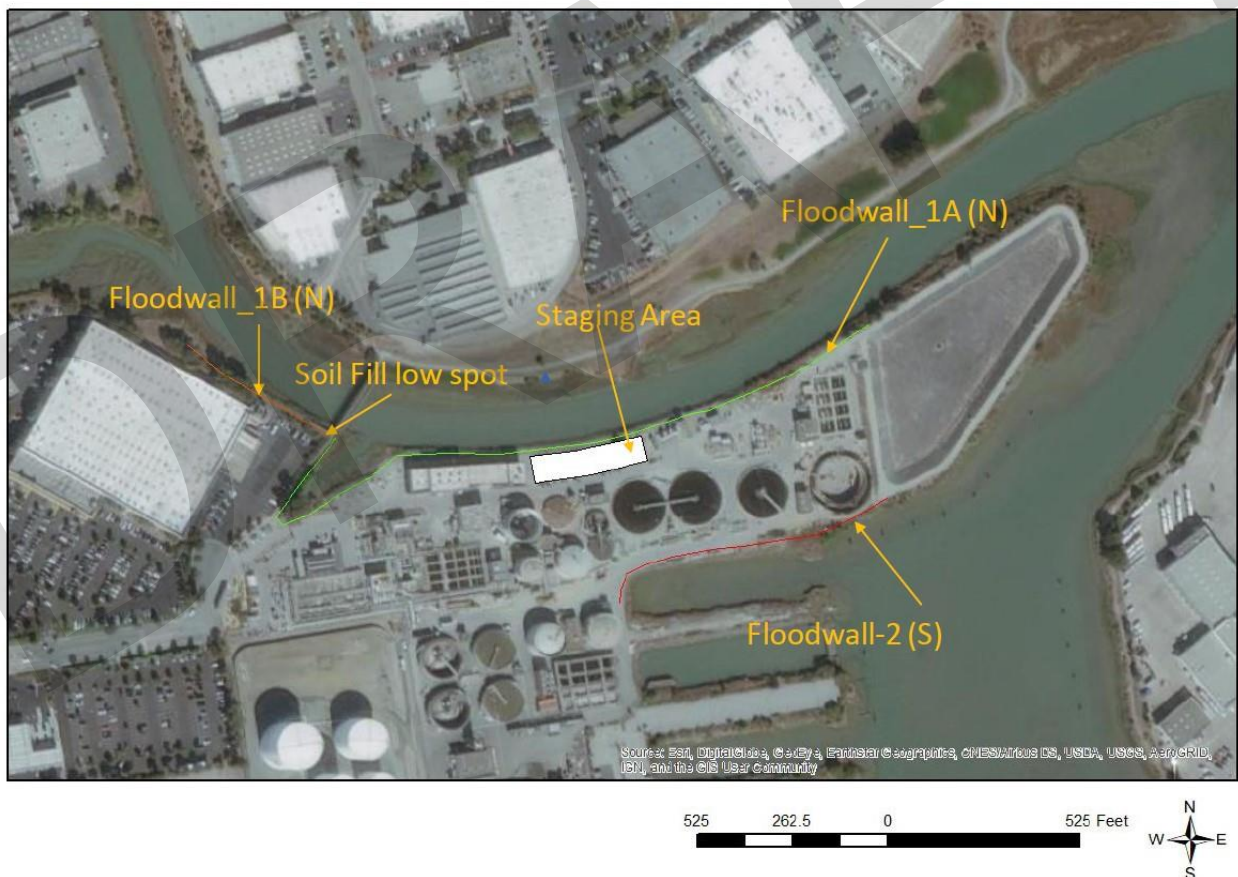
A Floodwall is considered to provide a CSRM benefits to the feasibility study. The alignment for this floodwall starts from an area at the northwest near the San Francisco Trail Bridge to a higher ground area near the retention pond to the east. The proposed floodwall is considered to reduce the risk of 100-year flood and provides a line of protection to the treatment plant facility buildings and equipment. In areas where the construction of an inverted T-shape cantilever floodwall is not feasible due to space constraints, I-wall floodwall needs to be constructed. Figure 9 shows areas where floodwall need to be constructed.

Figure 9 - Floodwall Alternatives

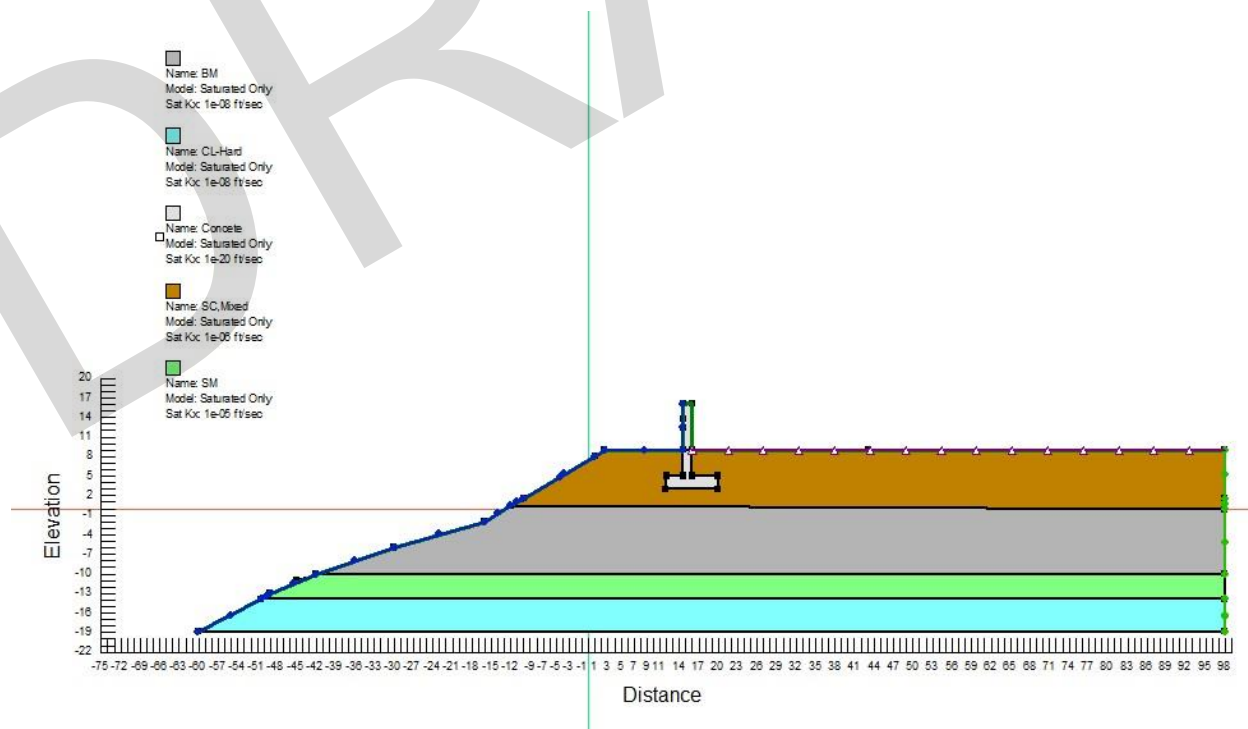
A Seep/W analysis was performed at a cross section of the continuous floodwall footing. The result revealed that the seepage was not significant and would not be an issue due to low exit gradient and low permeability of Bay Mud blanket thickness as shown in Figure 8.

Figure 10- Seepage Model and Soil Profile

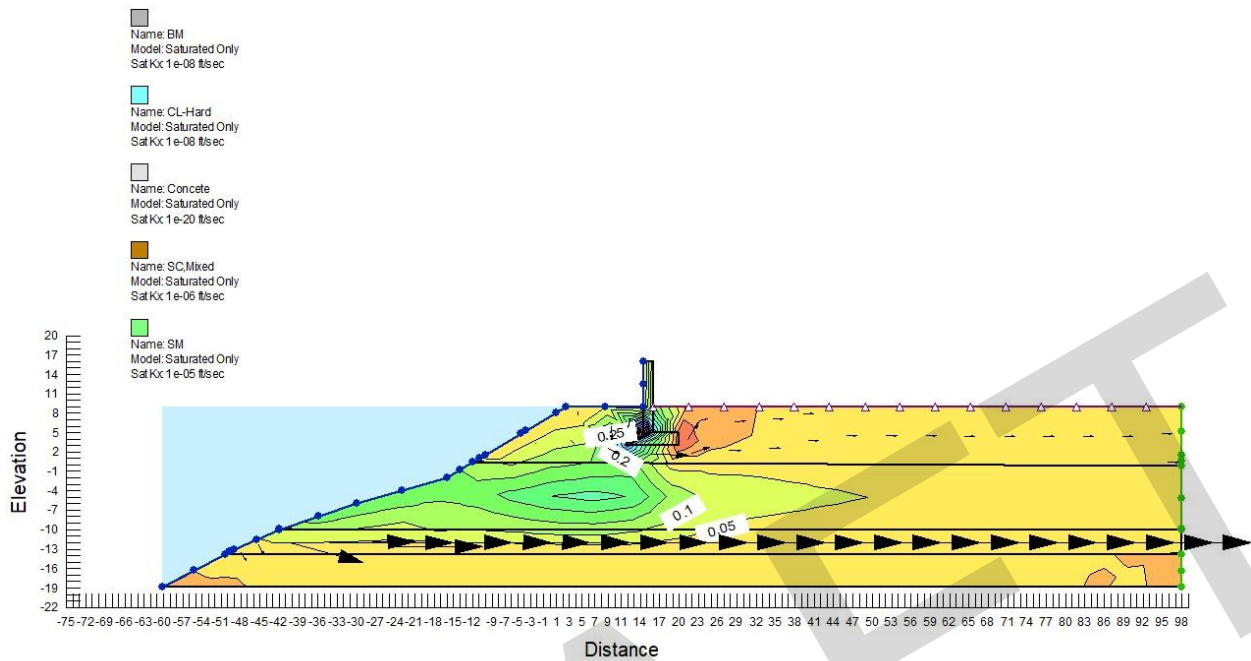
Figure 11- Seepage Model Analysis

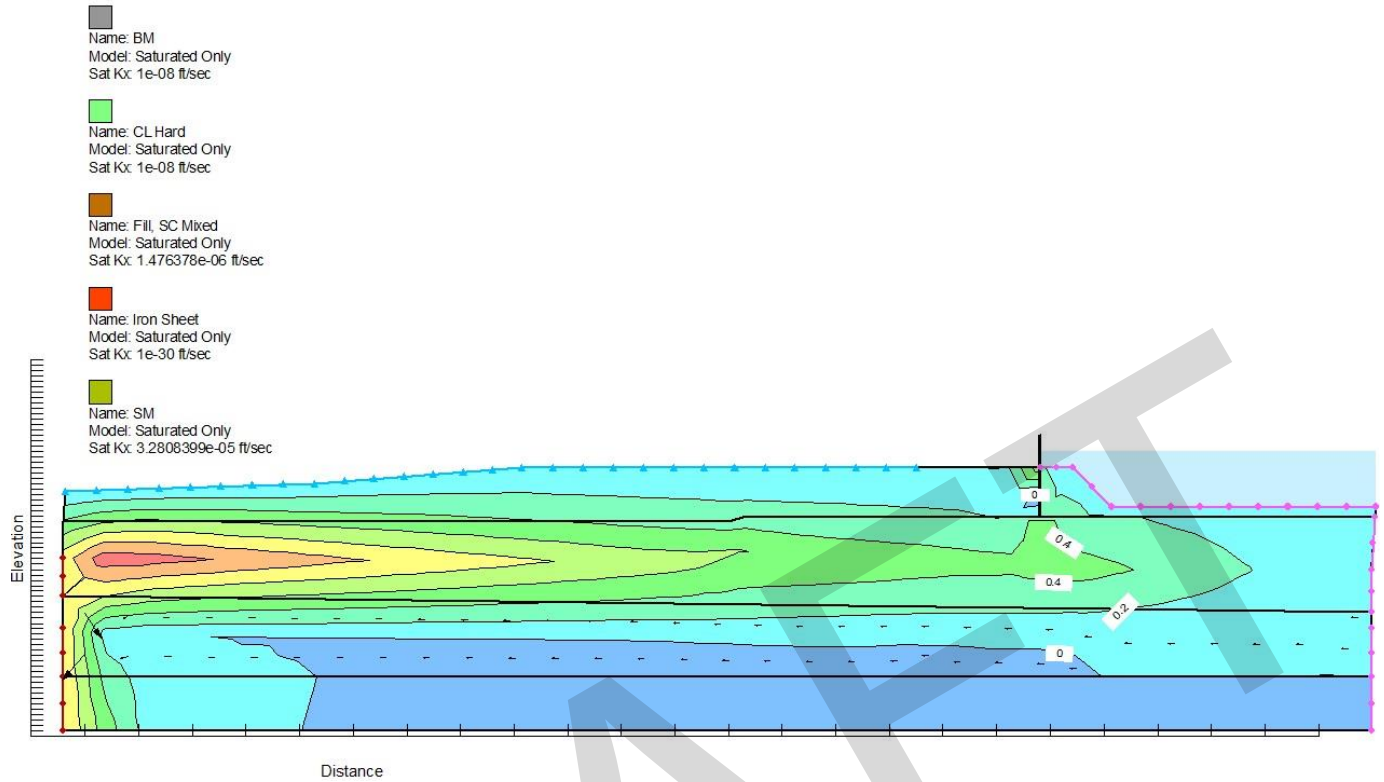
I-wall stability should be analyzed for a full range of failure modes. One of the failure modes includes a flood-side gap between the soil and I-wall with hydrostatic pressure acting along the full gap depth. Computer software Slope/W was used to determine the slope stability and hydrostatic pressure between the soil and I-wall. Since the ground at the landside of the I-wall is flat, the slope stability is not a concern. The result of seep/W analysis performed for this failure under an unusual hydraulic loading condition shows that the seepage is not significant and will not be an issue due to low exit gradient (less than 0.5) and low permeability of bay mud blanket as shown in figure 15.

Figure 12- Seepage Analysis at Gap-Soil Sheet Pile

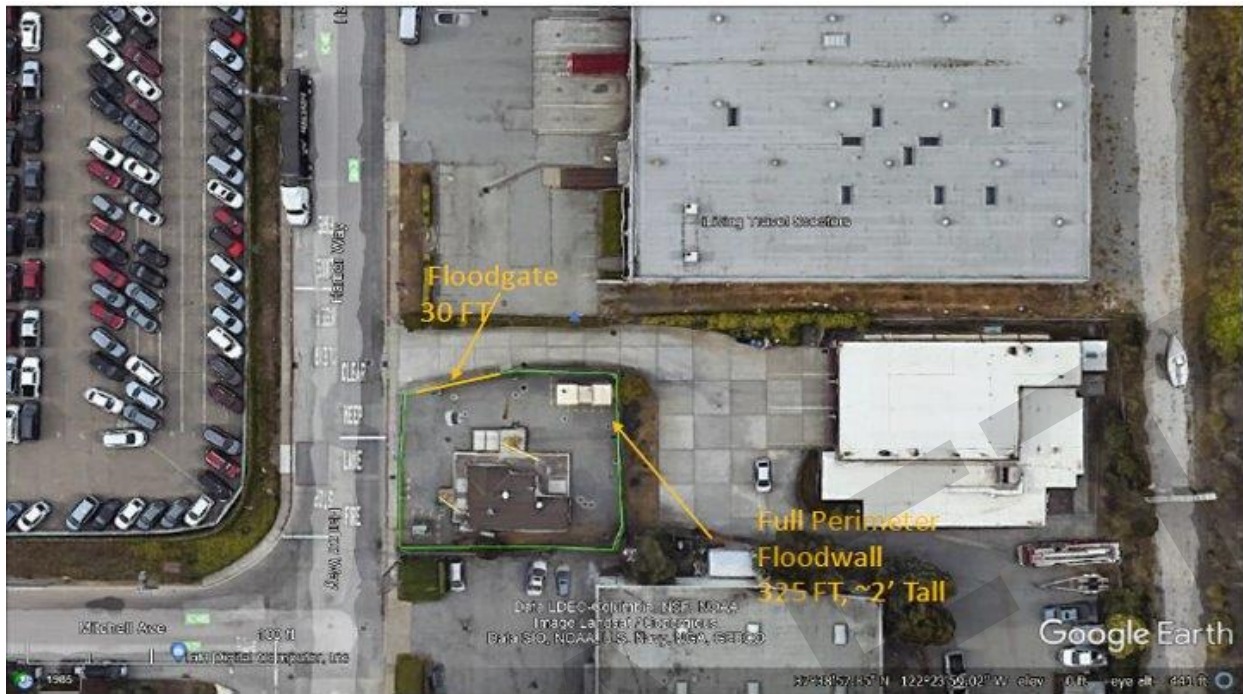
An Inverted T-shape floodwall/retaining wall is considered at the perimeter of Pump station no. 4 as shown in Figure 13. The dimensions of the shallow foundation for the wall are included in Appendix A. The height of the wall should be at least 2 feet above the ground to prevent any overtopping expected during the medium scenario of SLR; however, the height of the wall can be extended to 4 feet to prevent the overtopping due to the most severe high-water events (500-year, High SLR scenario) or a 50-year flood event as shown in Figure 14.

Figure 13-Pump Station No.4 with Proposed Floodwall/Retaining wall

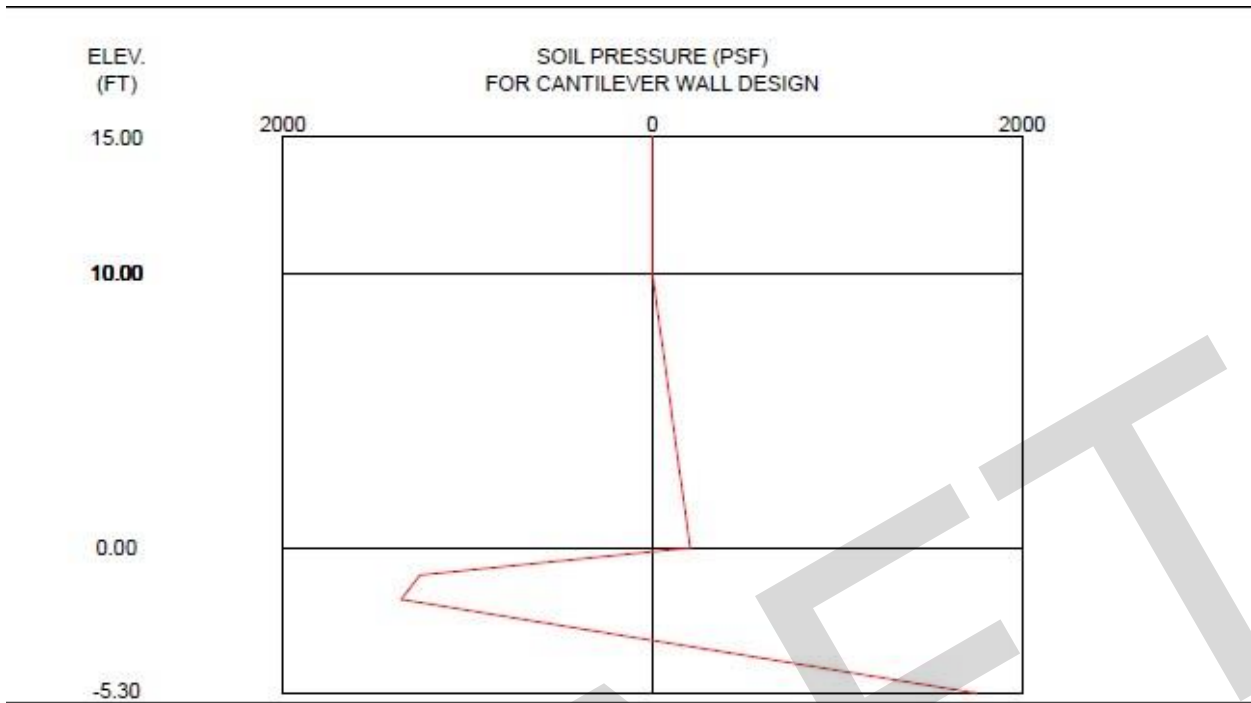
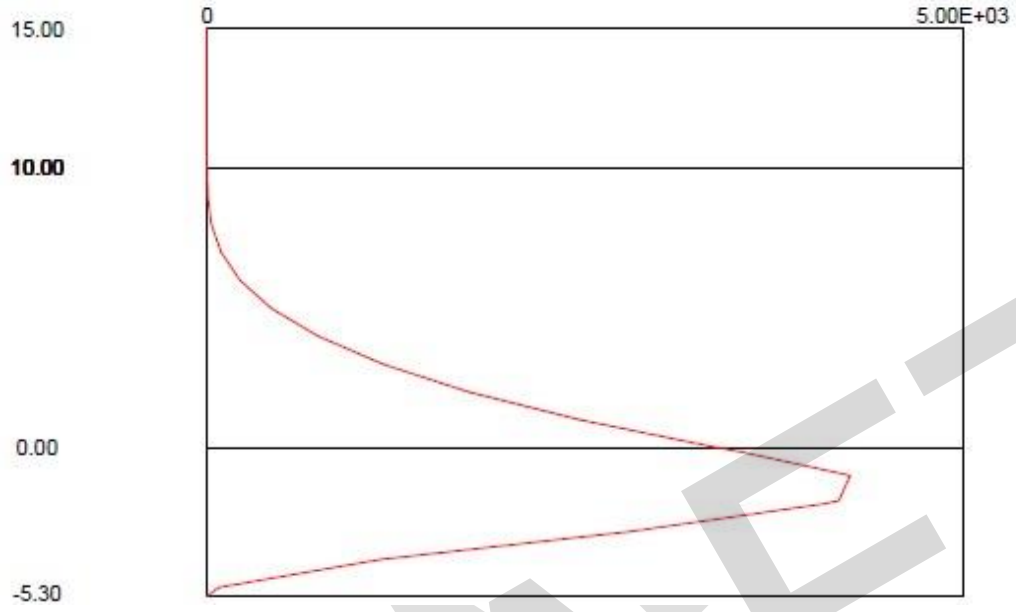
BENDING MOMENT (LB-FT)
FOR CANTILEVER WALL DESIGN

CWALSHT computations for I-floodwall

CWALSHT was used to compute the depth of embedment, bending moment, and scaled deflection of I-wall sheet pile. I-Wall stability was analyzed for potential failure modes in accordance with Engineering and Design of I-Walls (EC 1110-2-6066).
