**US Army Corps
of Engineers®**

Appendix I

Geotechnical Engineering

Continuing Authorities Program (CAP), Section 103

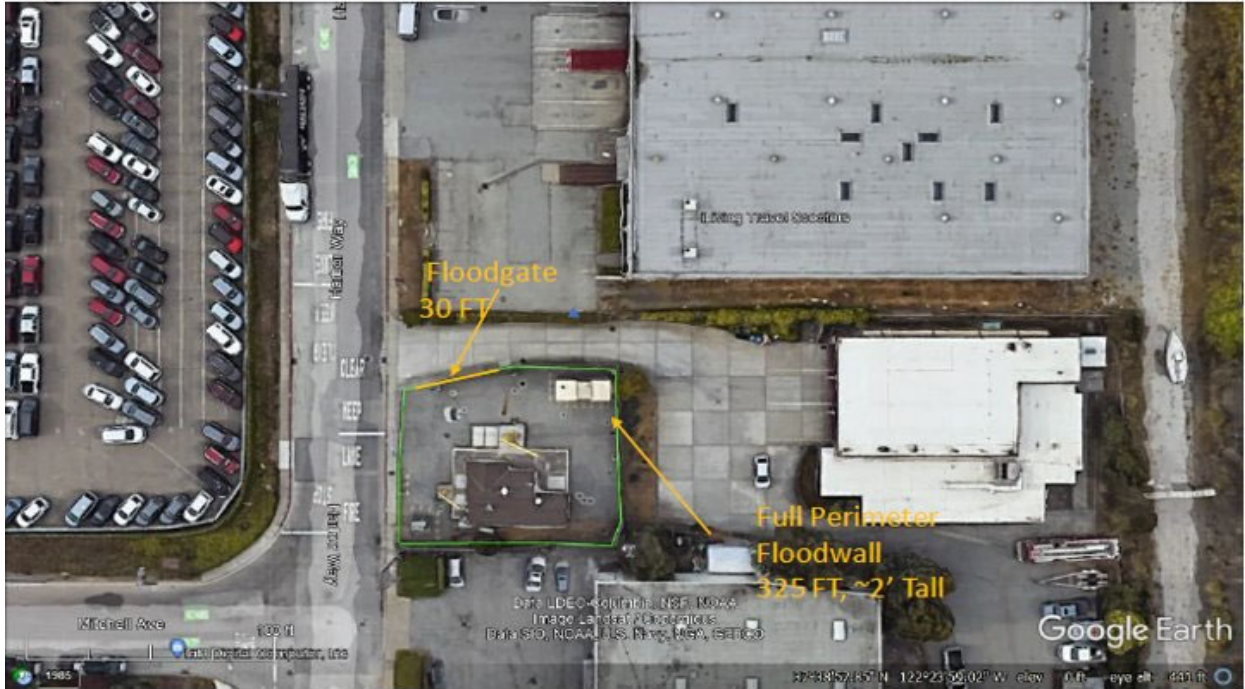
Figure 13-Pump Station No.4 with Proposed Floodwall/Retaining wall

An Inverted T-shape floodwall/retaining wall could be considered at the perimeter of Pump Station no. 4 as shown in Figure 13. The dimensions of the shallow foundation for the wall are included in Appendix A. The height of the wall should be at least 2 feet above the ground to prevent any overtopping expected during the medium scenario of SLR; however, the height of the wall can be extended to 4 feet to prevent the overtopping due to the most severe high-water events (500-year) or a 50-year flood event with intermediate sea level rise as shown in Figure 14.
