PROJECT	COYOTE VALLEY STREAM RESTORATION	BY	BD	FIGURE	FIGURE 2
CLIENT	COYOTE VALLEY BAND OF POMO INDIANS	DATE	10/11/2016	JOB NO.	7753.05
LOCATION	7751 N STATE ST, REDWOOD VALLEY, CA	CHECK	JER	SCALE	SHOWN
	RIVER BANK REPAIR PLAN

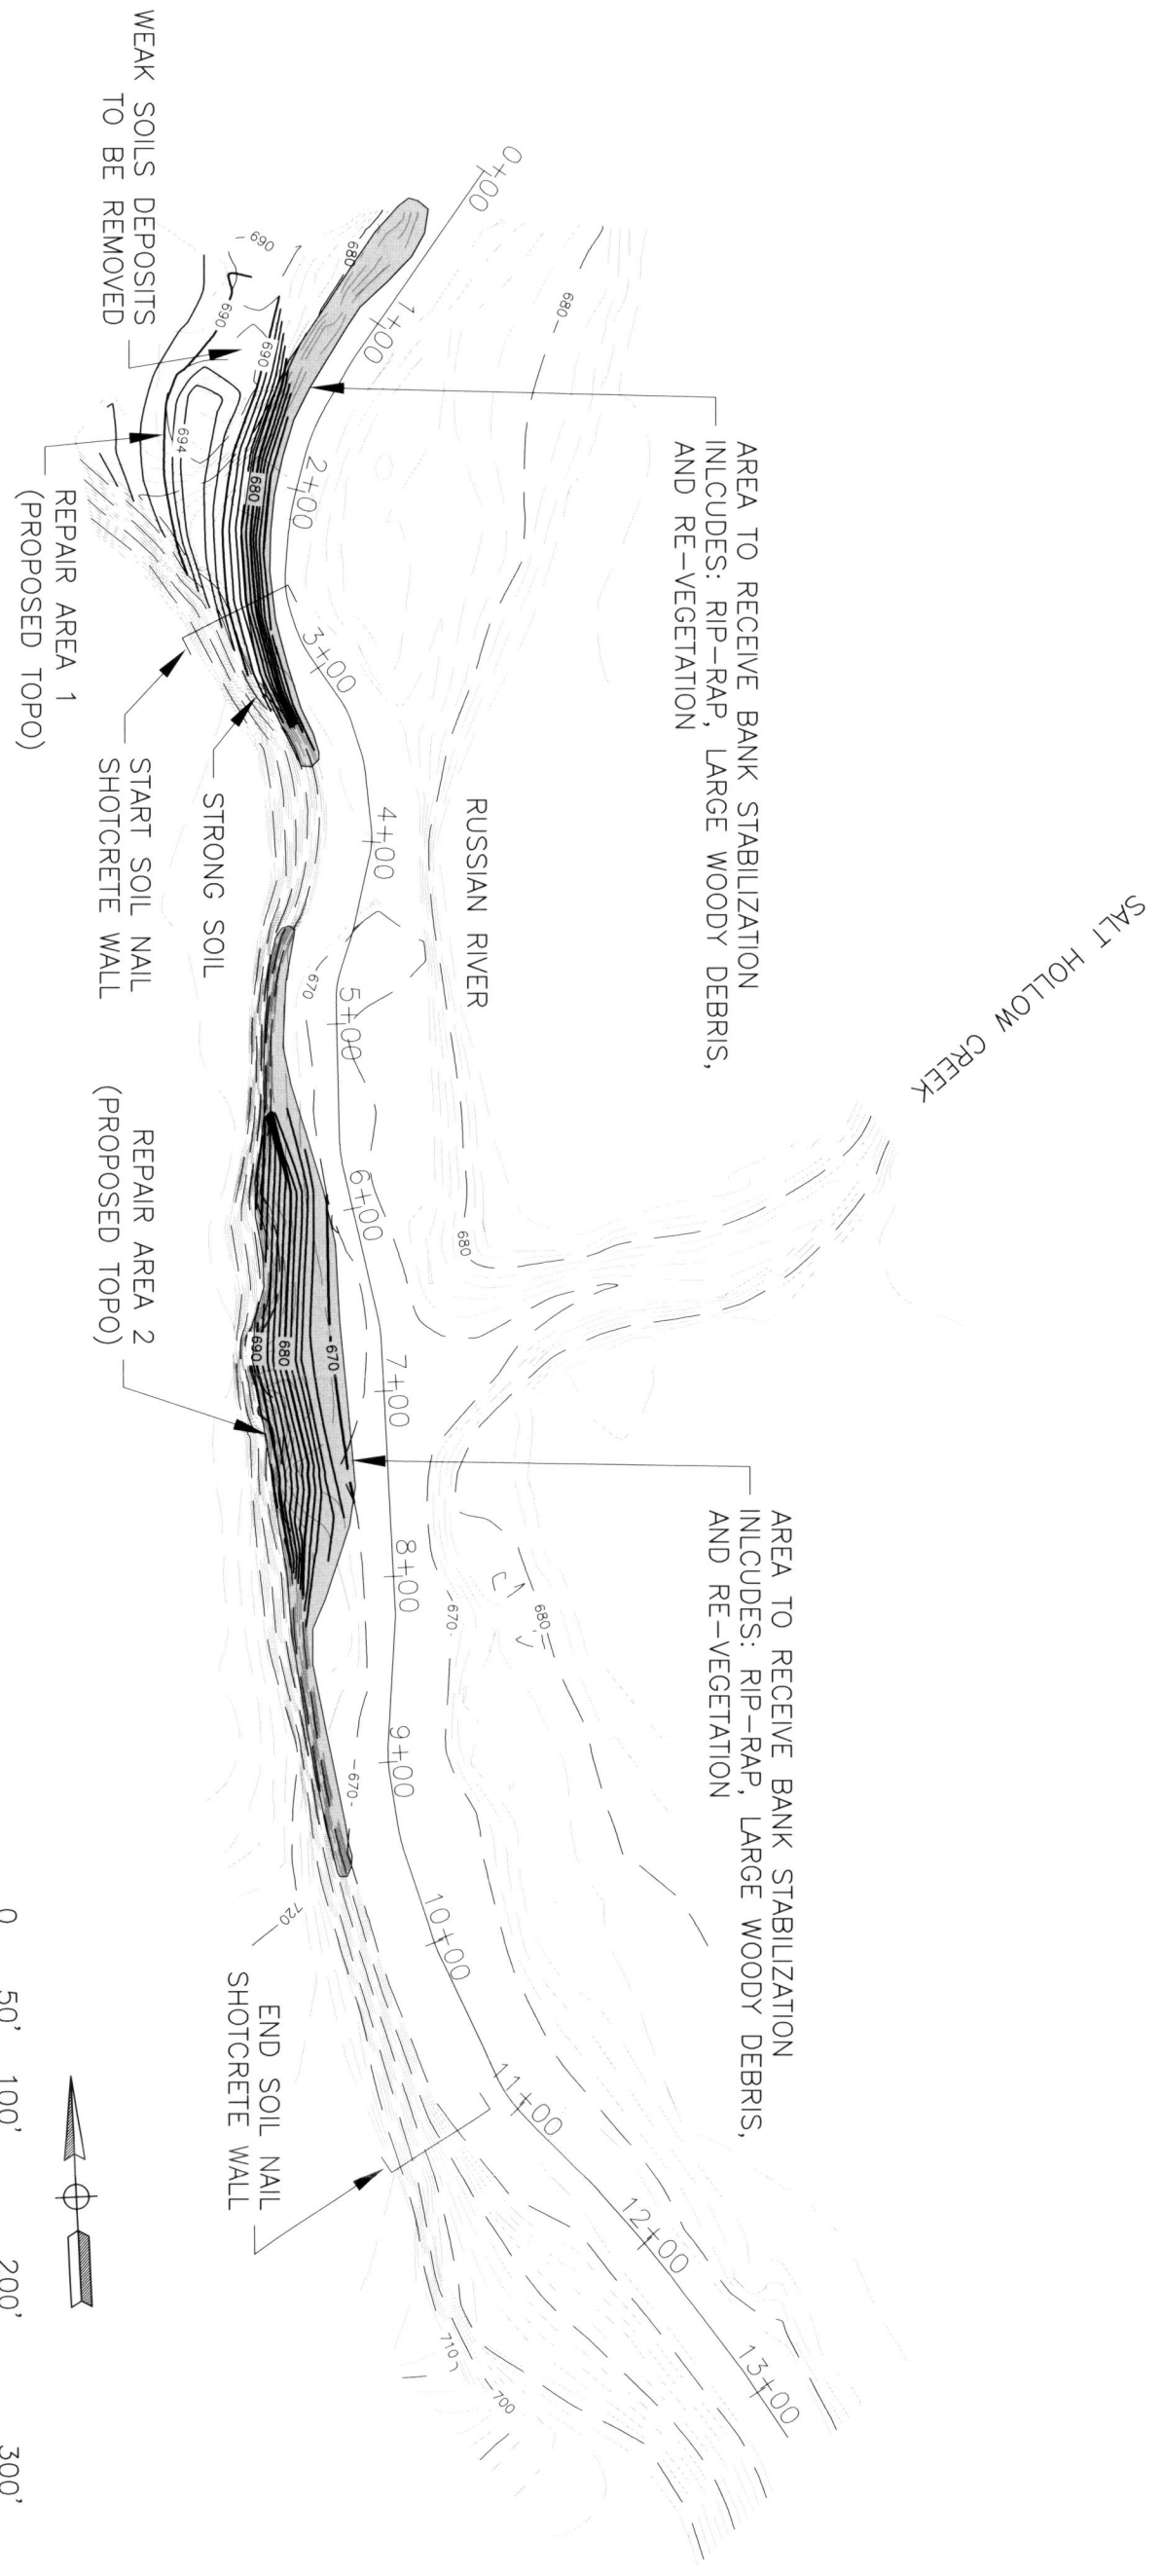
SITE PLAN
SCALE: 1"=100'

AREA TO RECEIVE BANK STABILIZATION
 INCLUDES: RIP-RAP, LARGE WOODY DEBRIS,
 AND RE-VEGETATION

- NOTES:
 ADDITIONAL STABILIZATION MEASURES INCLUDE BUT MAY NOT BE LIMITED TO:
1. KEYWAY 850 FEET LONG TO BE CONSTRUCTED AT BOTTOM OF RIVER BANK
 2. SOIL NAIL SHOTCRETE WALL APPROXIMATELY 850 FEET LONG AND EXTENDING 20 FEET ABOVE BOTTOM OF RIVER BANK
 3. HYDROSEED UPPER 35 FEET OF RIVER BANK
 4. TERRACE RE-PLANTING
 5. REDIRECT RUNOFF FROM ADJACENT ROADWAY AND HOMES
