Figure 8-7: Recommended sites for phased native eelgrass restoration in San Francisco Bay.

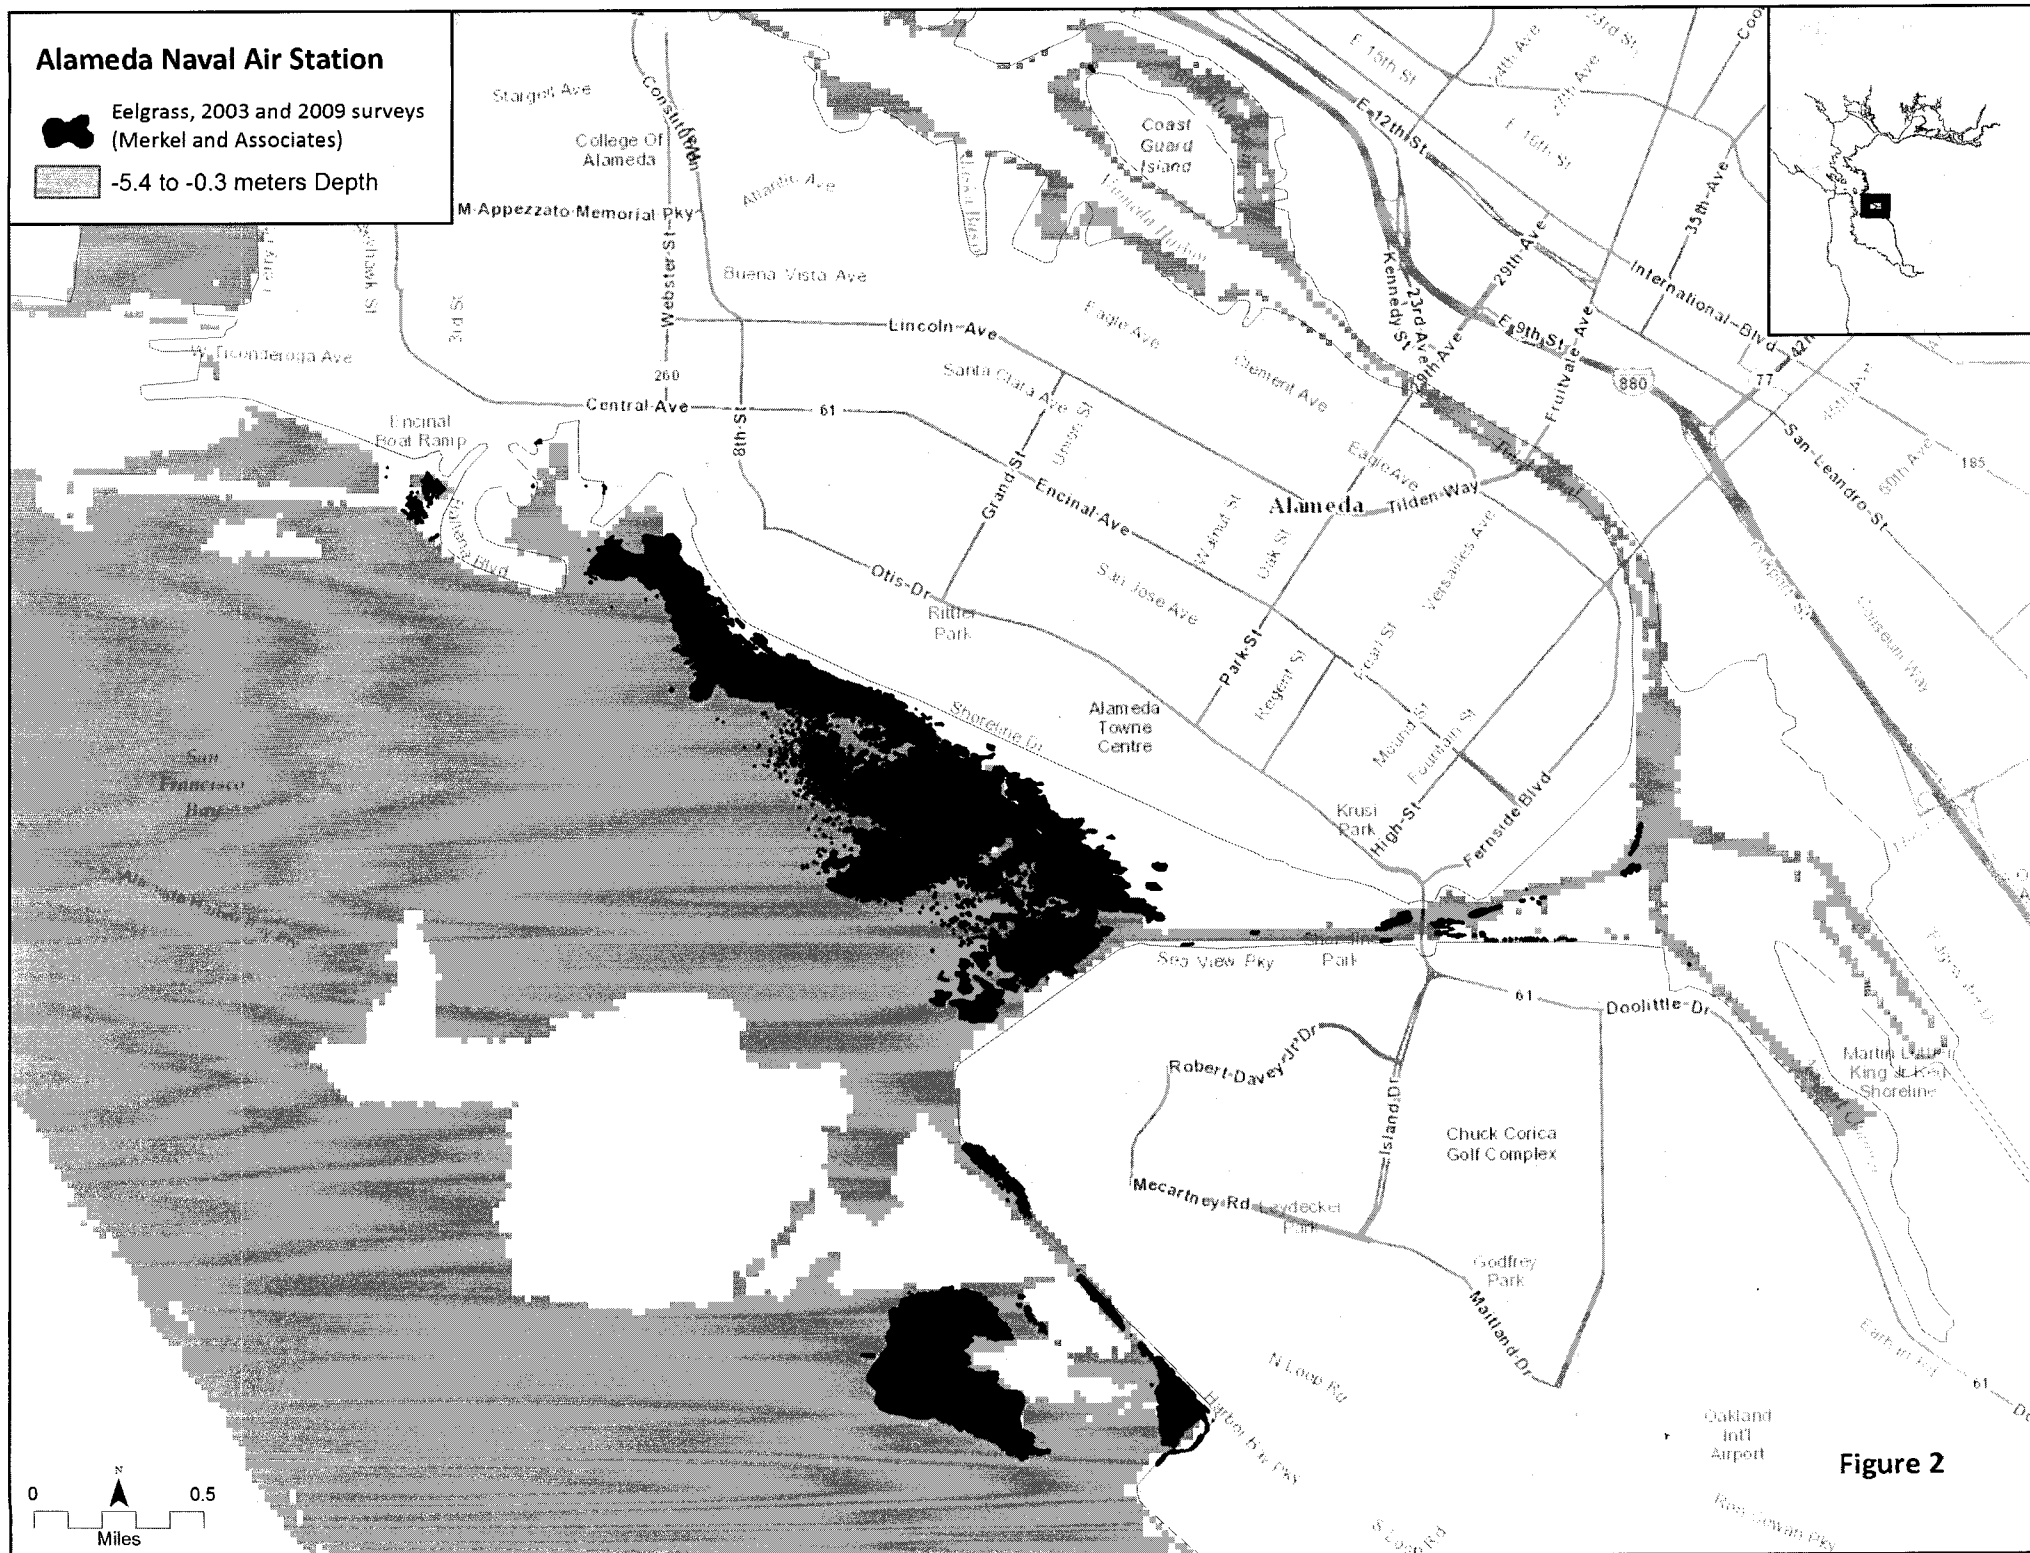
Figure 2

# Alameda Naval Air Station

Eelgrass, 2003 and 2009 surveys (Merkel and Associates)
-

-5.4 to -0.3 meters Depth

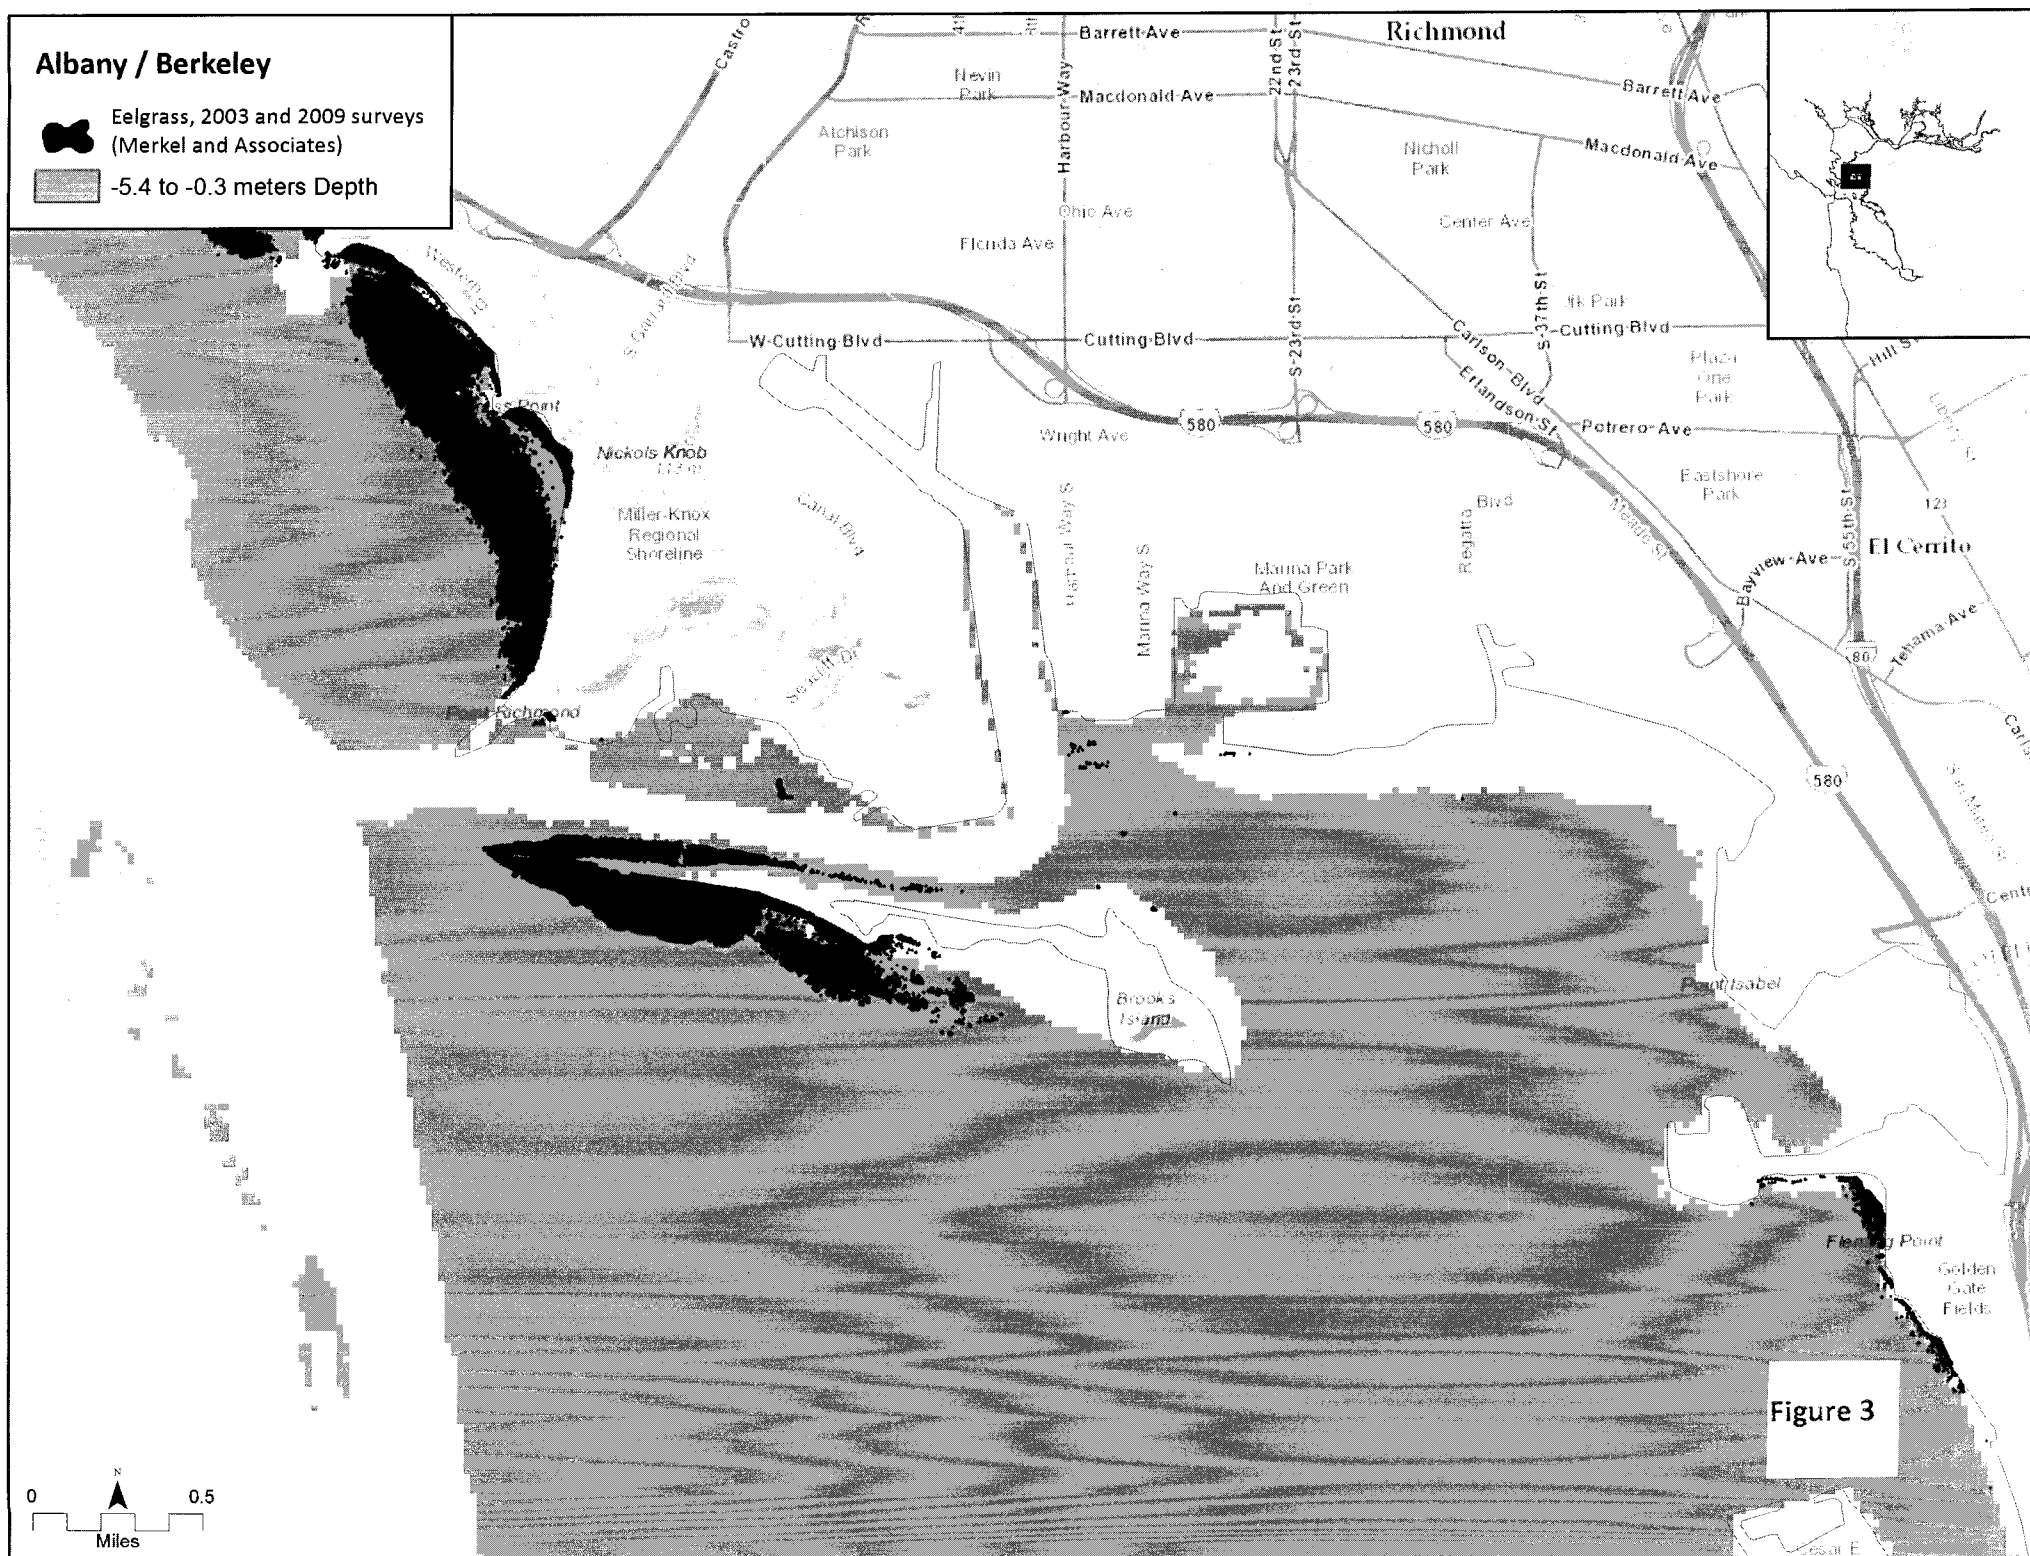
Figure 3

## Albany / Berkeley

Eelgrass, 2003 and 2009 surveys  
(Merkel and Associates)

-5.4 to -0.3 meters Depth

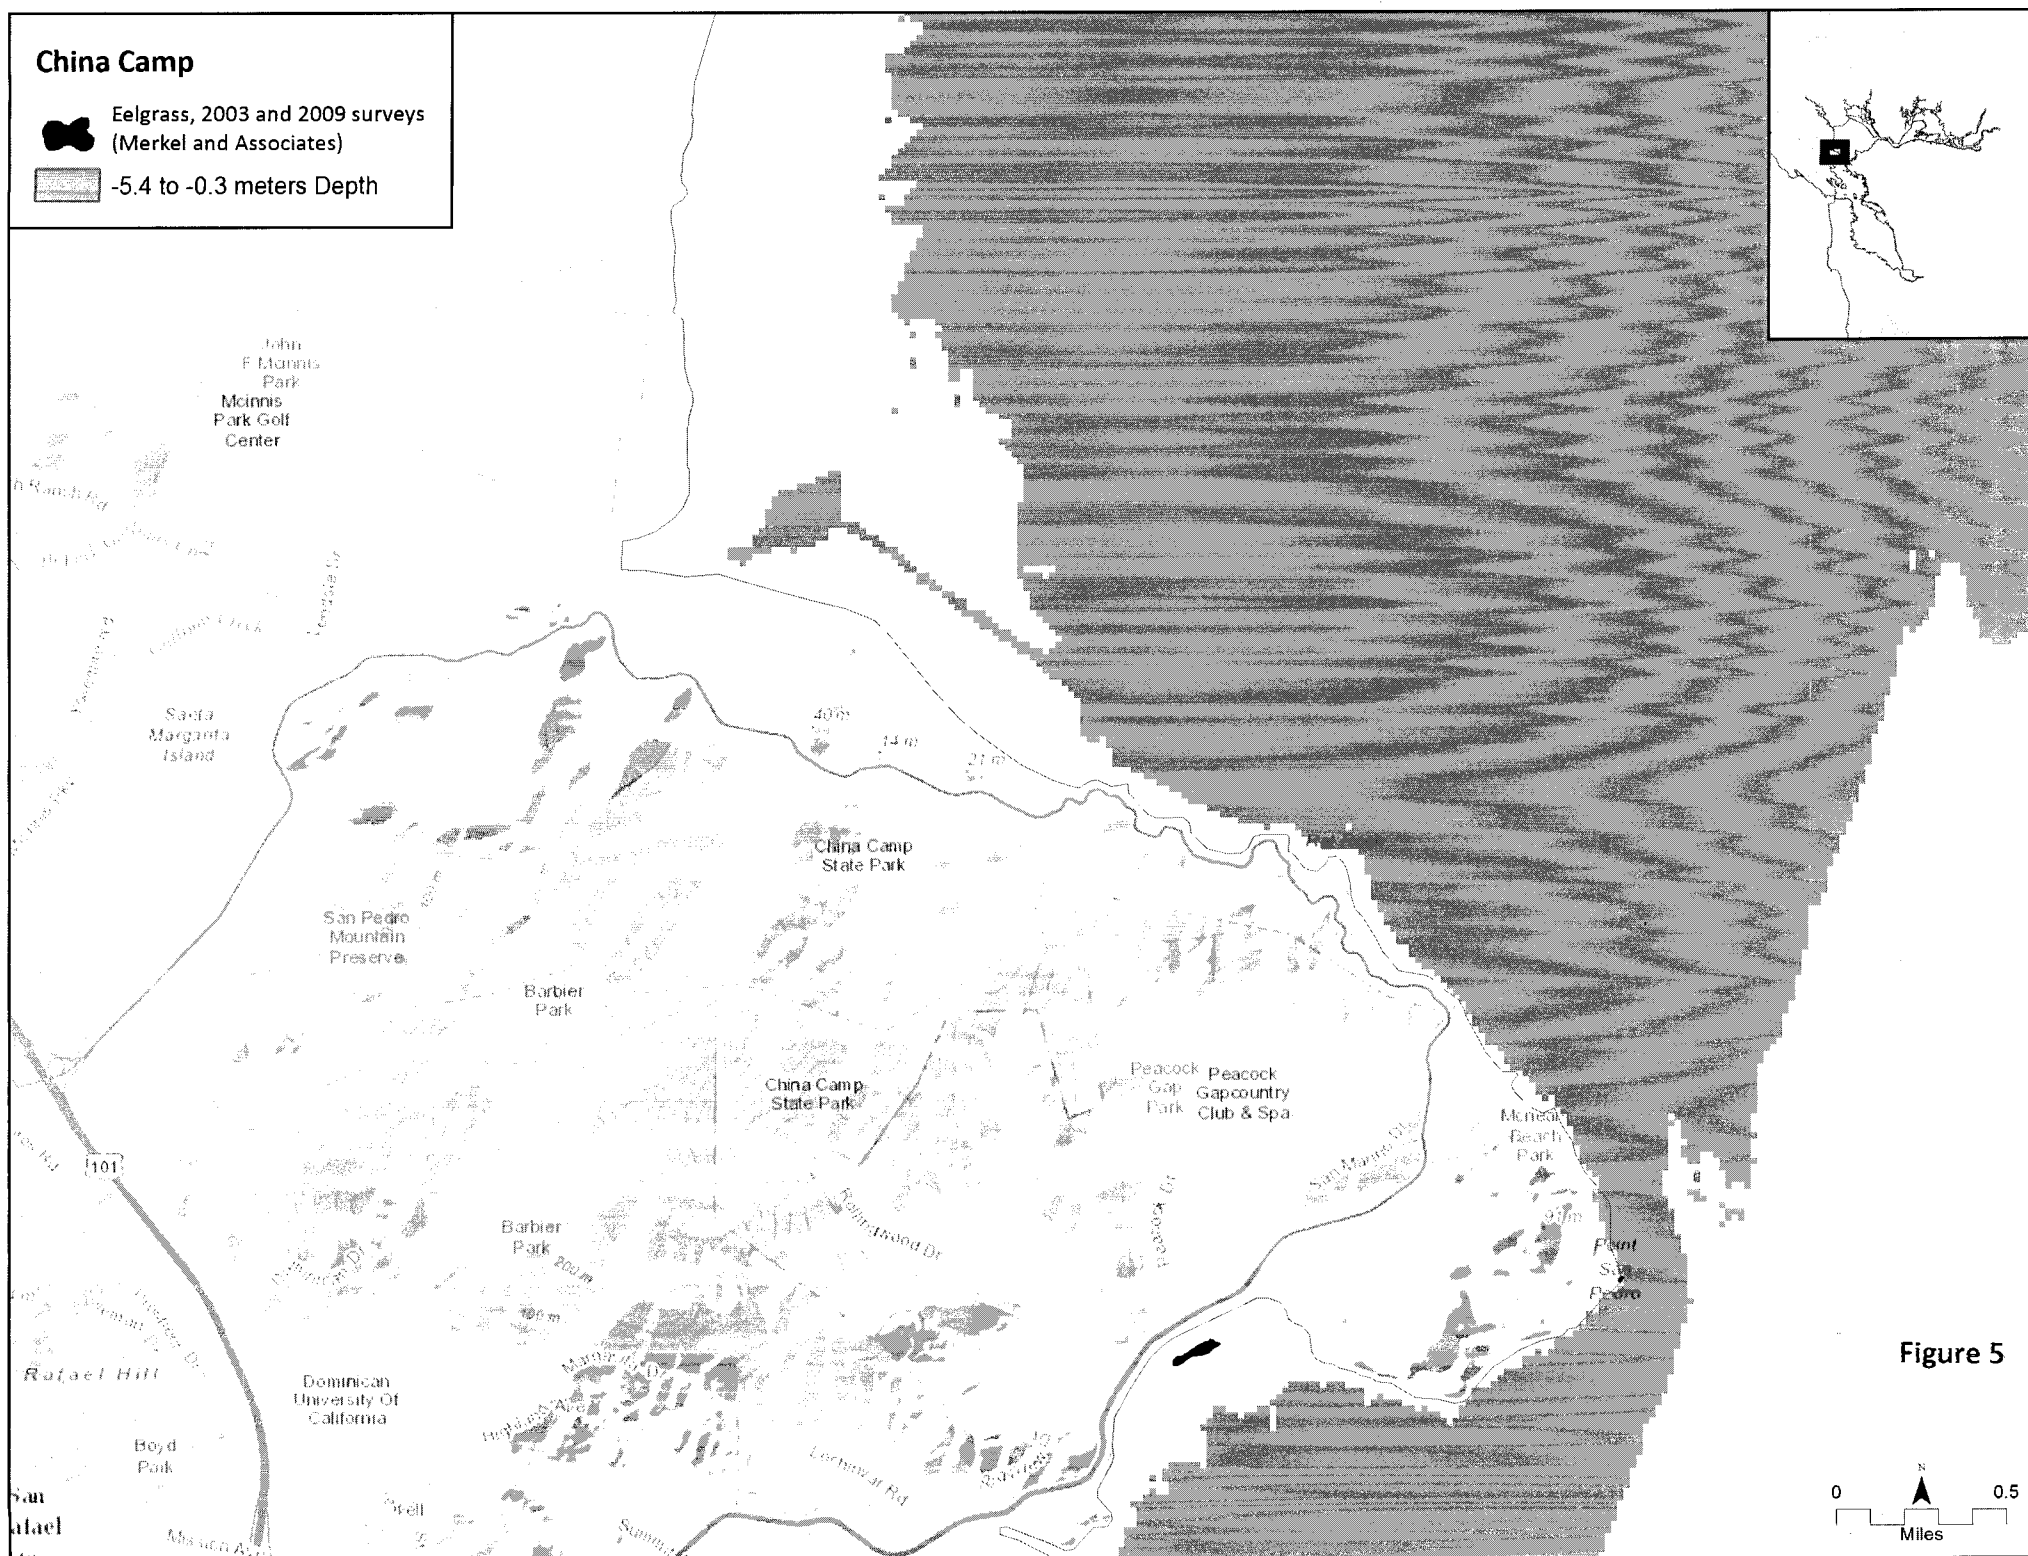
Figure 5

# China Camp

Eelgrass, 2003 and 2009 surveys (Merkel and Associates)
-

-5.4 to -0.3 meters Depth

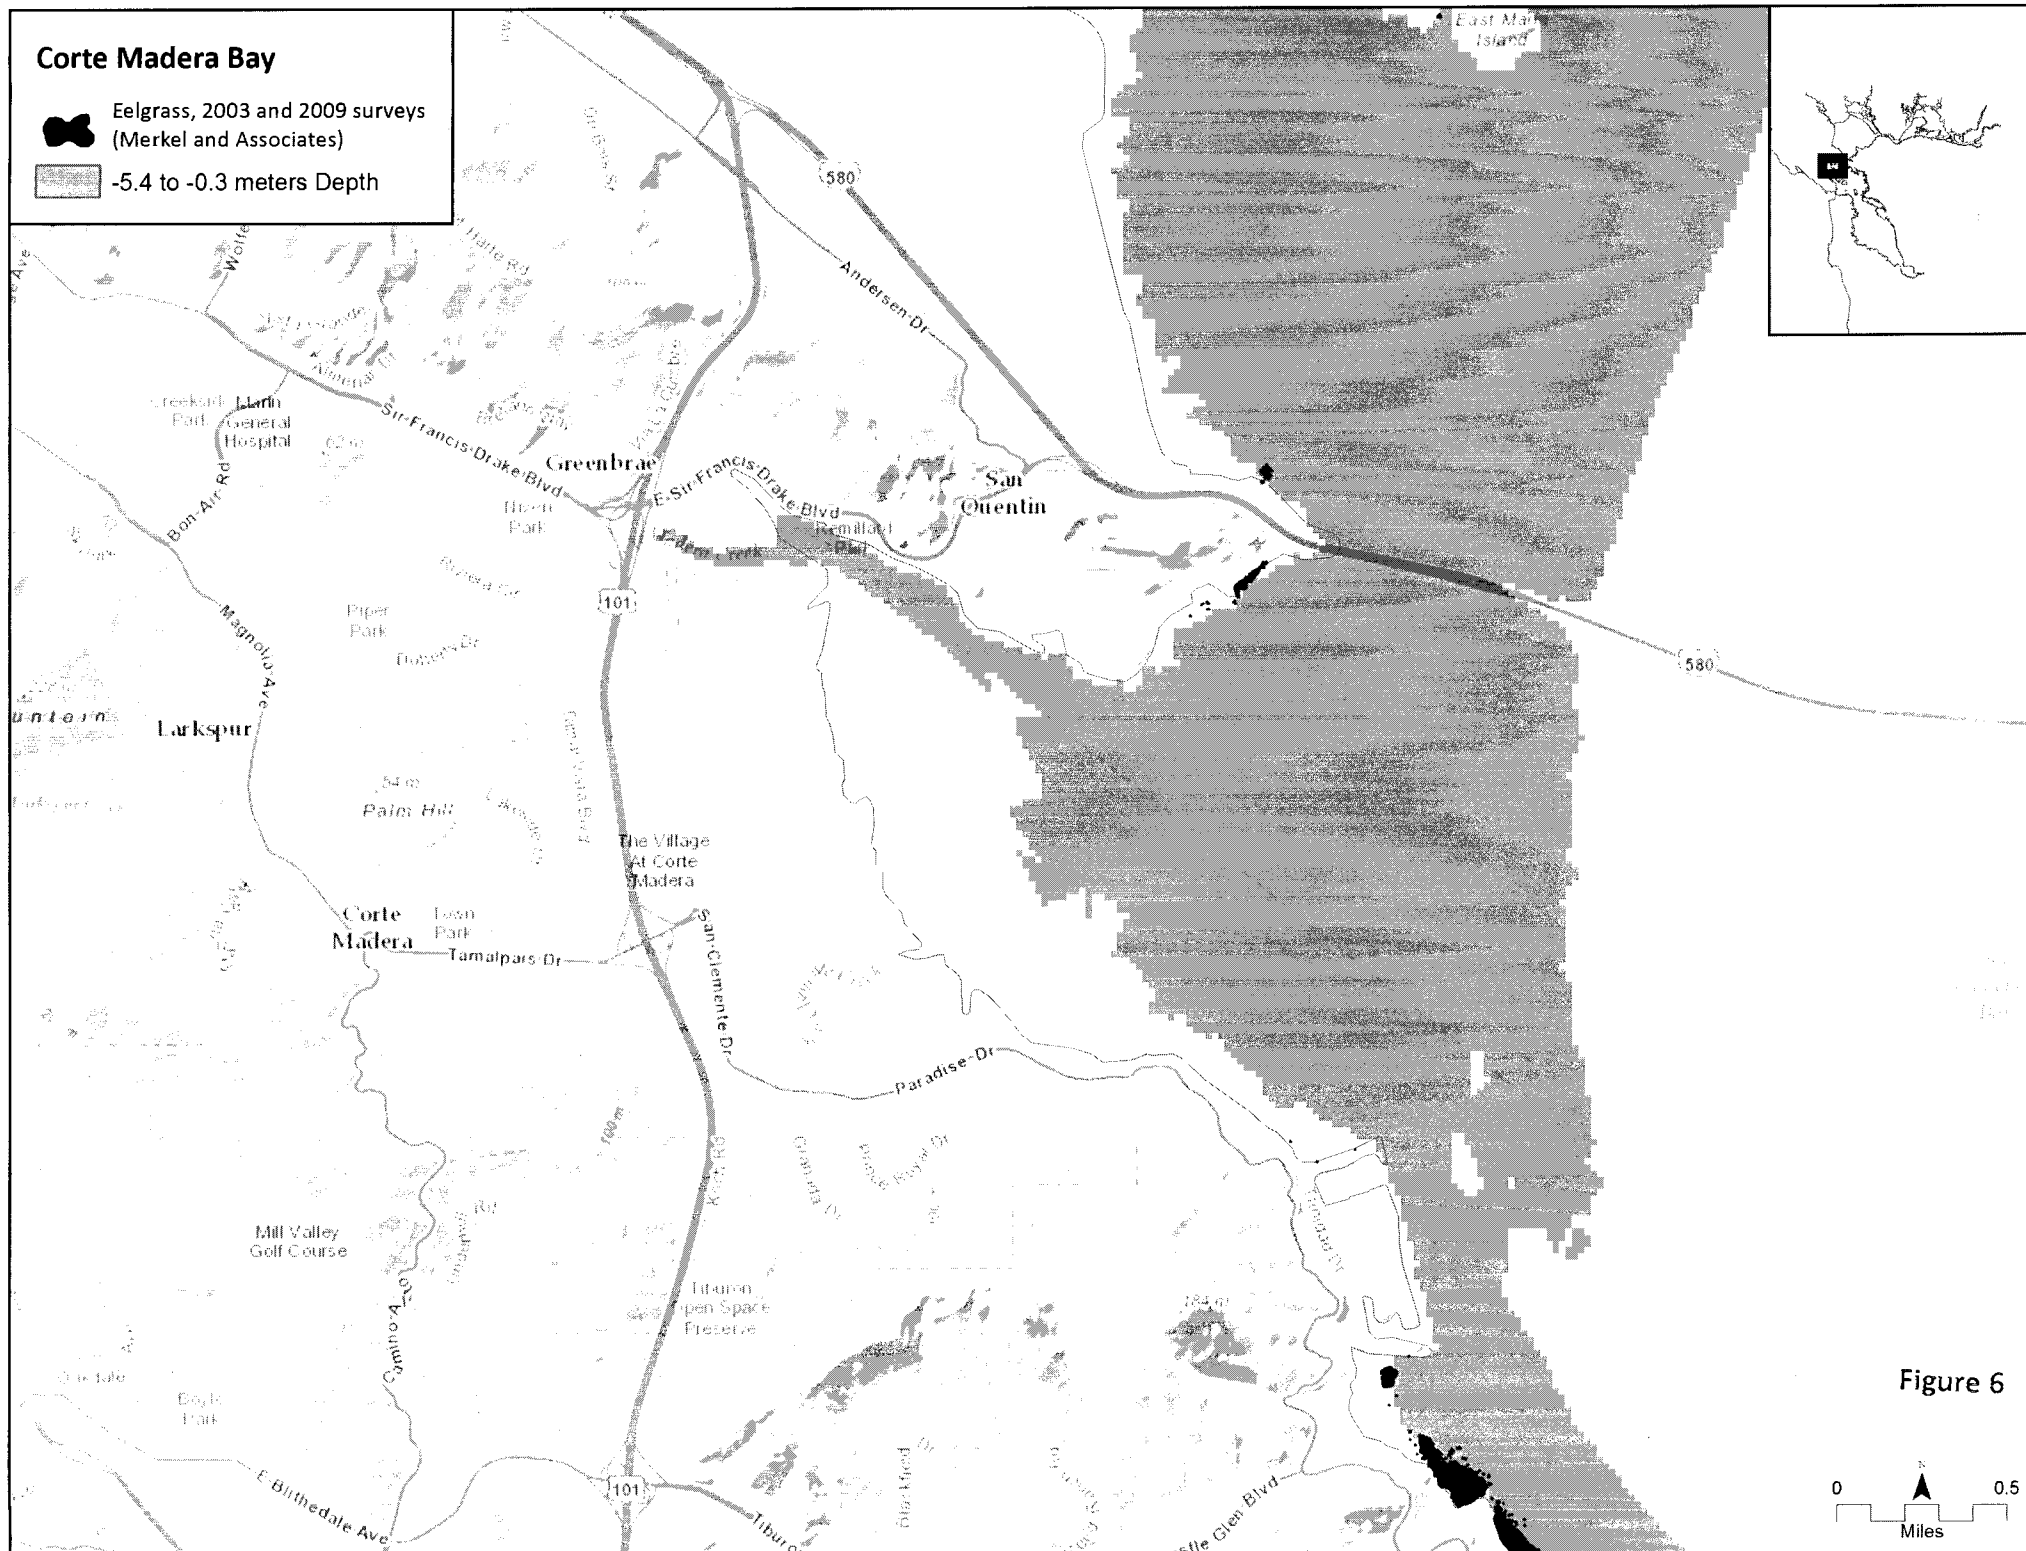
Figure 6

# Corte Madera Bay

Eelgrass, 2003 and 2009 surveys (Merkel and Associates)
-

-5.4 to -0.3 meters Depth

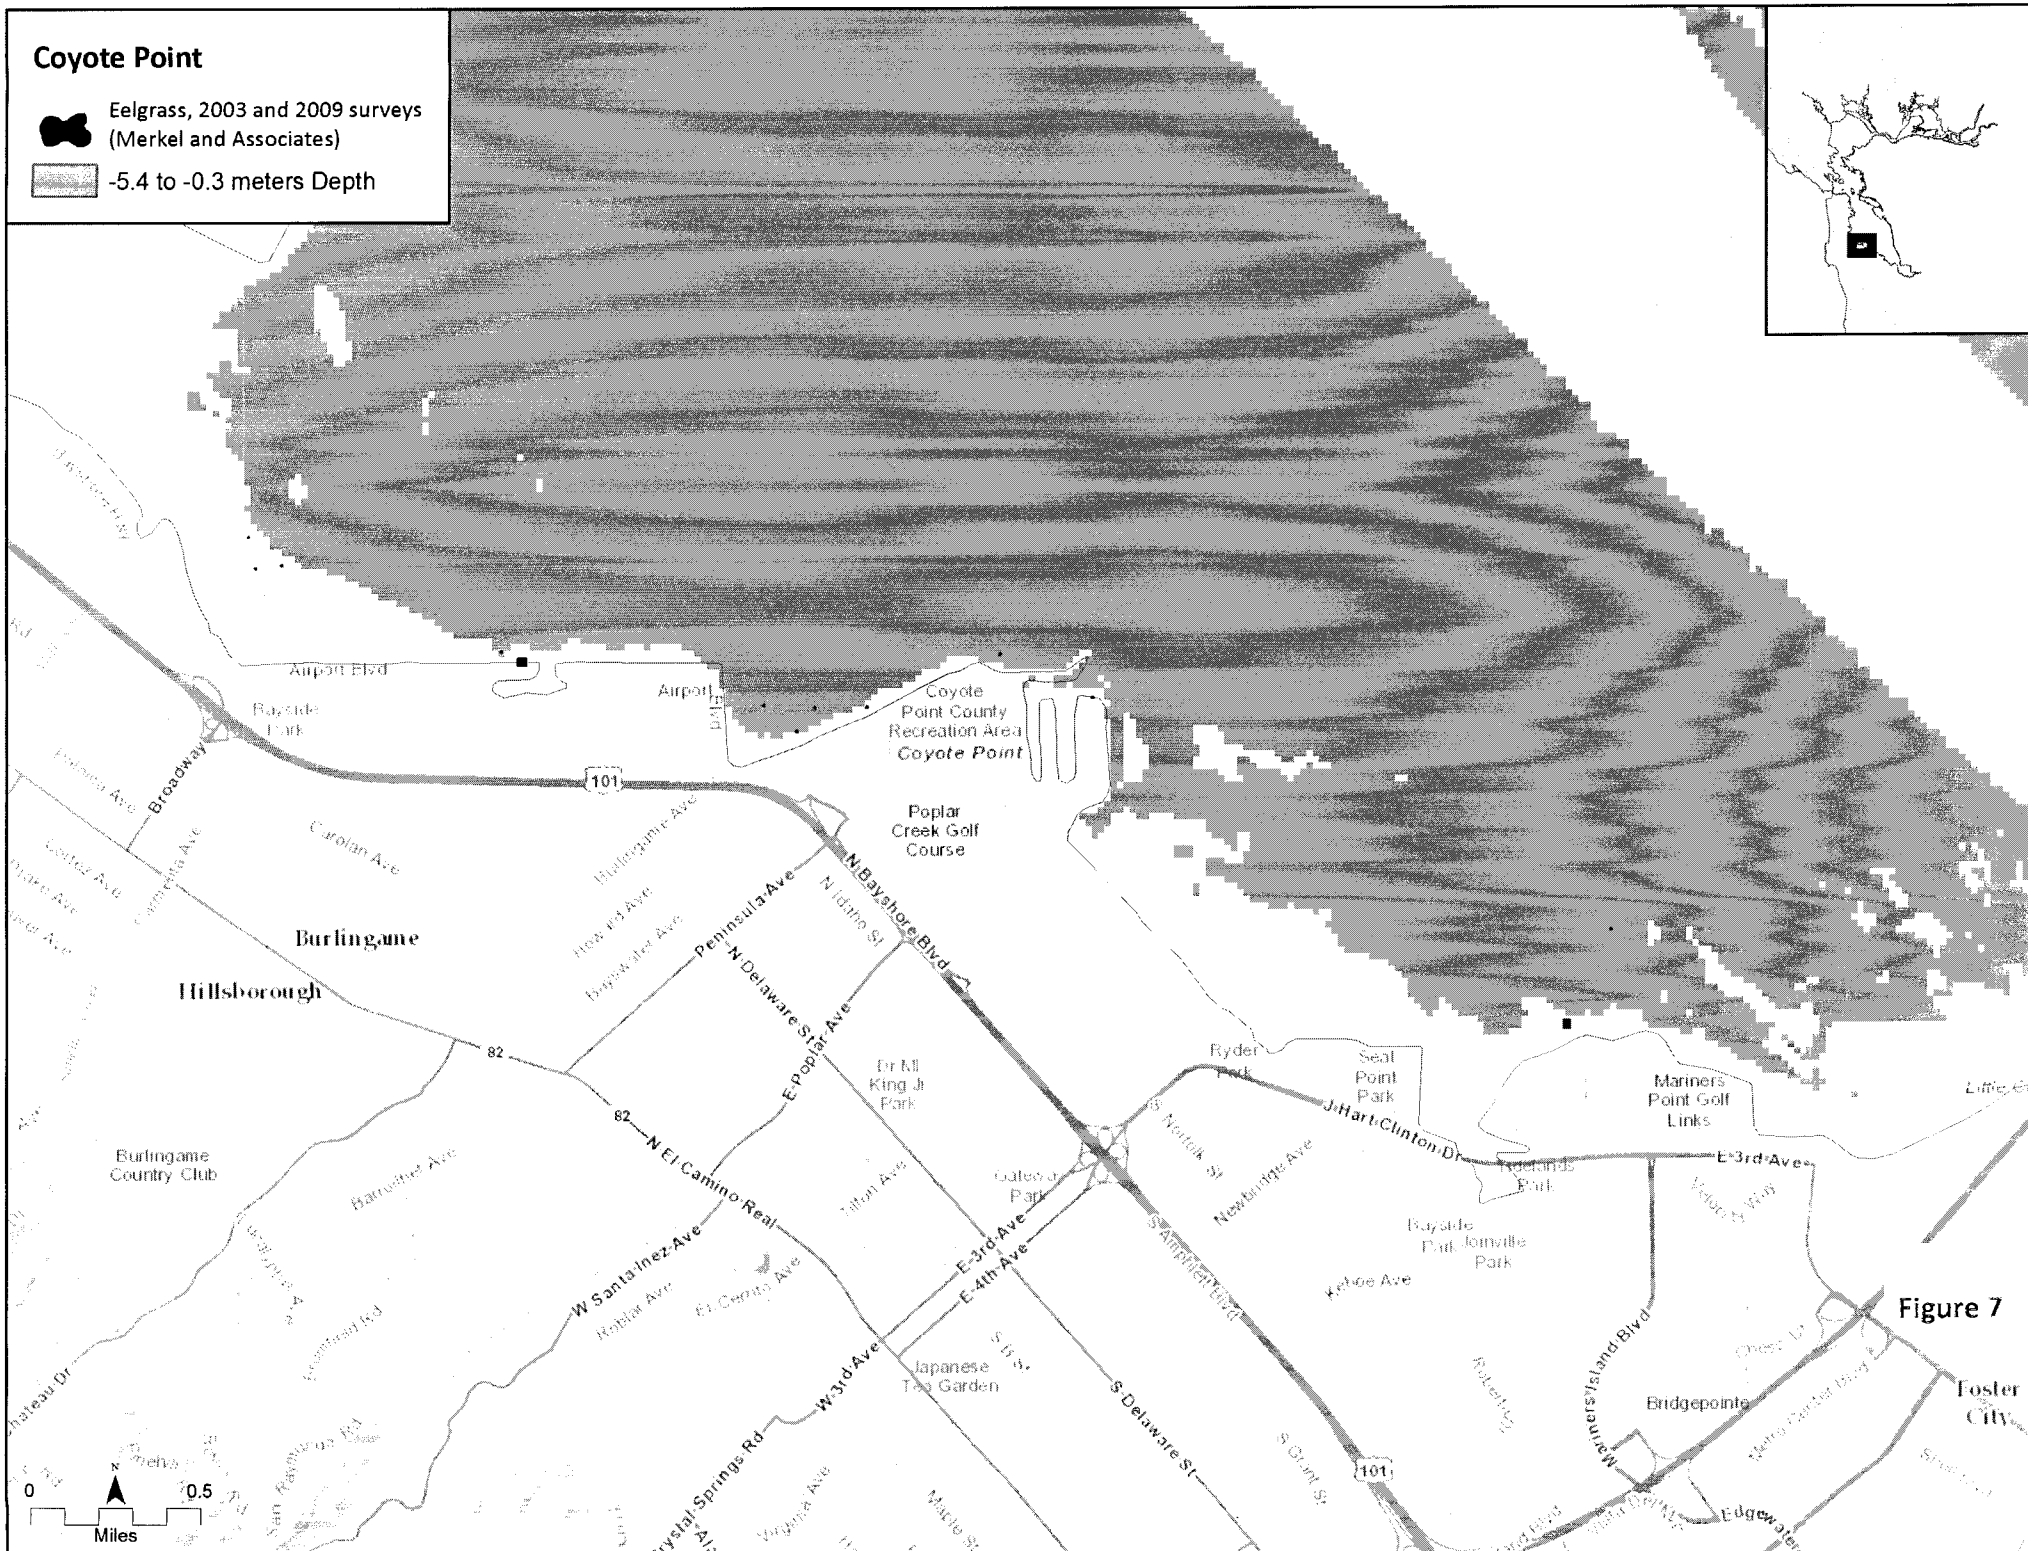
Figure 7

# Coyote Point

Eelgrass, 2003 and 2009 surveys (Merkel and Associates)
-

-5.4 to -0.3 meters Depth

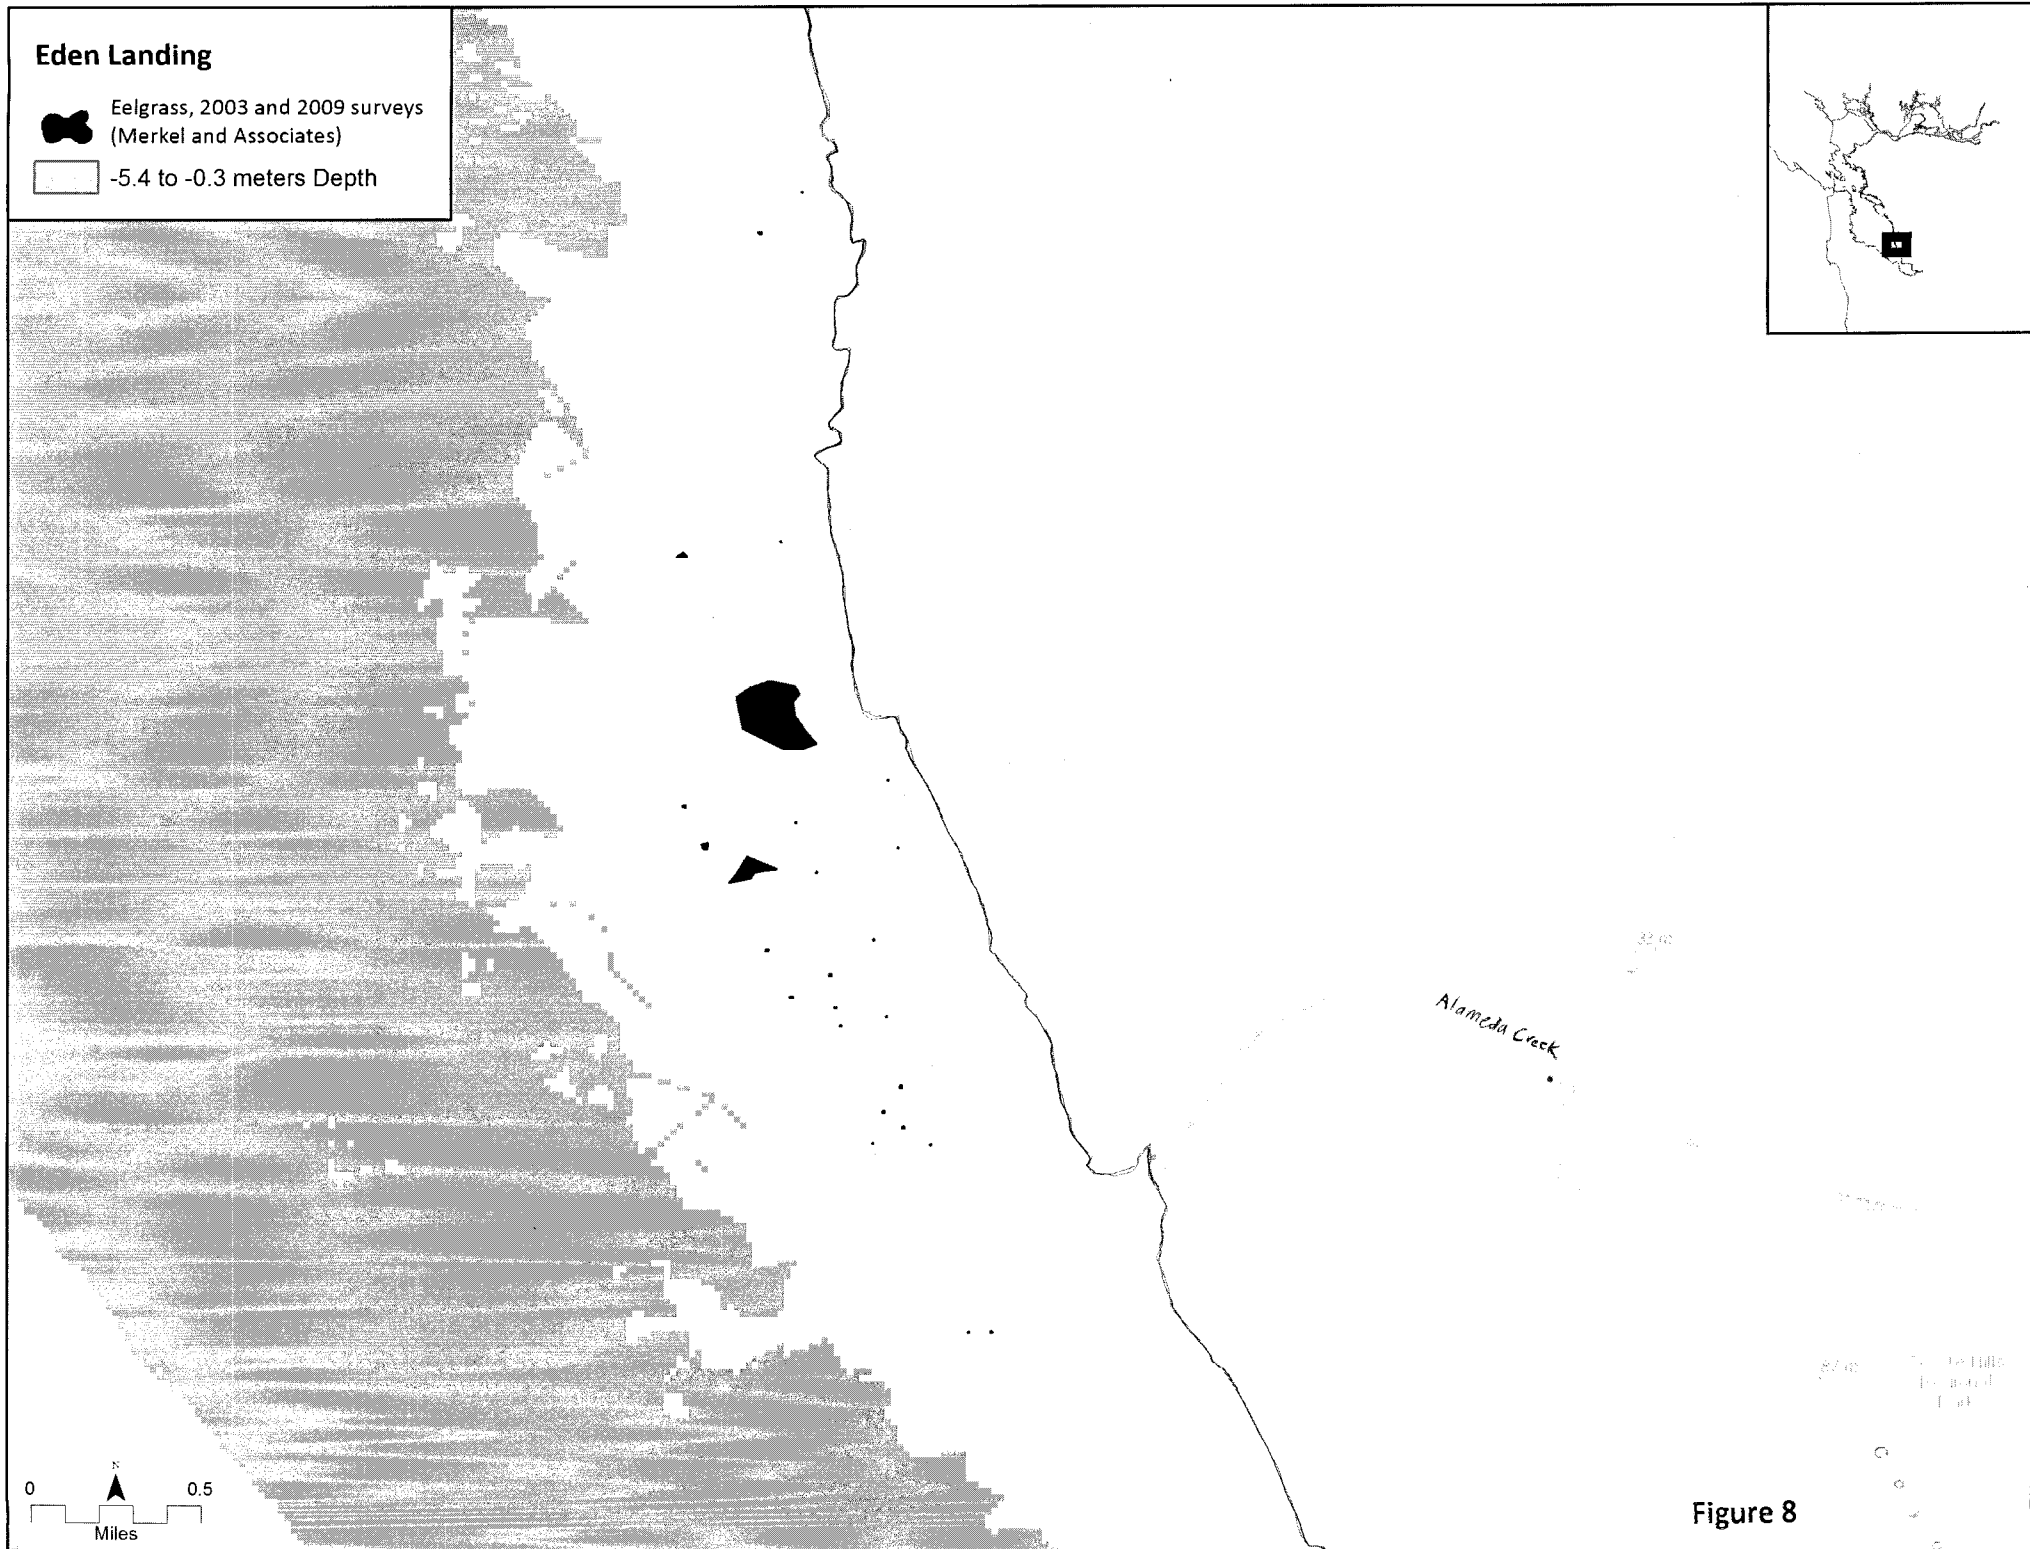
Figure 8

## Eden Landing

Eelgrass, 2003 and 2009 surveys (Merkel and Associates)
-

-5.4 to -0.3 meters Depth

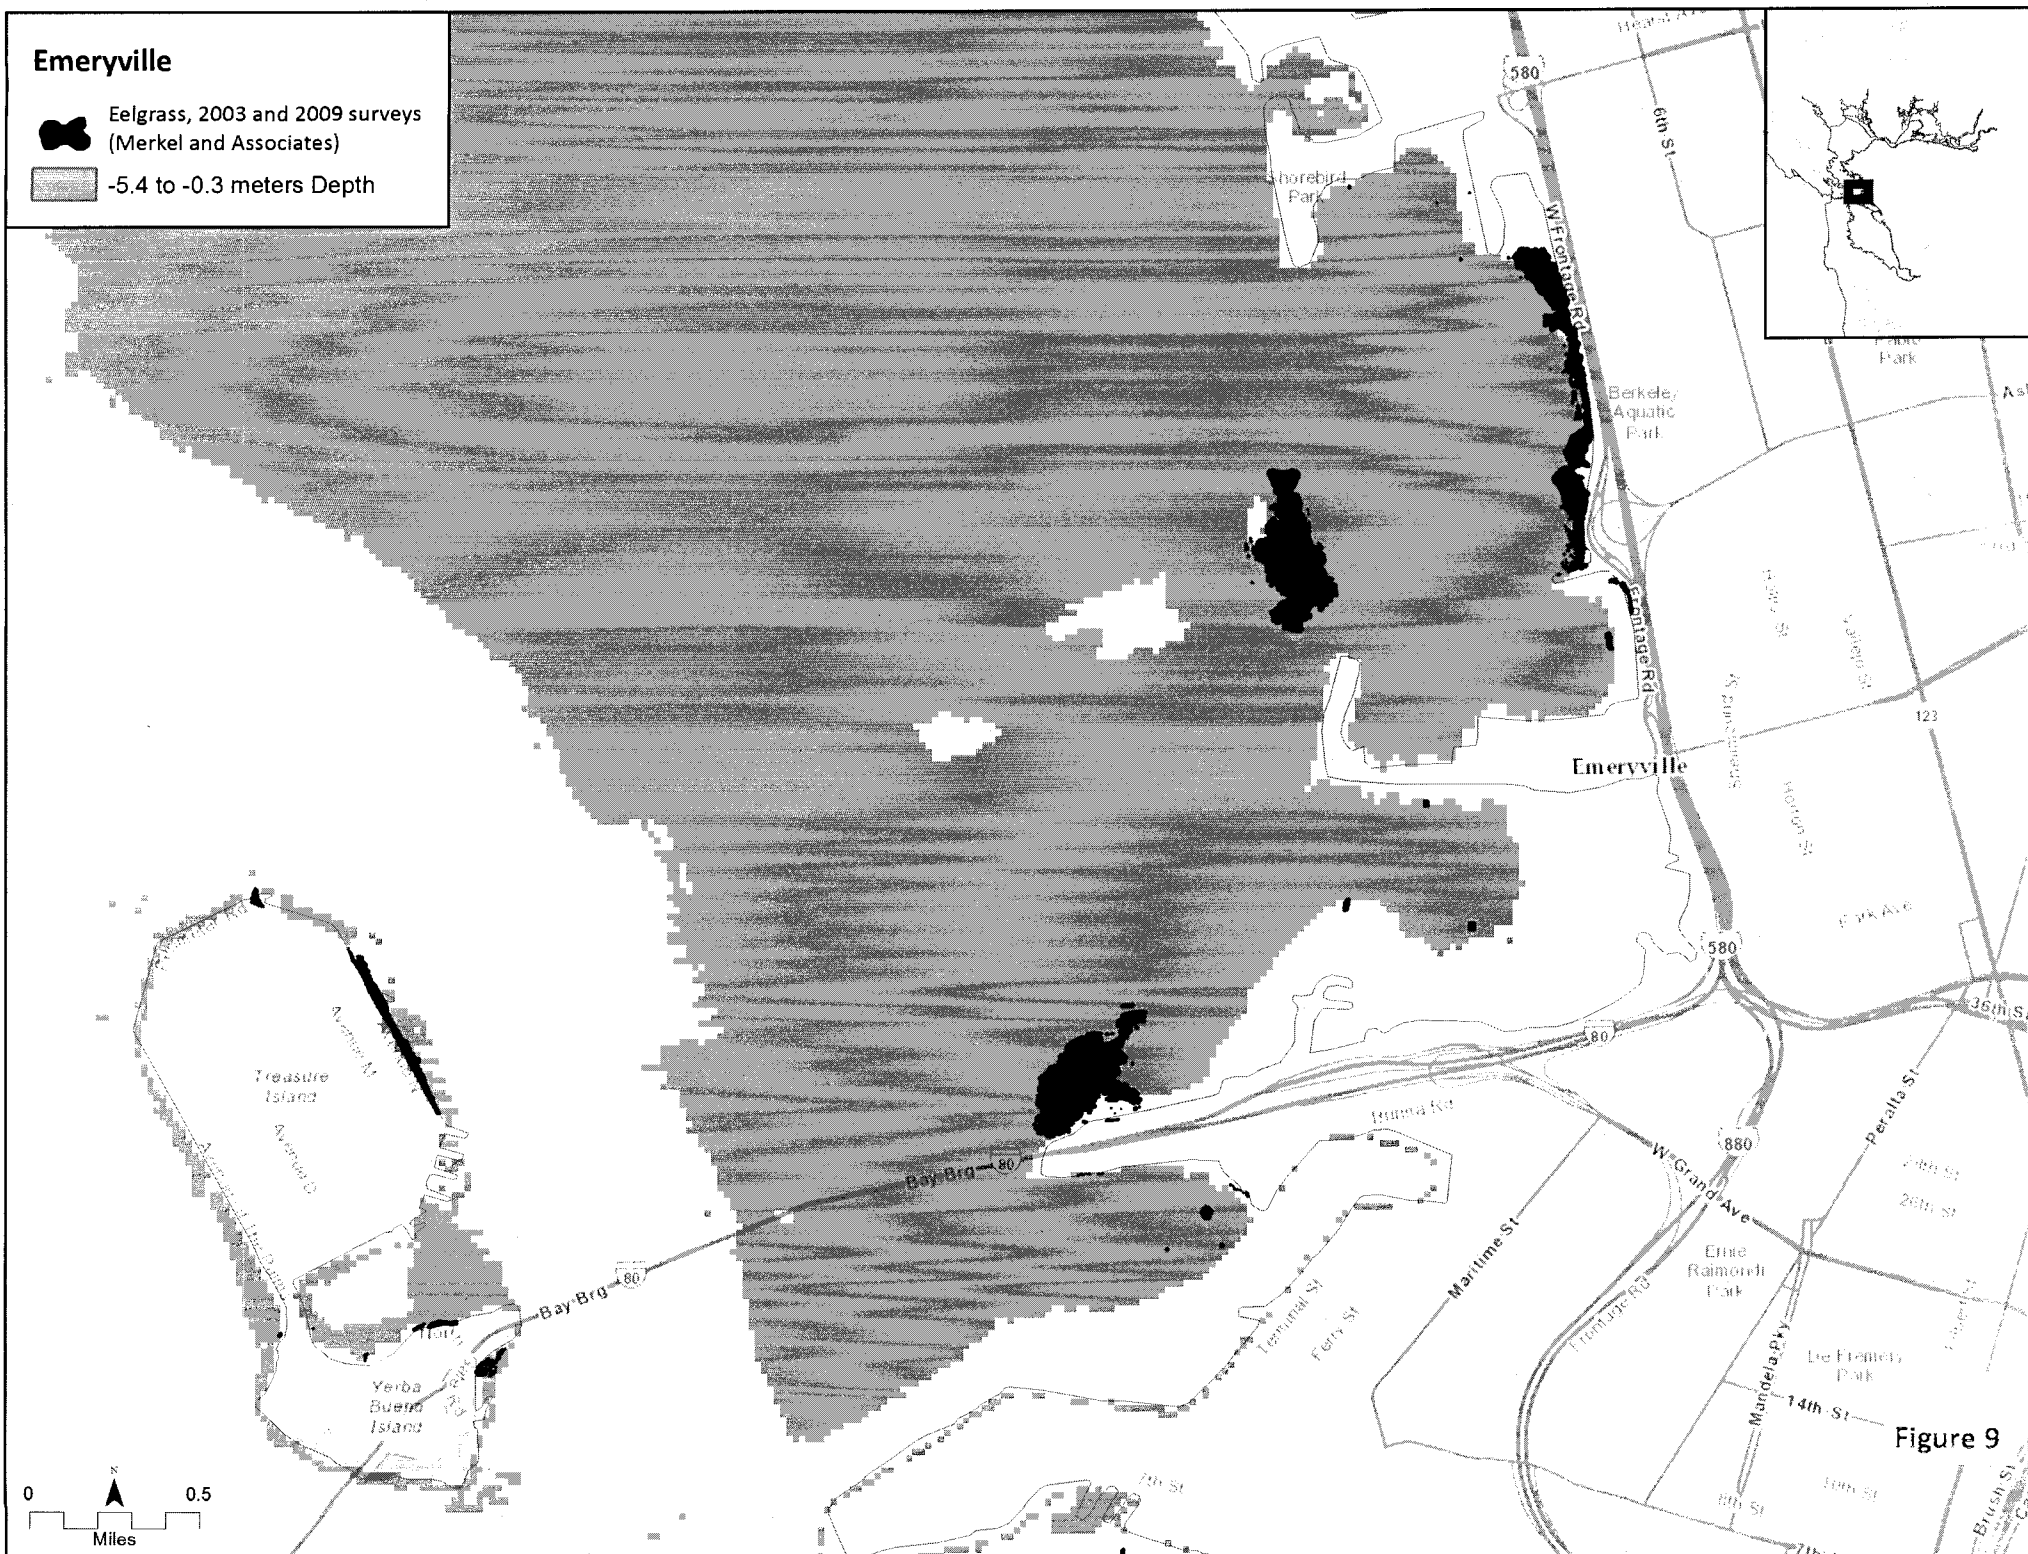
Figure 9

# Emeryville

- Elgrass, 2003 and 2009 surveys  
(Merkel and Associates)
- 5.4 to -0.3 meters Depth
