Figure 8-7: Recommended sites for phased native eelgrass restoration in San Francisco Bay.

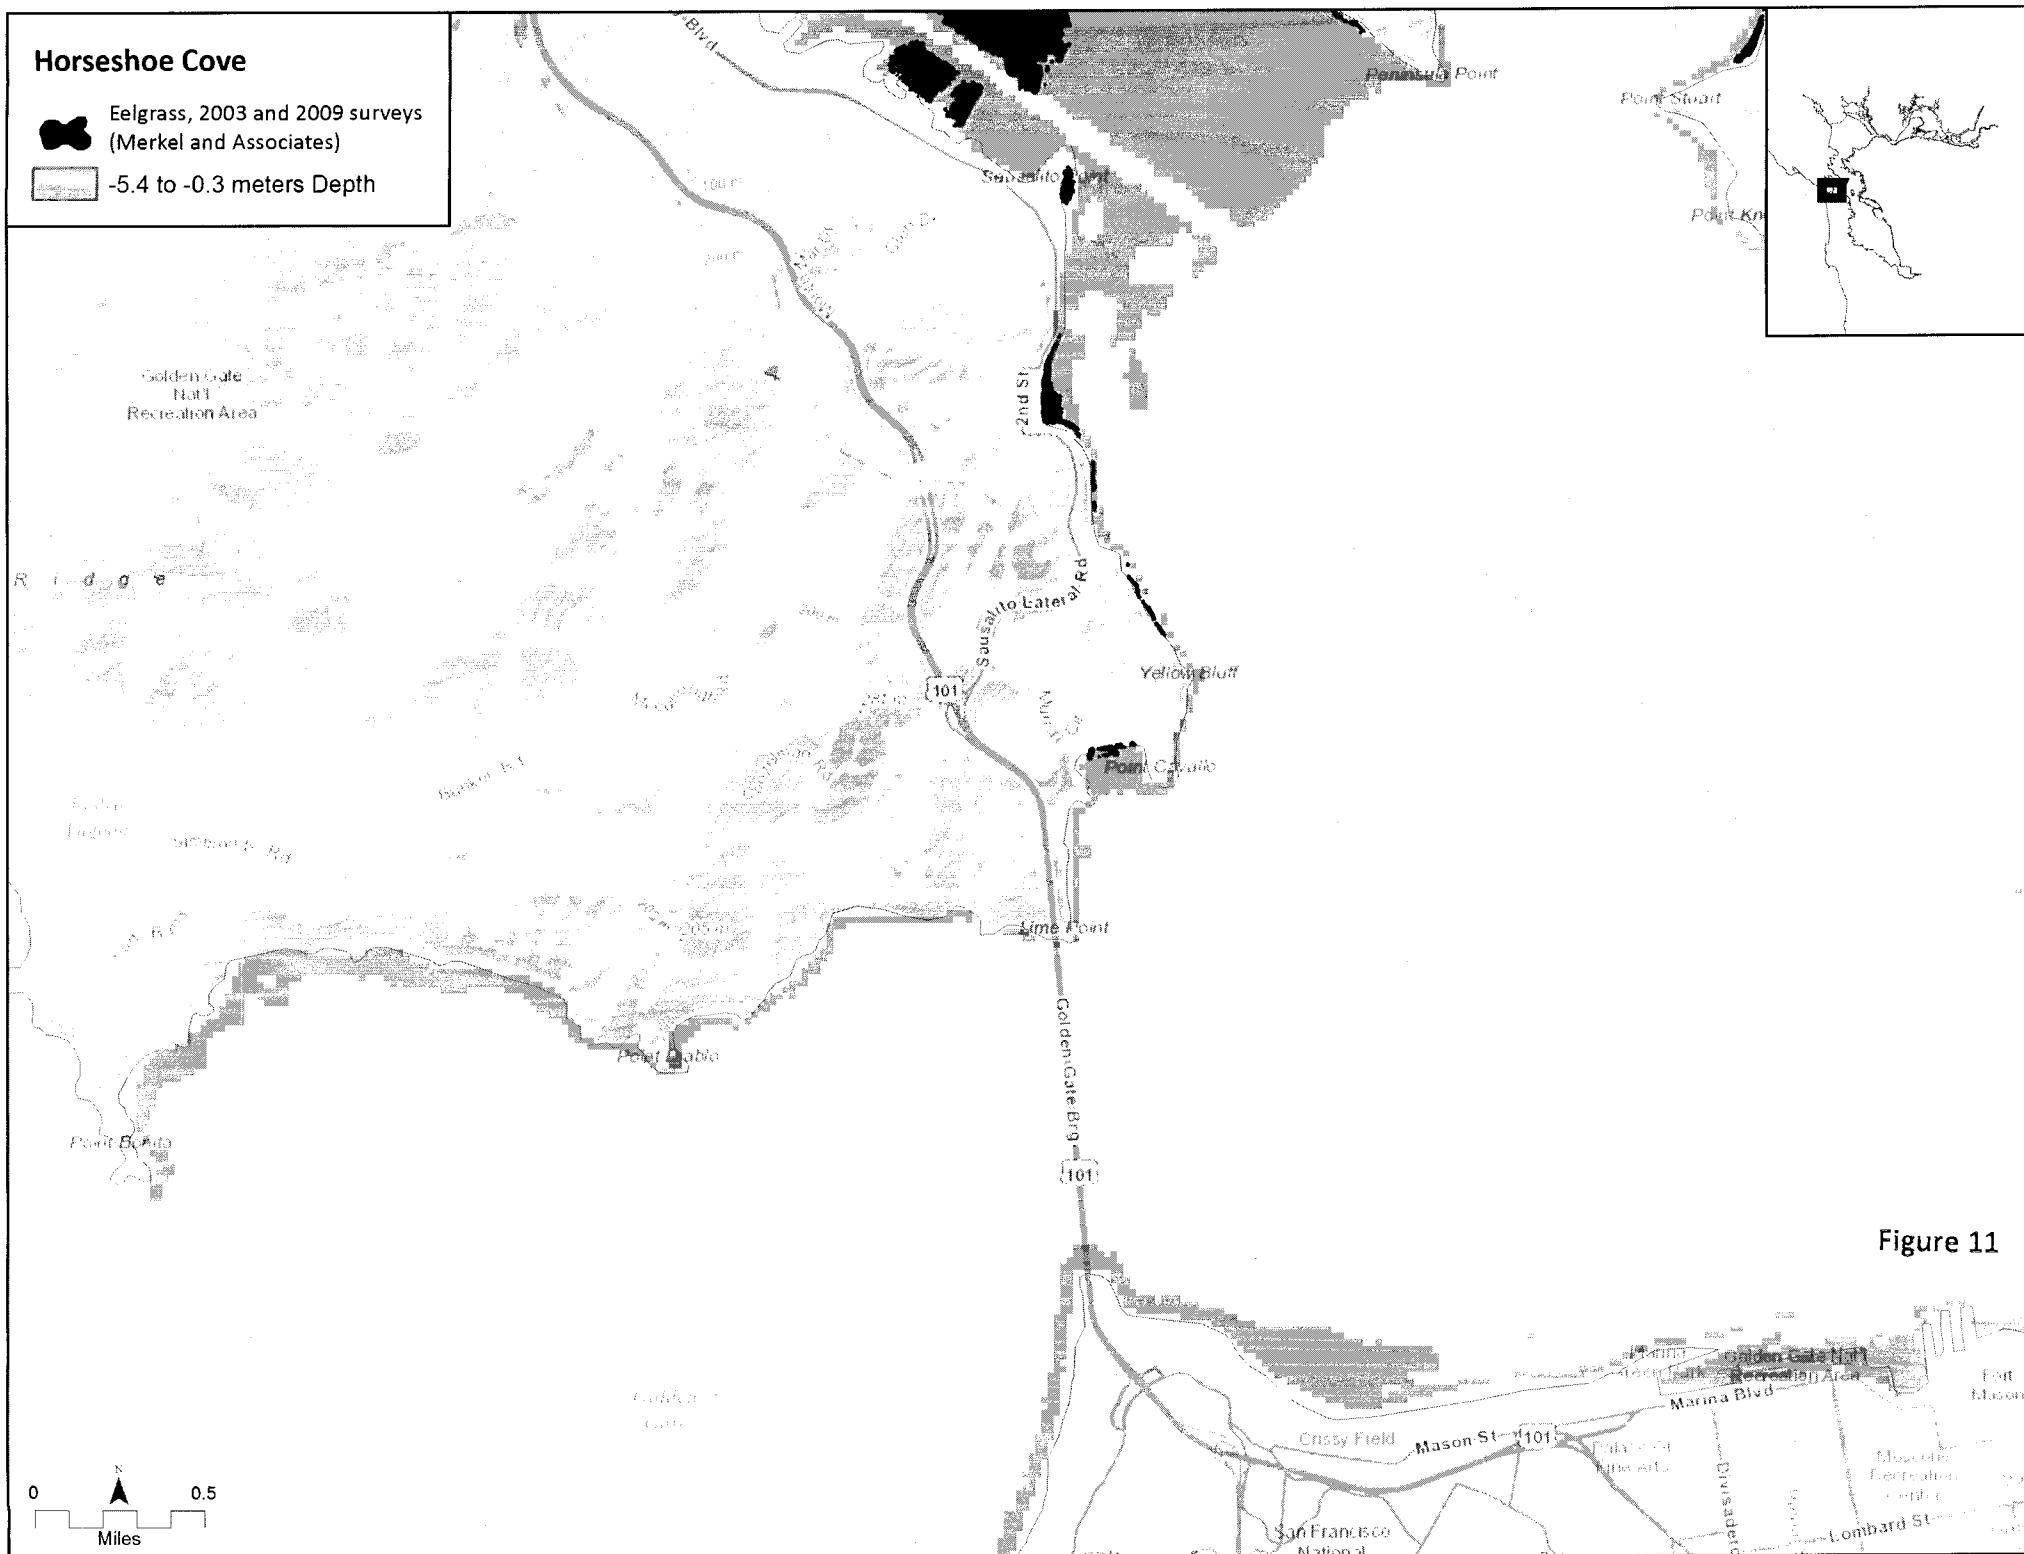
Figure 11

# Horseshoe Cove

Eelgrass, 2003 and 2009 surveys (Merkel and Associates)
-

-5.4 to -0.3 meters Depth

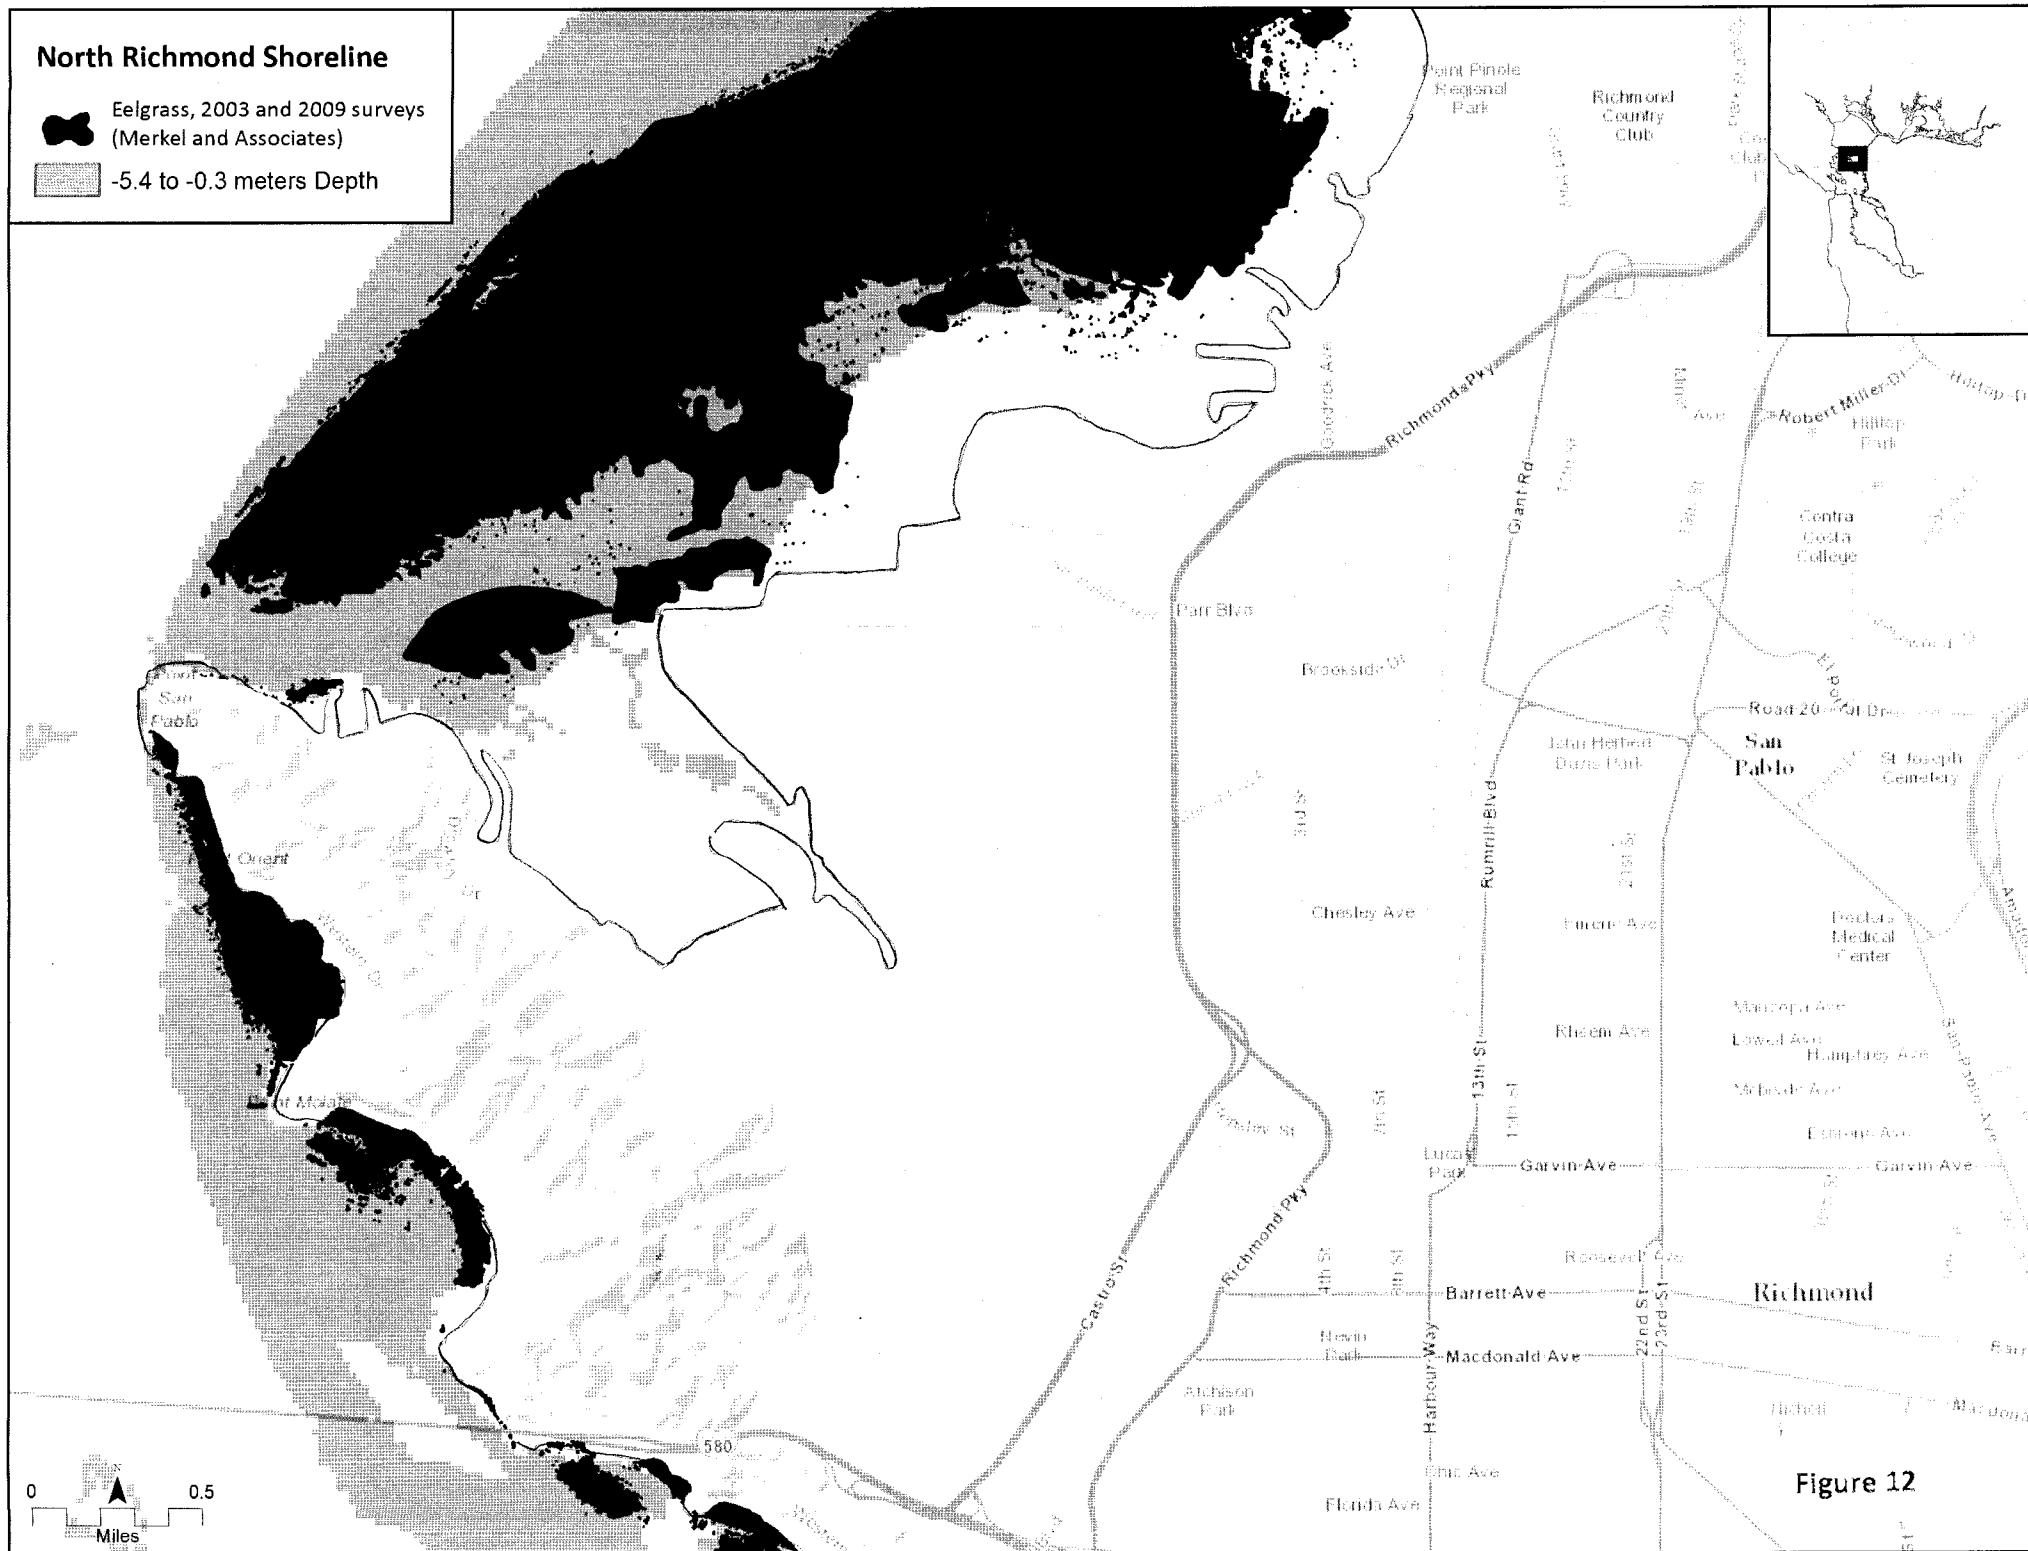
Figure 12

# North Richmond Shoreline

Eelgrass, 2003 and 2009 surveys  
(Merkel and Associates)

-5.4 to -0.3 meters Depth

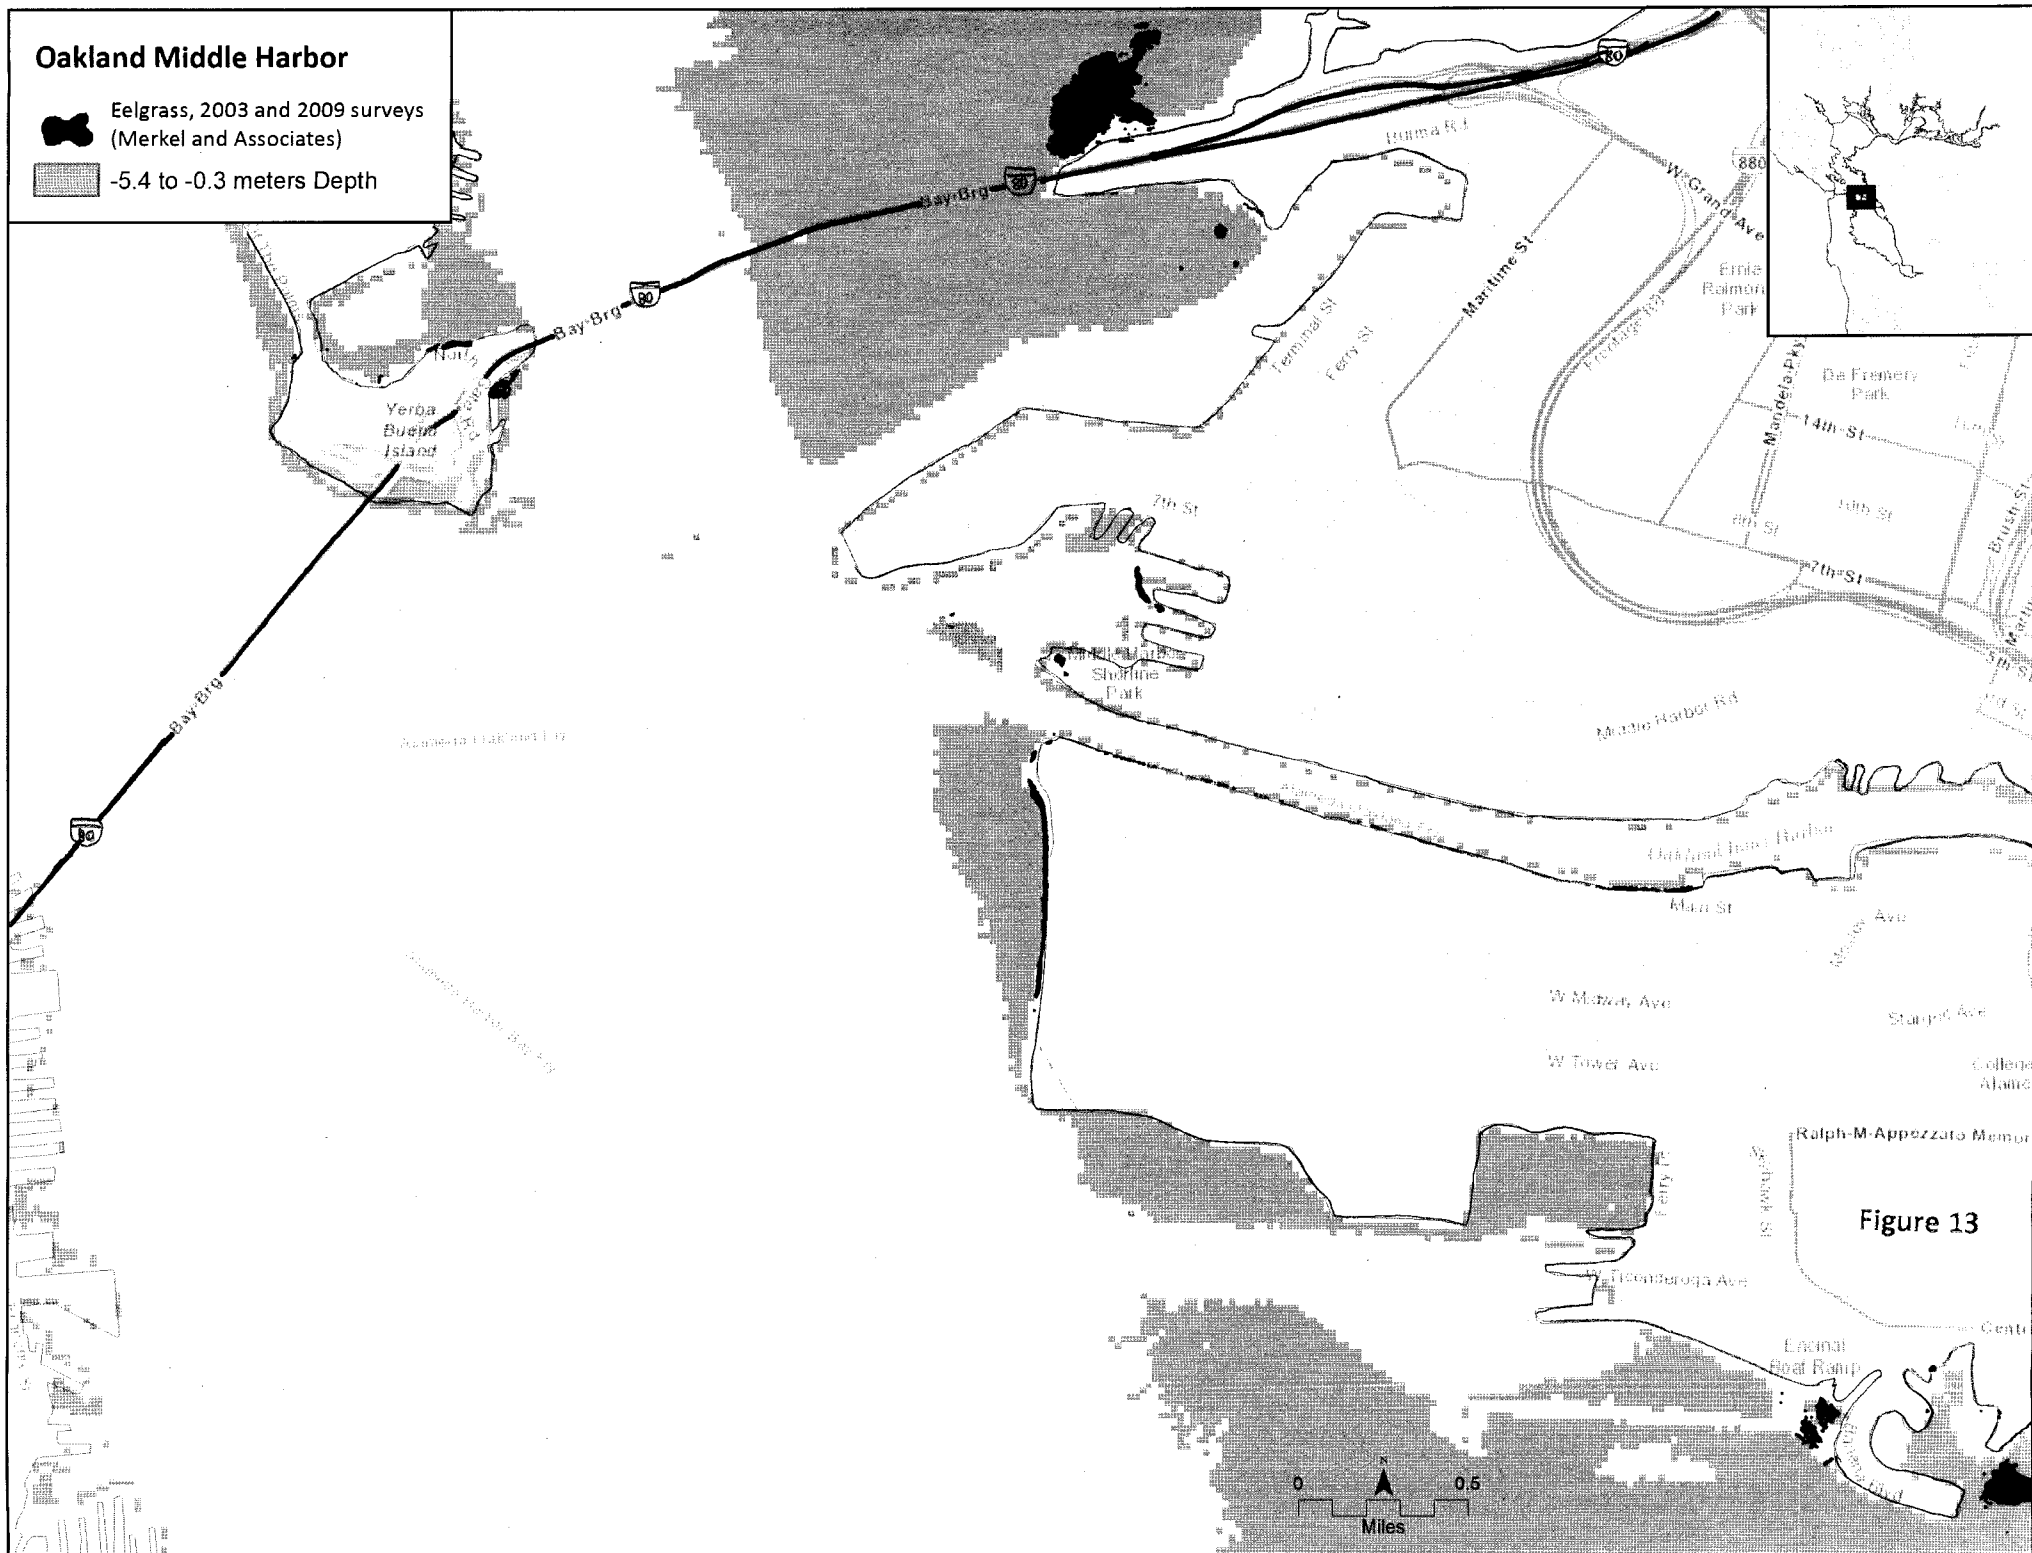
Figure 13

# Oakland Middle Harbor

- Eelgrass, 2003 and 2009 surveys  
(Merkel and Associates)
- 5.4 to -0.3 meters Depth

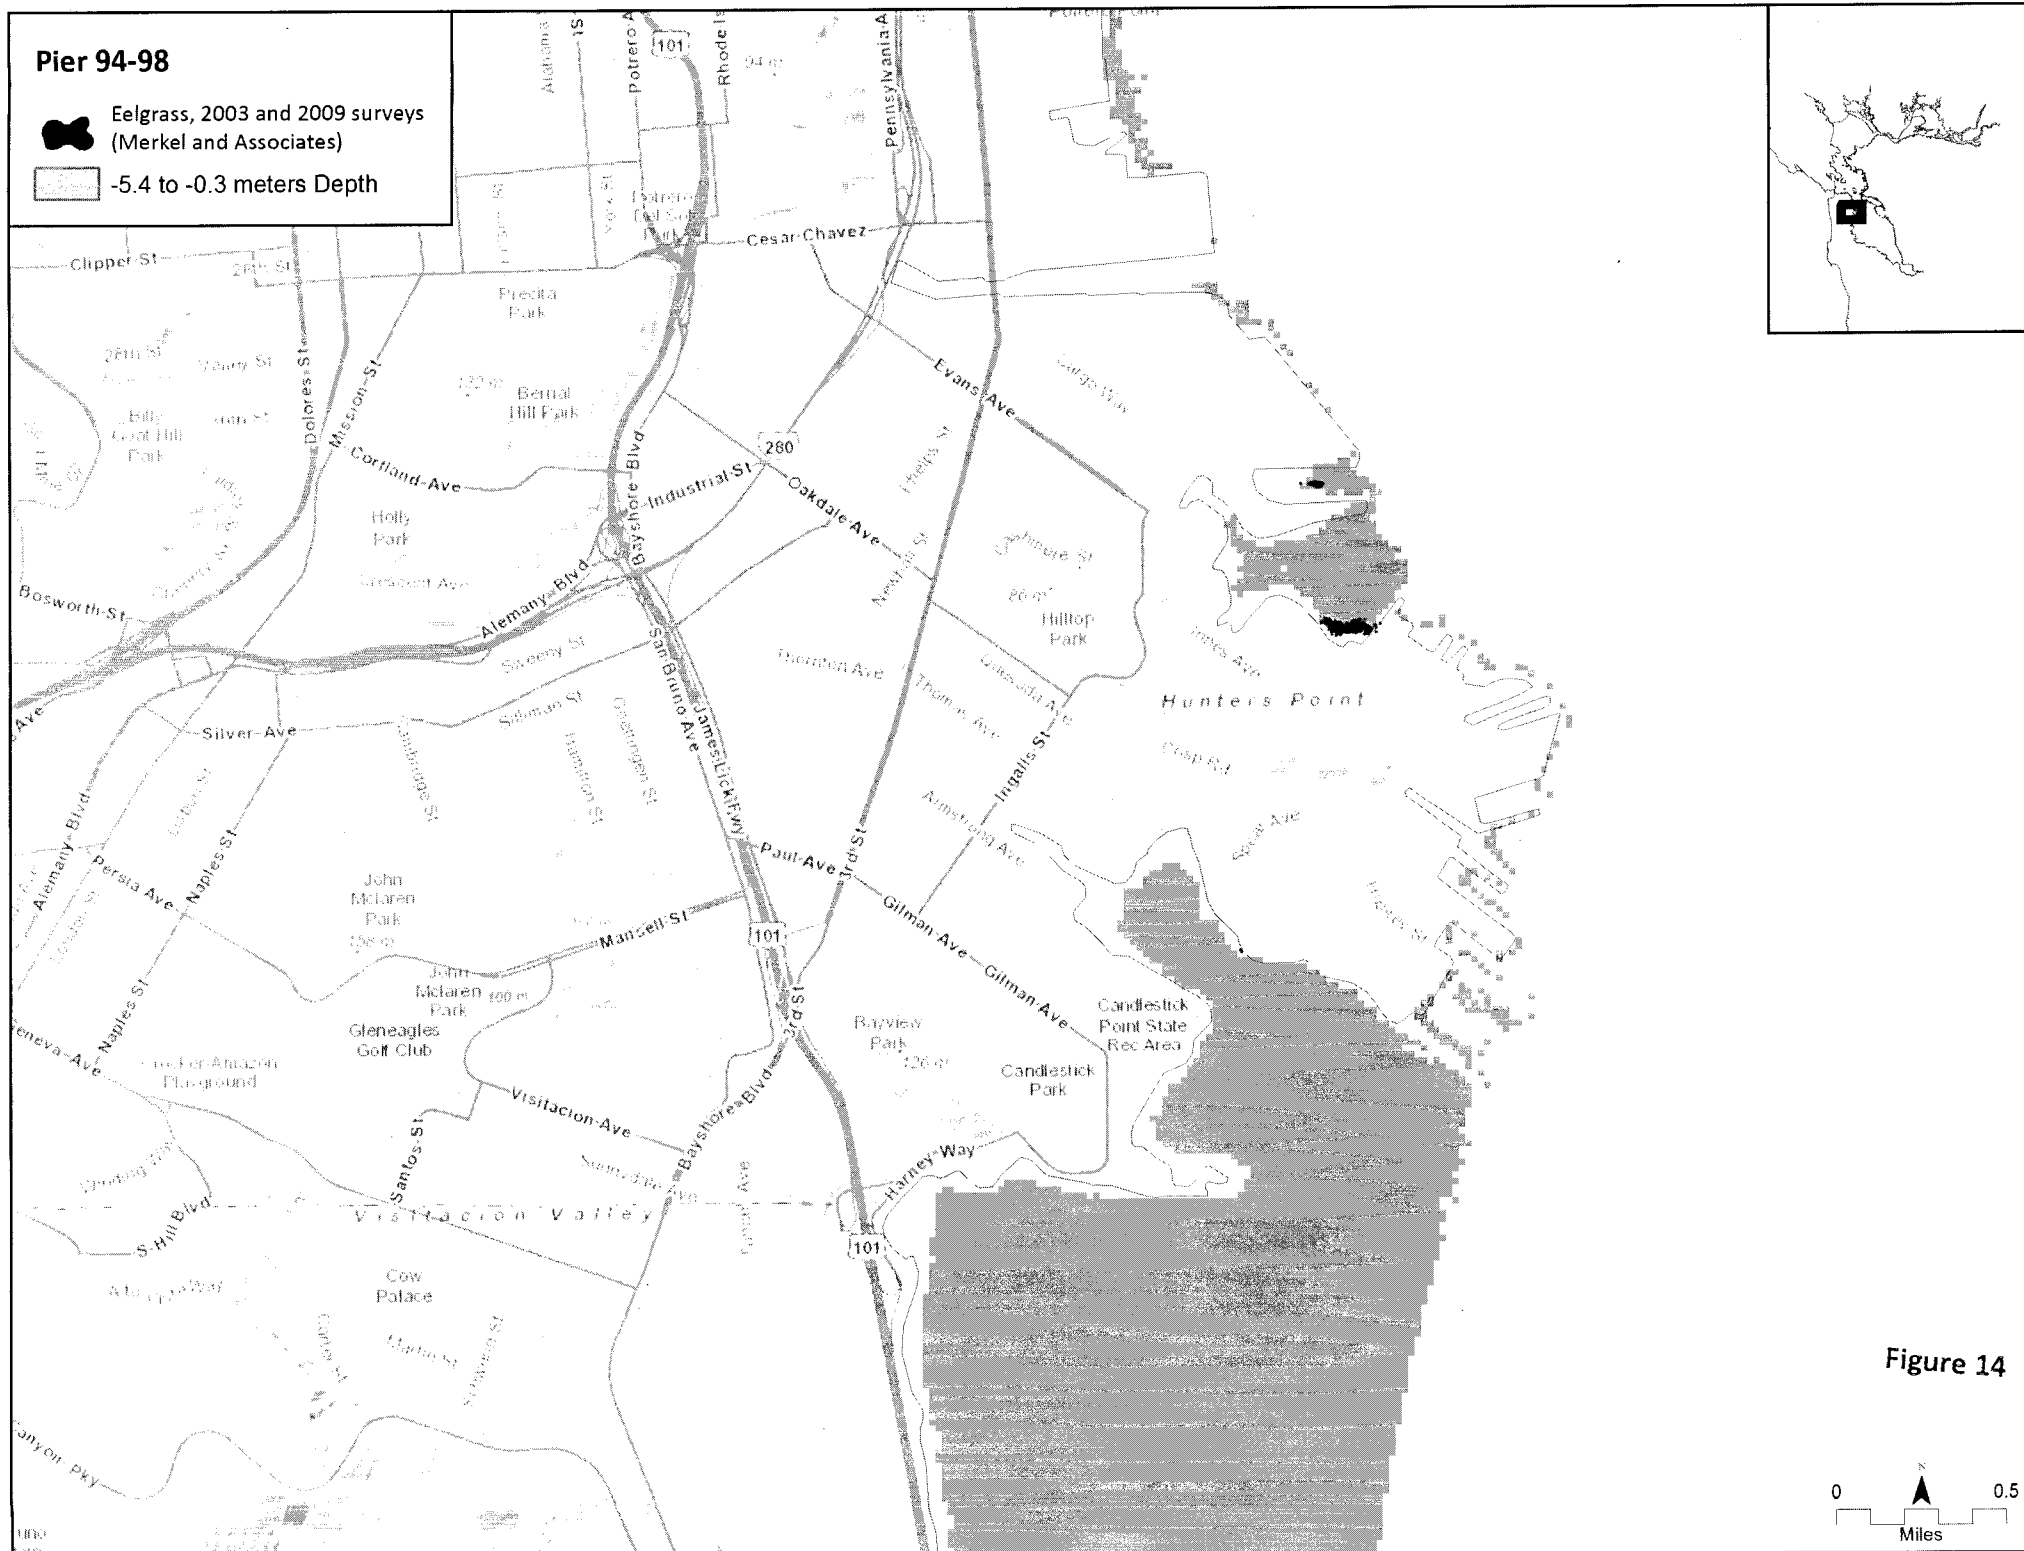
Figure 14

# Pier 94-98

Eelgrass, 2003 and 2009 surveys (Merkel and Associates)
-

-5.4 to -0.3 meters Depth

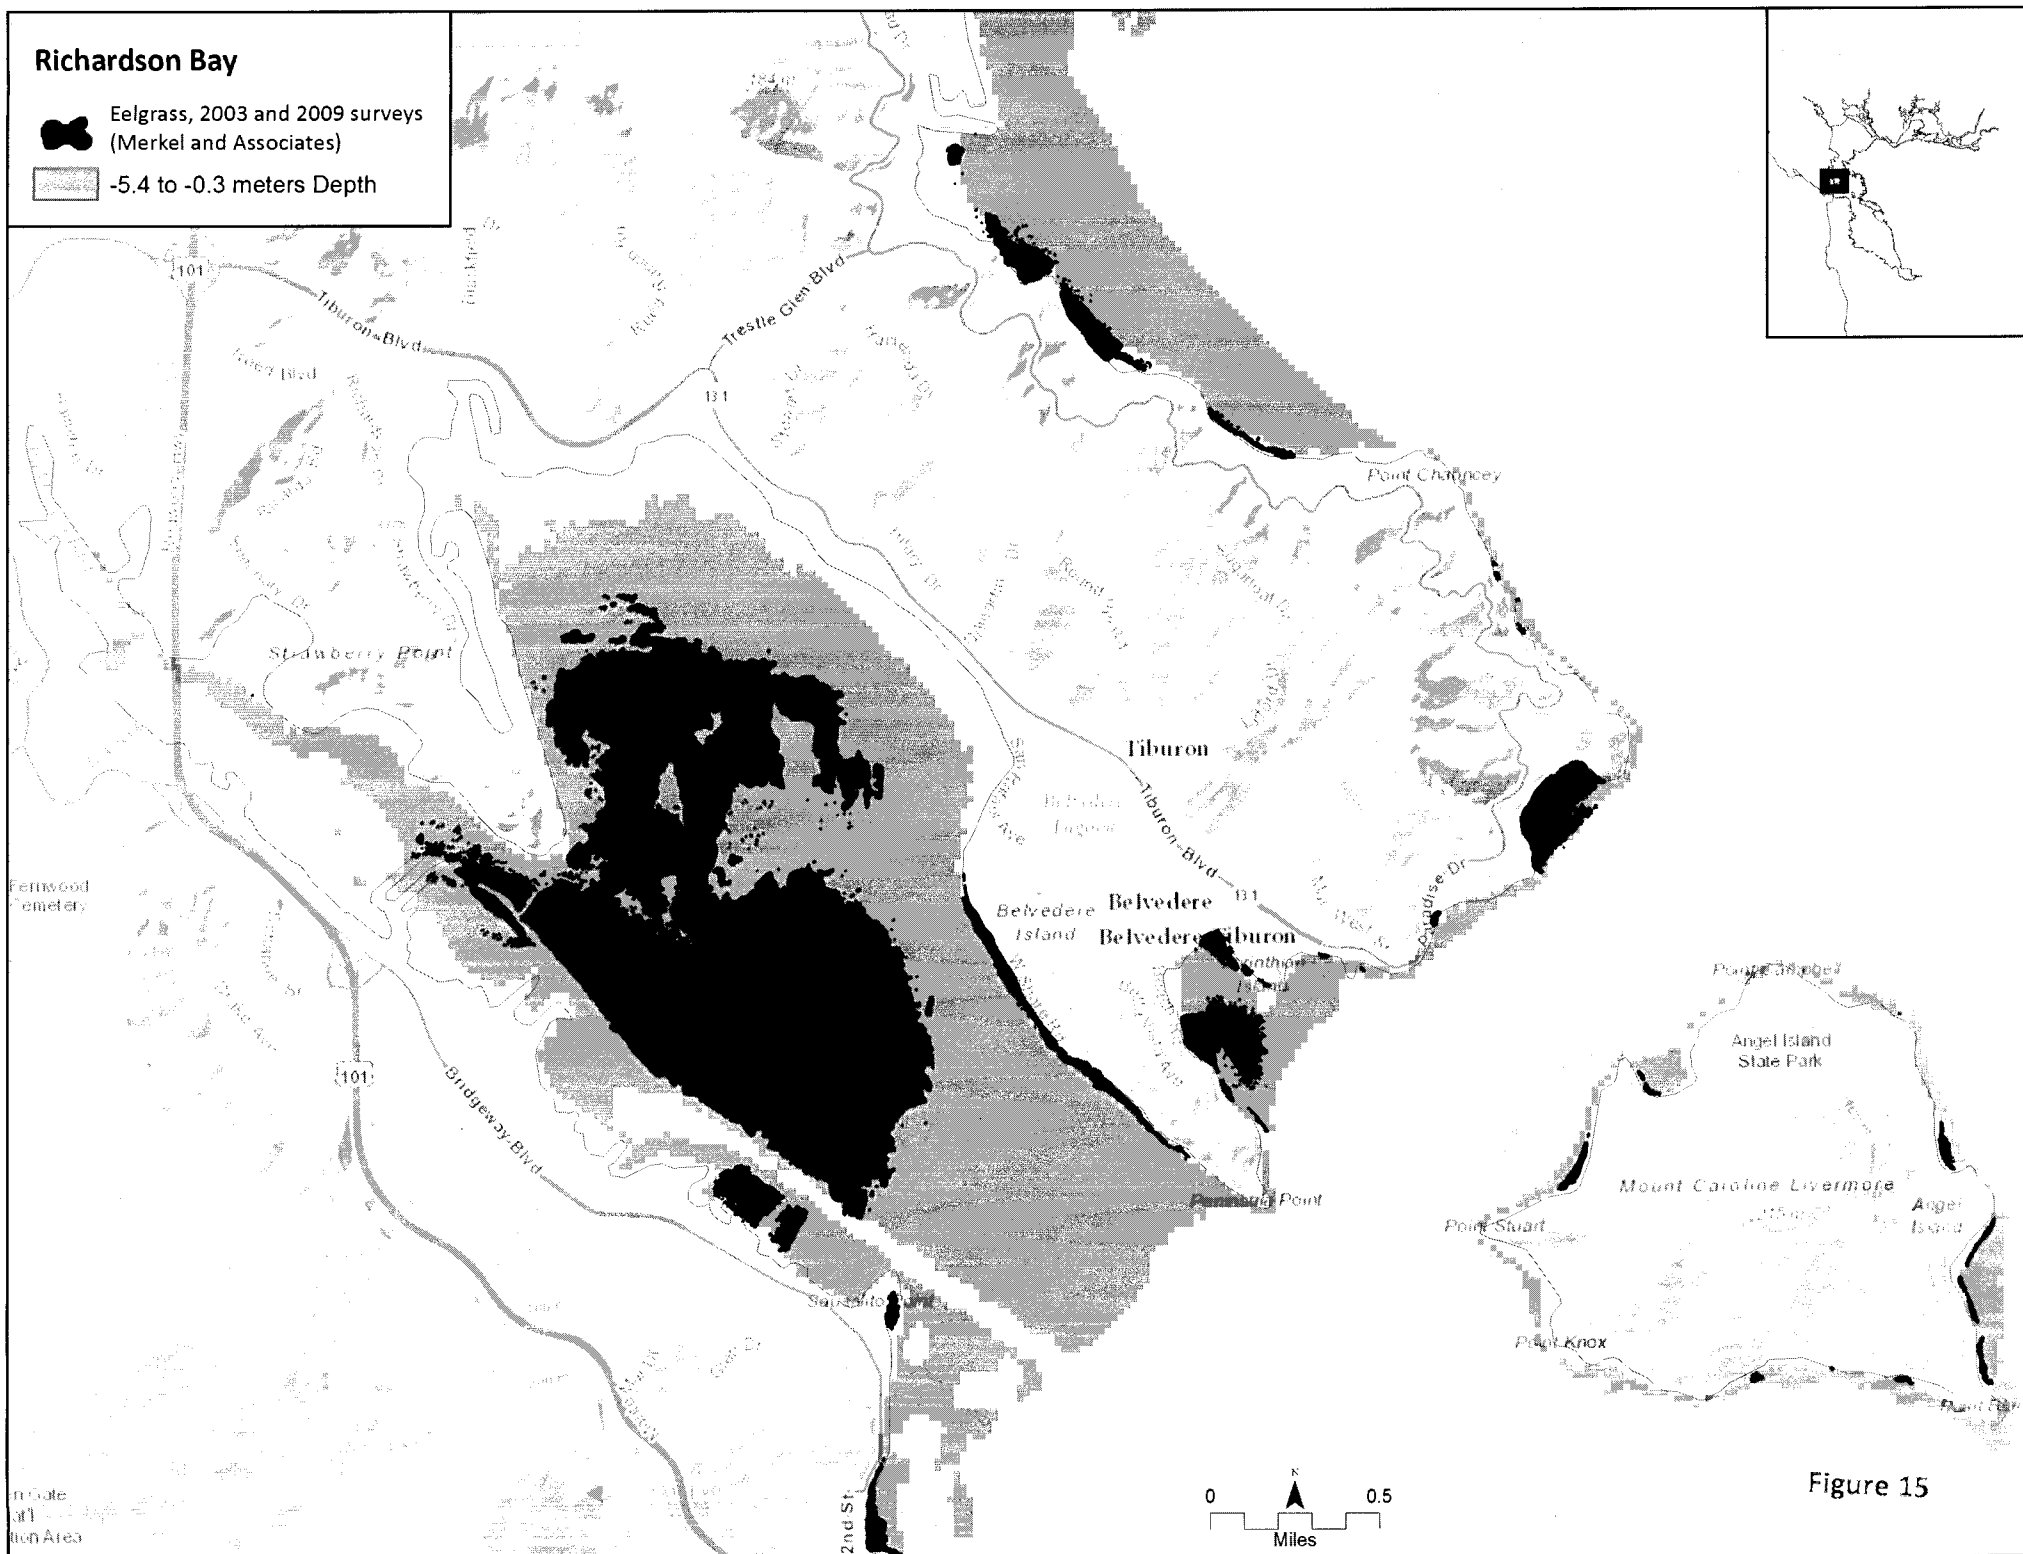
Figure 15

# Richardson Bay

Eelgrass, 2003 and 2009 surveys  
(Merkel and Associates)

-5.4 to -0.3 meters Depth

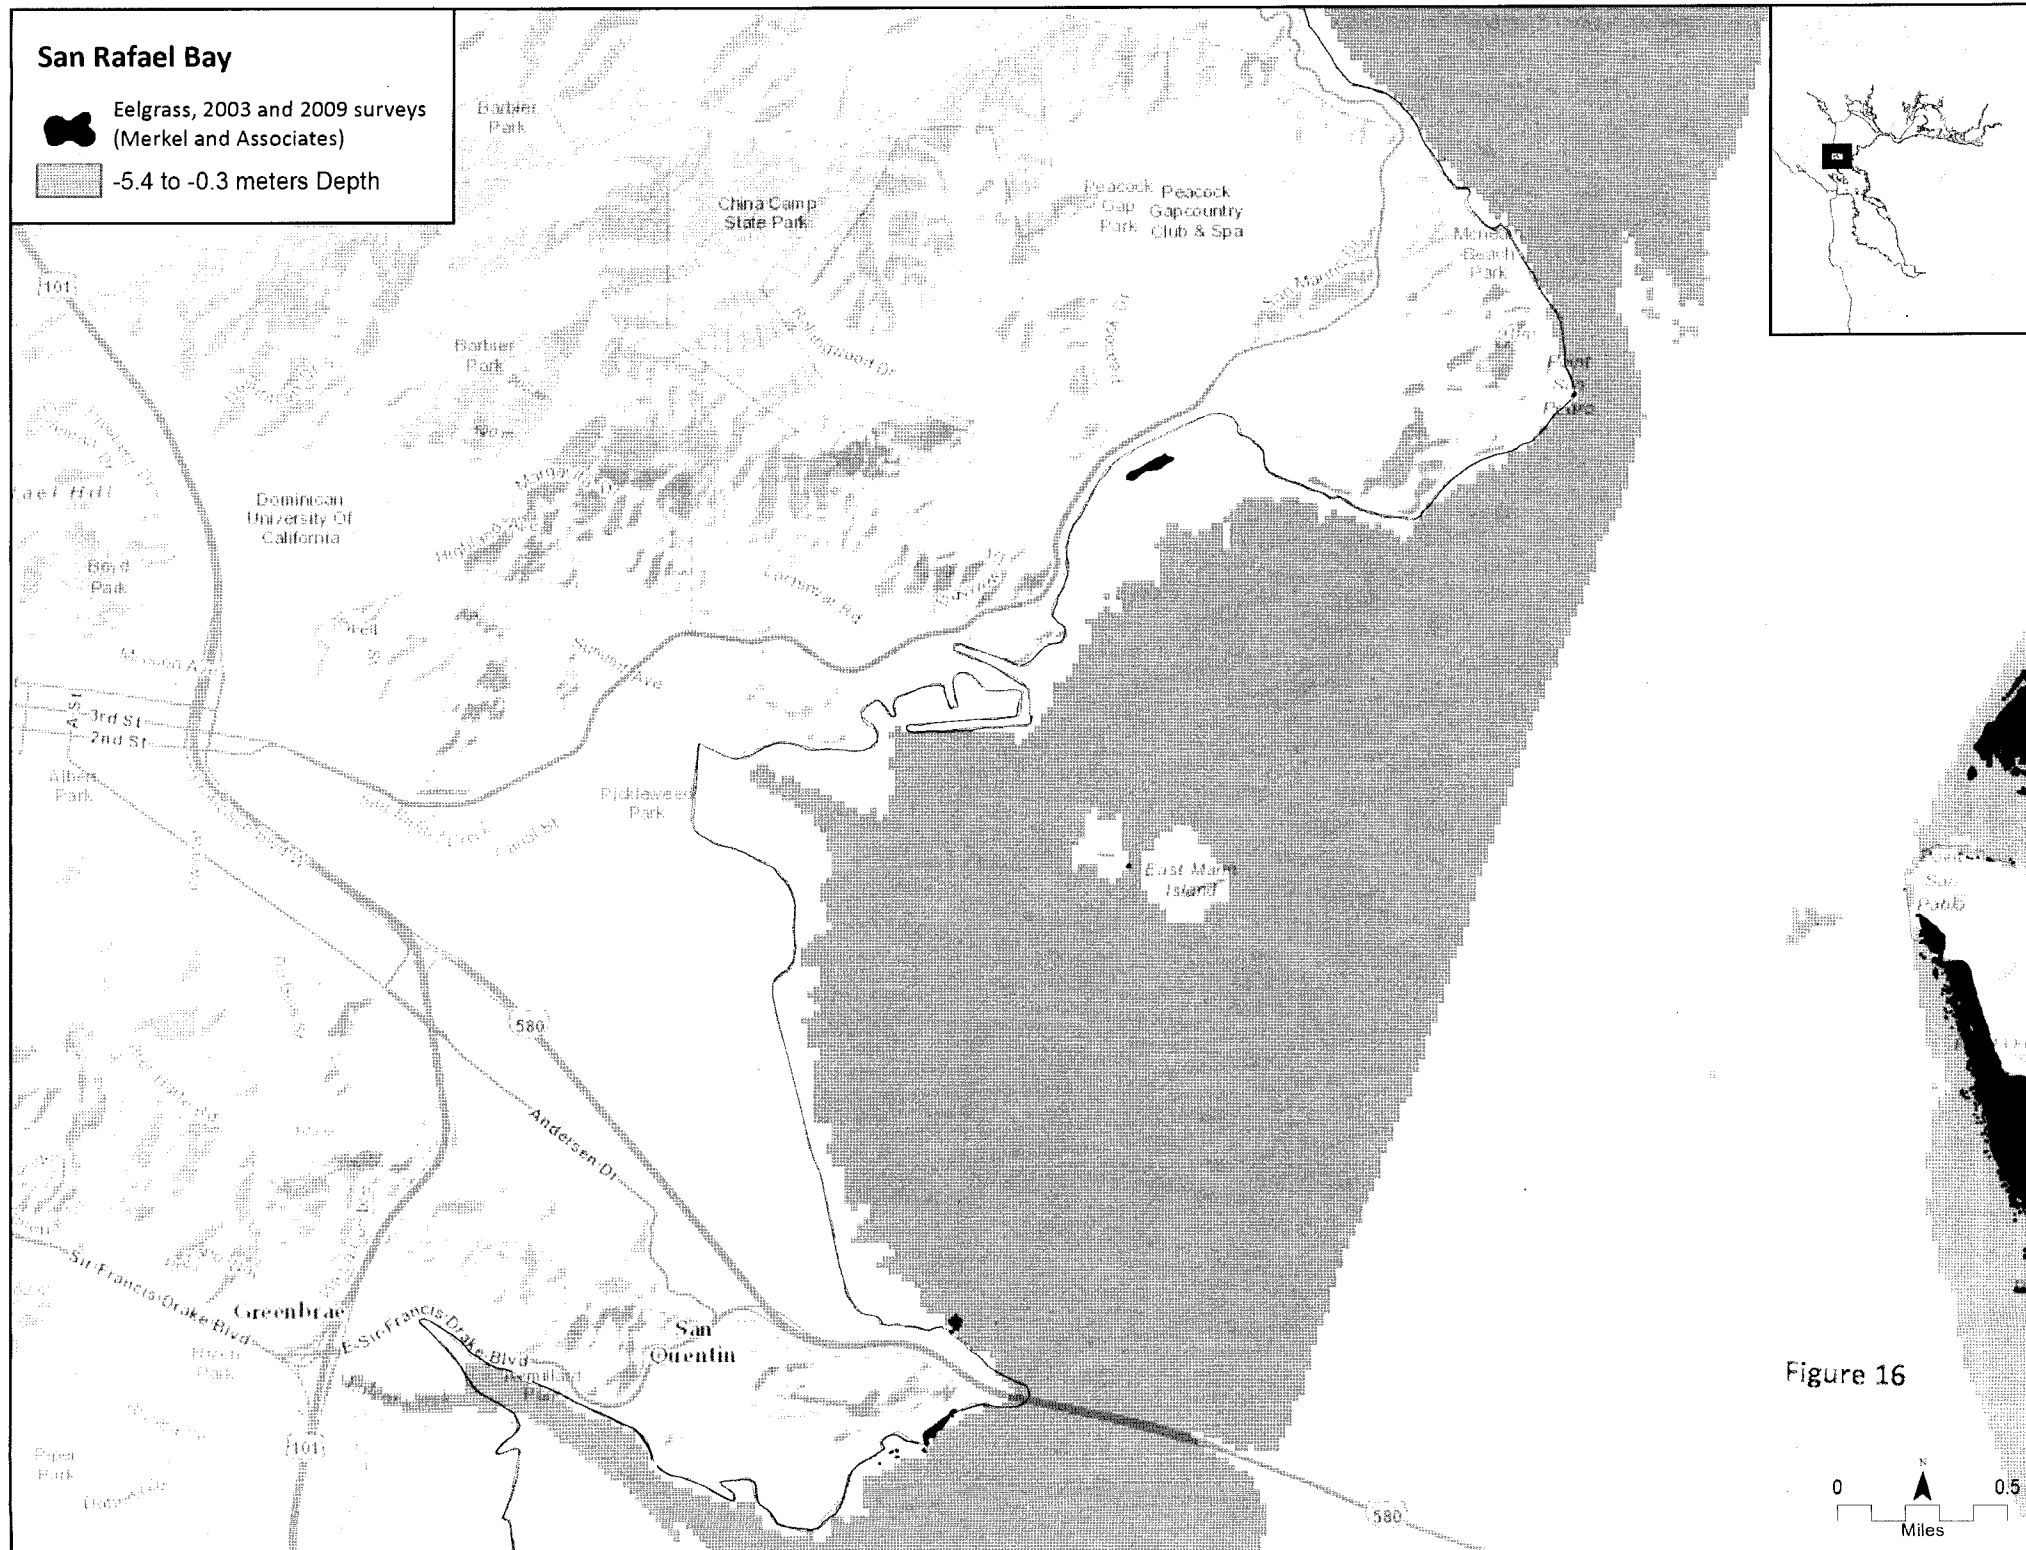
Figure 16

# San Rafael Bay

Eelgrass, 2003 and 2009 surveys (Merkel and Associates)
-

-5.4 to -0.3 meters Depth

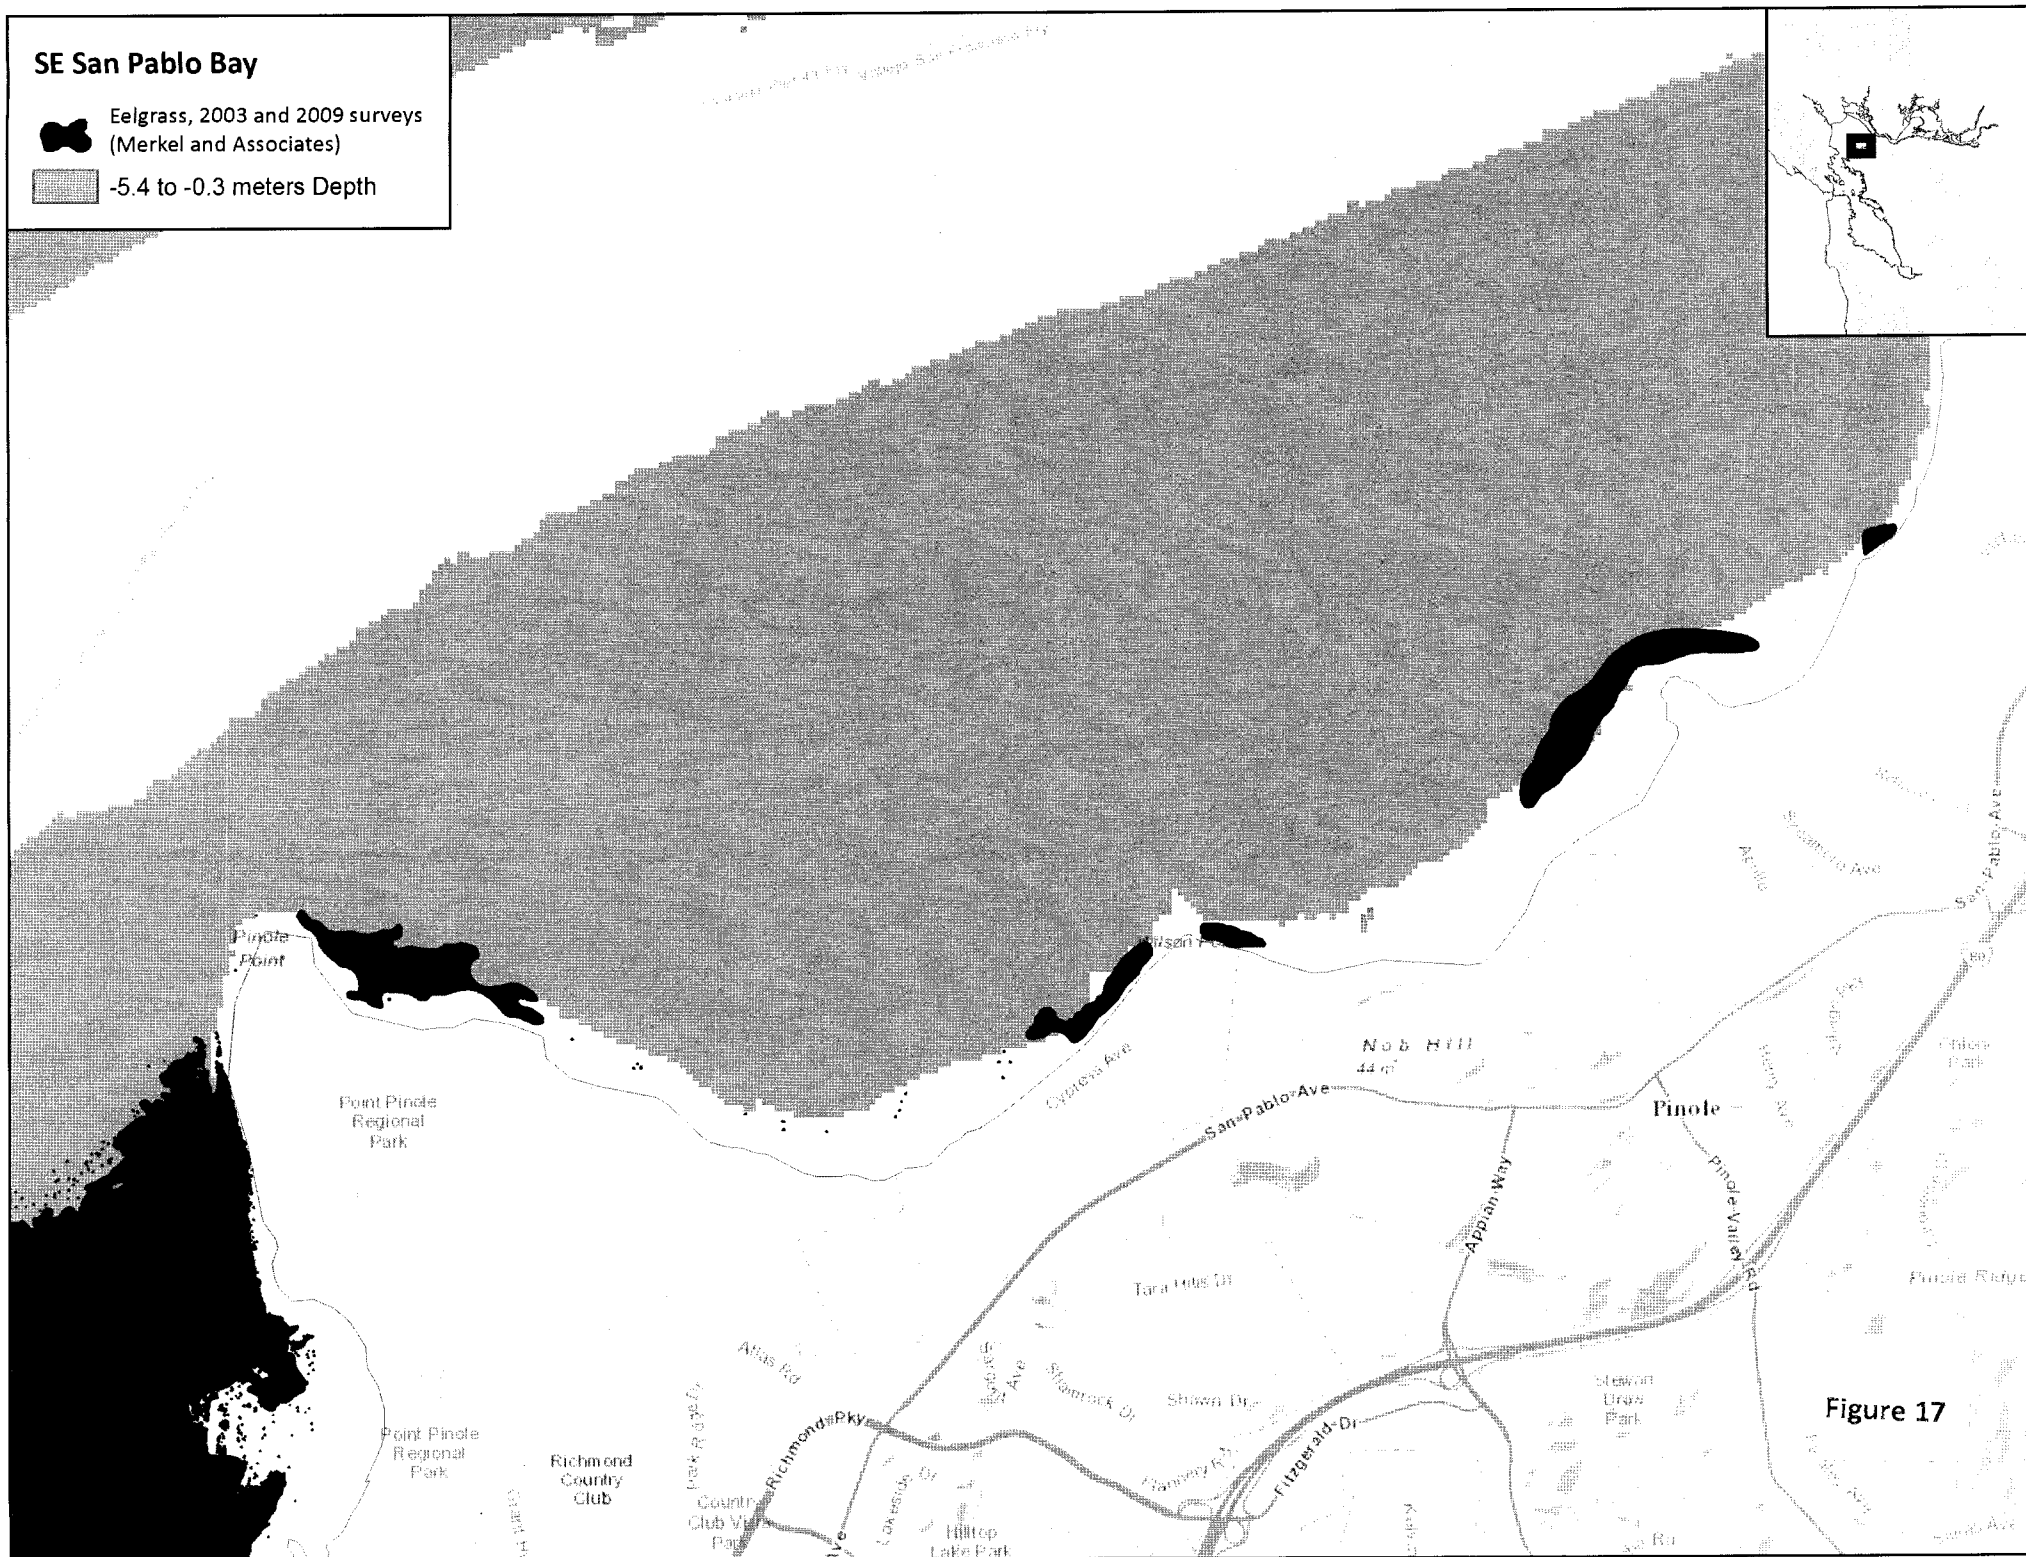
Figure 17

# SE San Pablo Bay

Eelgrass, 2003 and 2009 surveys (Merkel and Associates)
-

-5.4 to -0.3 meters Depth

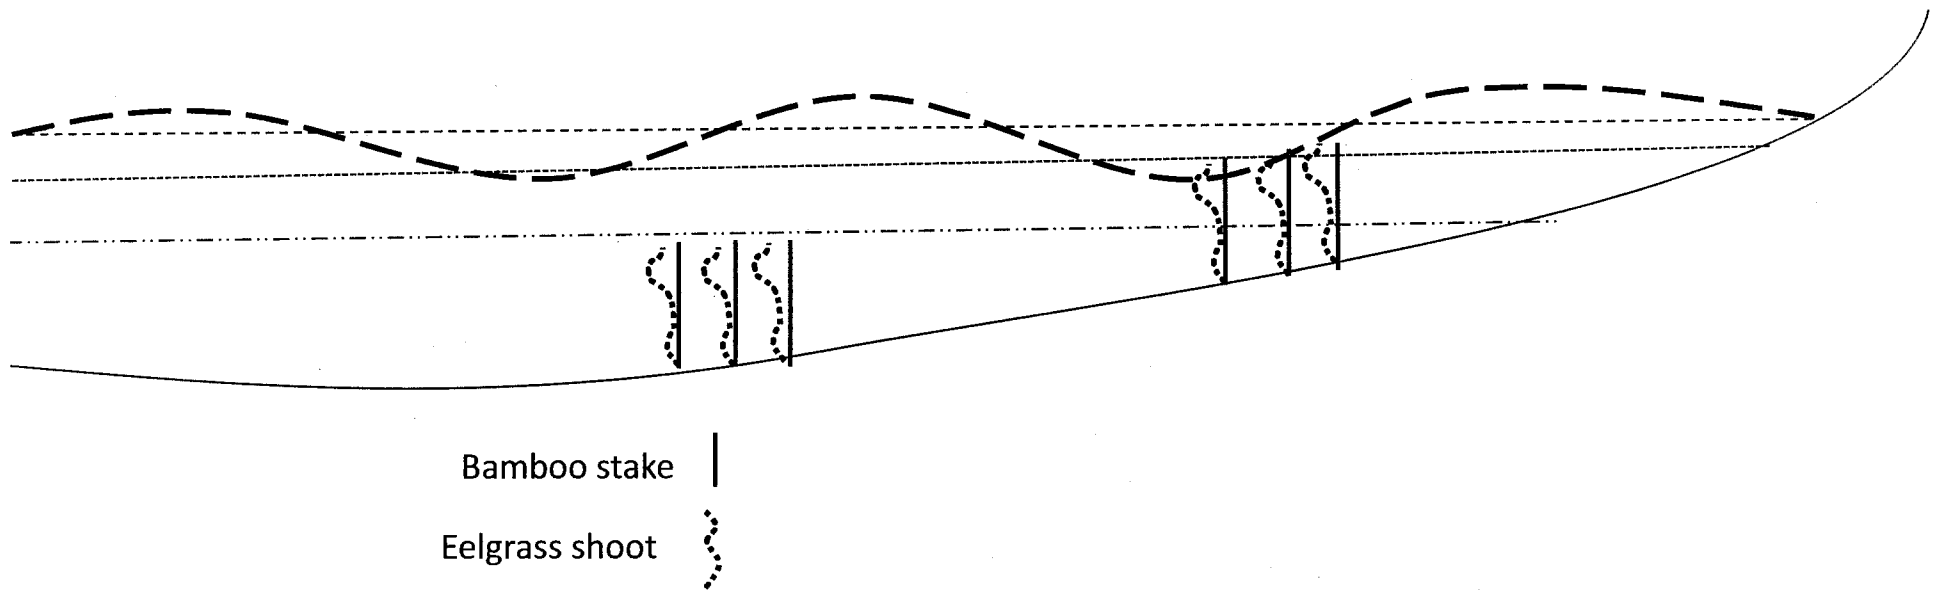
Figure 18

Depth range of 0.3 - -5.4 m MLLW
