Figure 8-7: Recommended sites for phased native eelgrass restoration in San Francisco Bay.

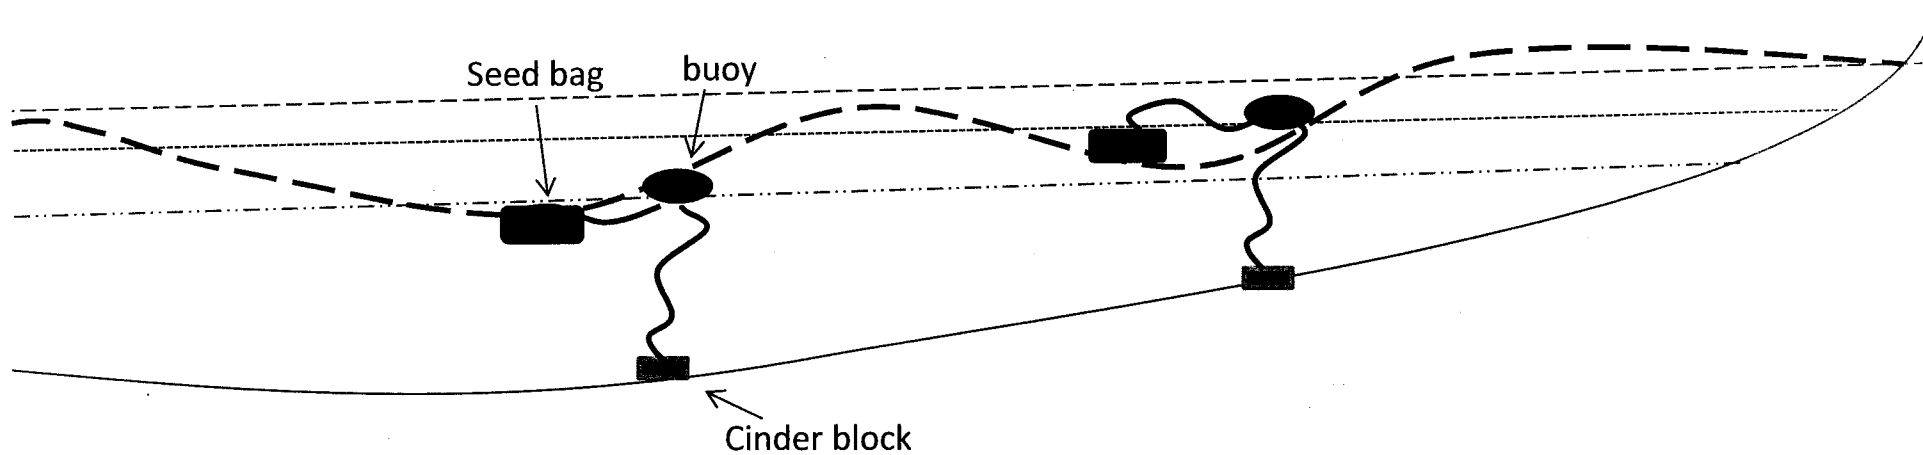
Figure 19

Depth range of 0.3 - -5.4 m MLLW
