Willits Bypass Project

Mitigation and Monitoring Proposal

U.S. Highway 101

January 2012

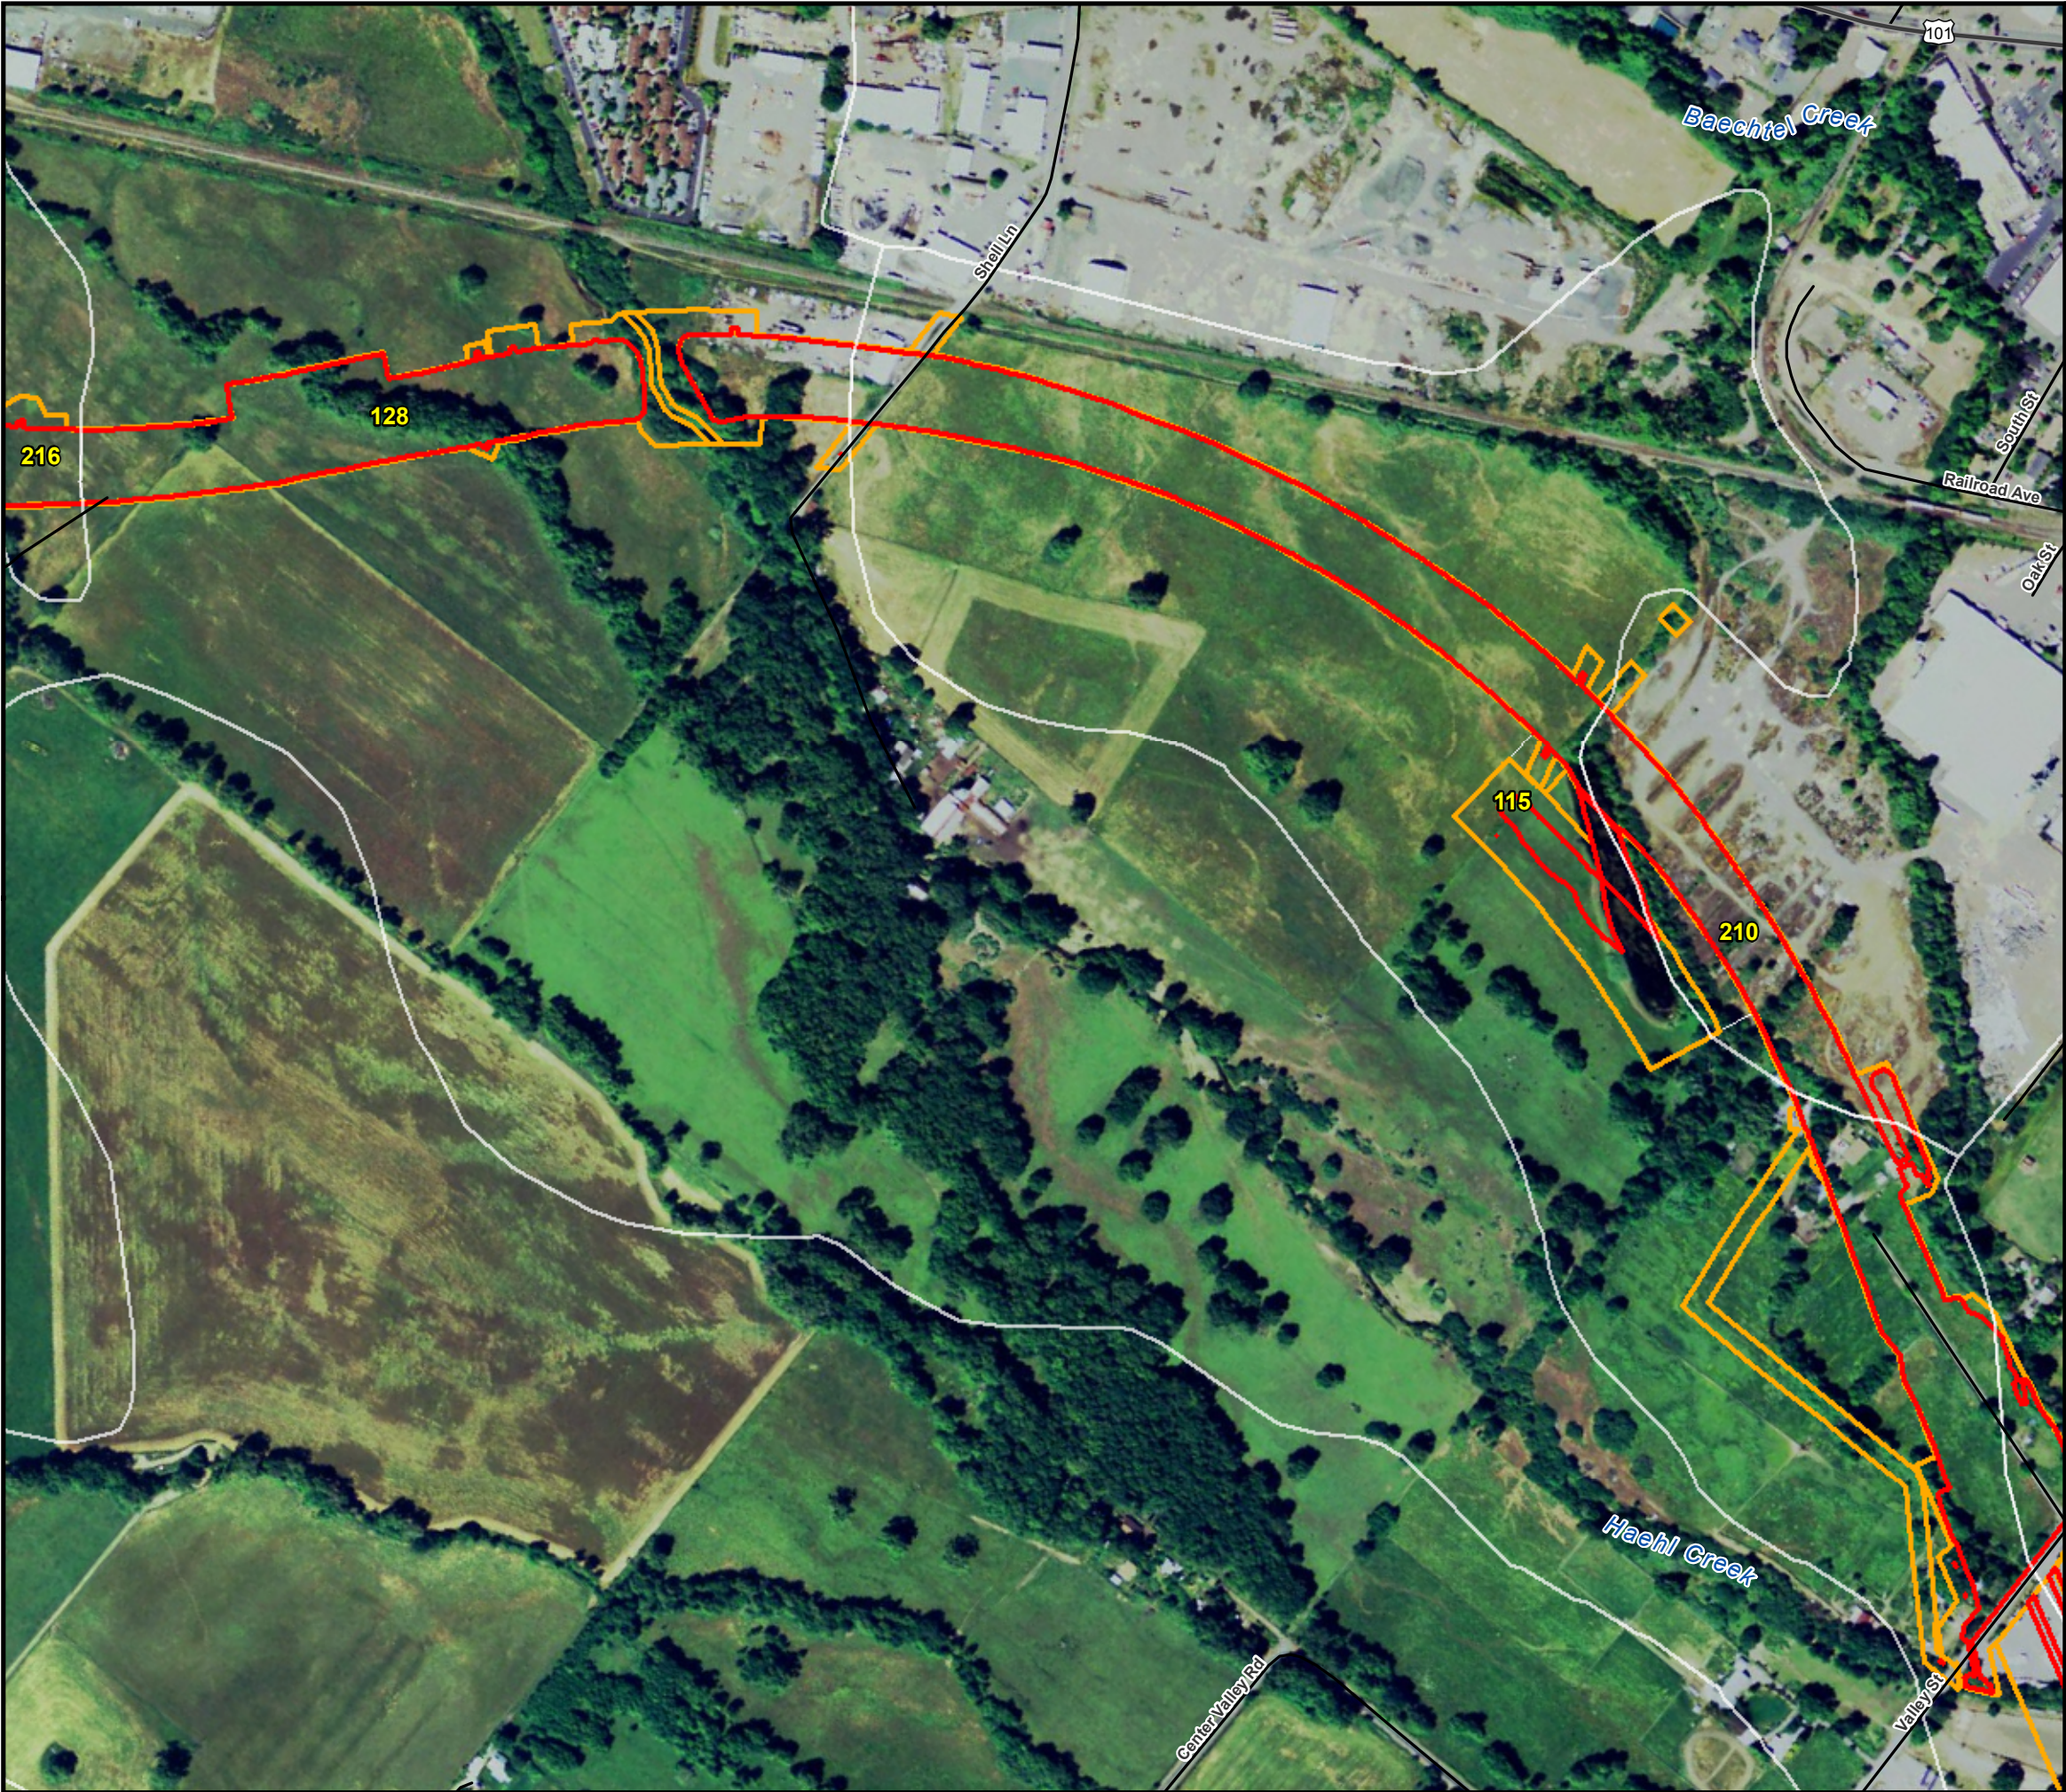
Figure 5-4c
Soil Types within the Proposed
Bypass Project Footprint
Proposed Willits Bypass Project

- SSURGO Map Unit
- Permanent Impact Boundary
- Temporary Impact Boundary
- Road

The Natural Resources Conservation Service (NRCS) *Eastern Mendocino County Soils Survey* was used to analyze soils in the bypass alignment footprint (Figures 5-4a through 5-4h). Hydric status for map units ranged from nonhydric to partially hydric, while the dominant drainage class ranged from very poorly drained to well-drained.

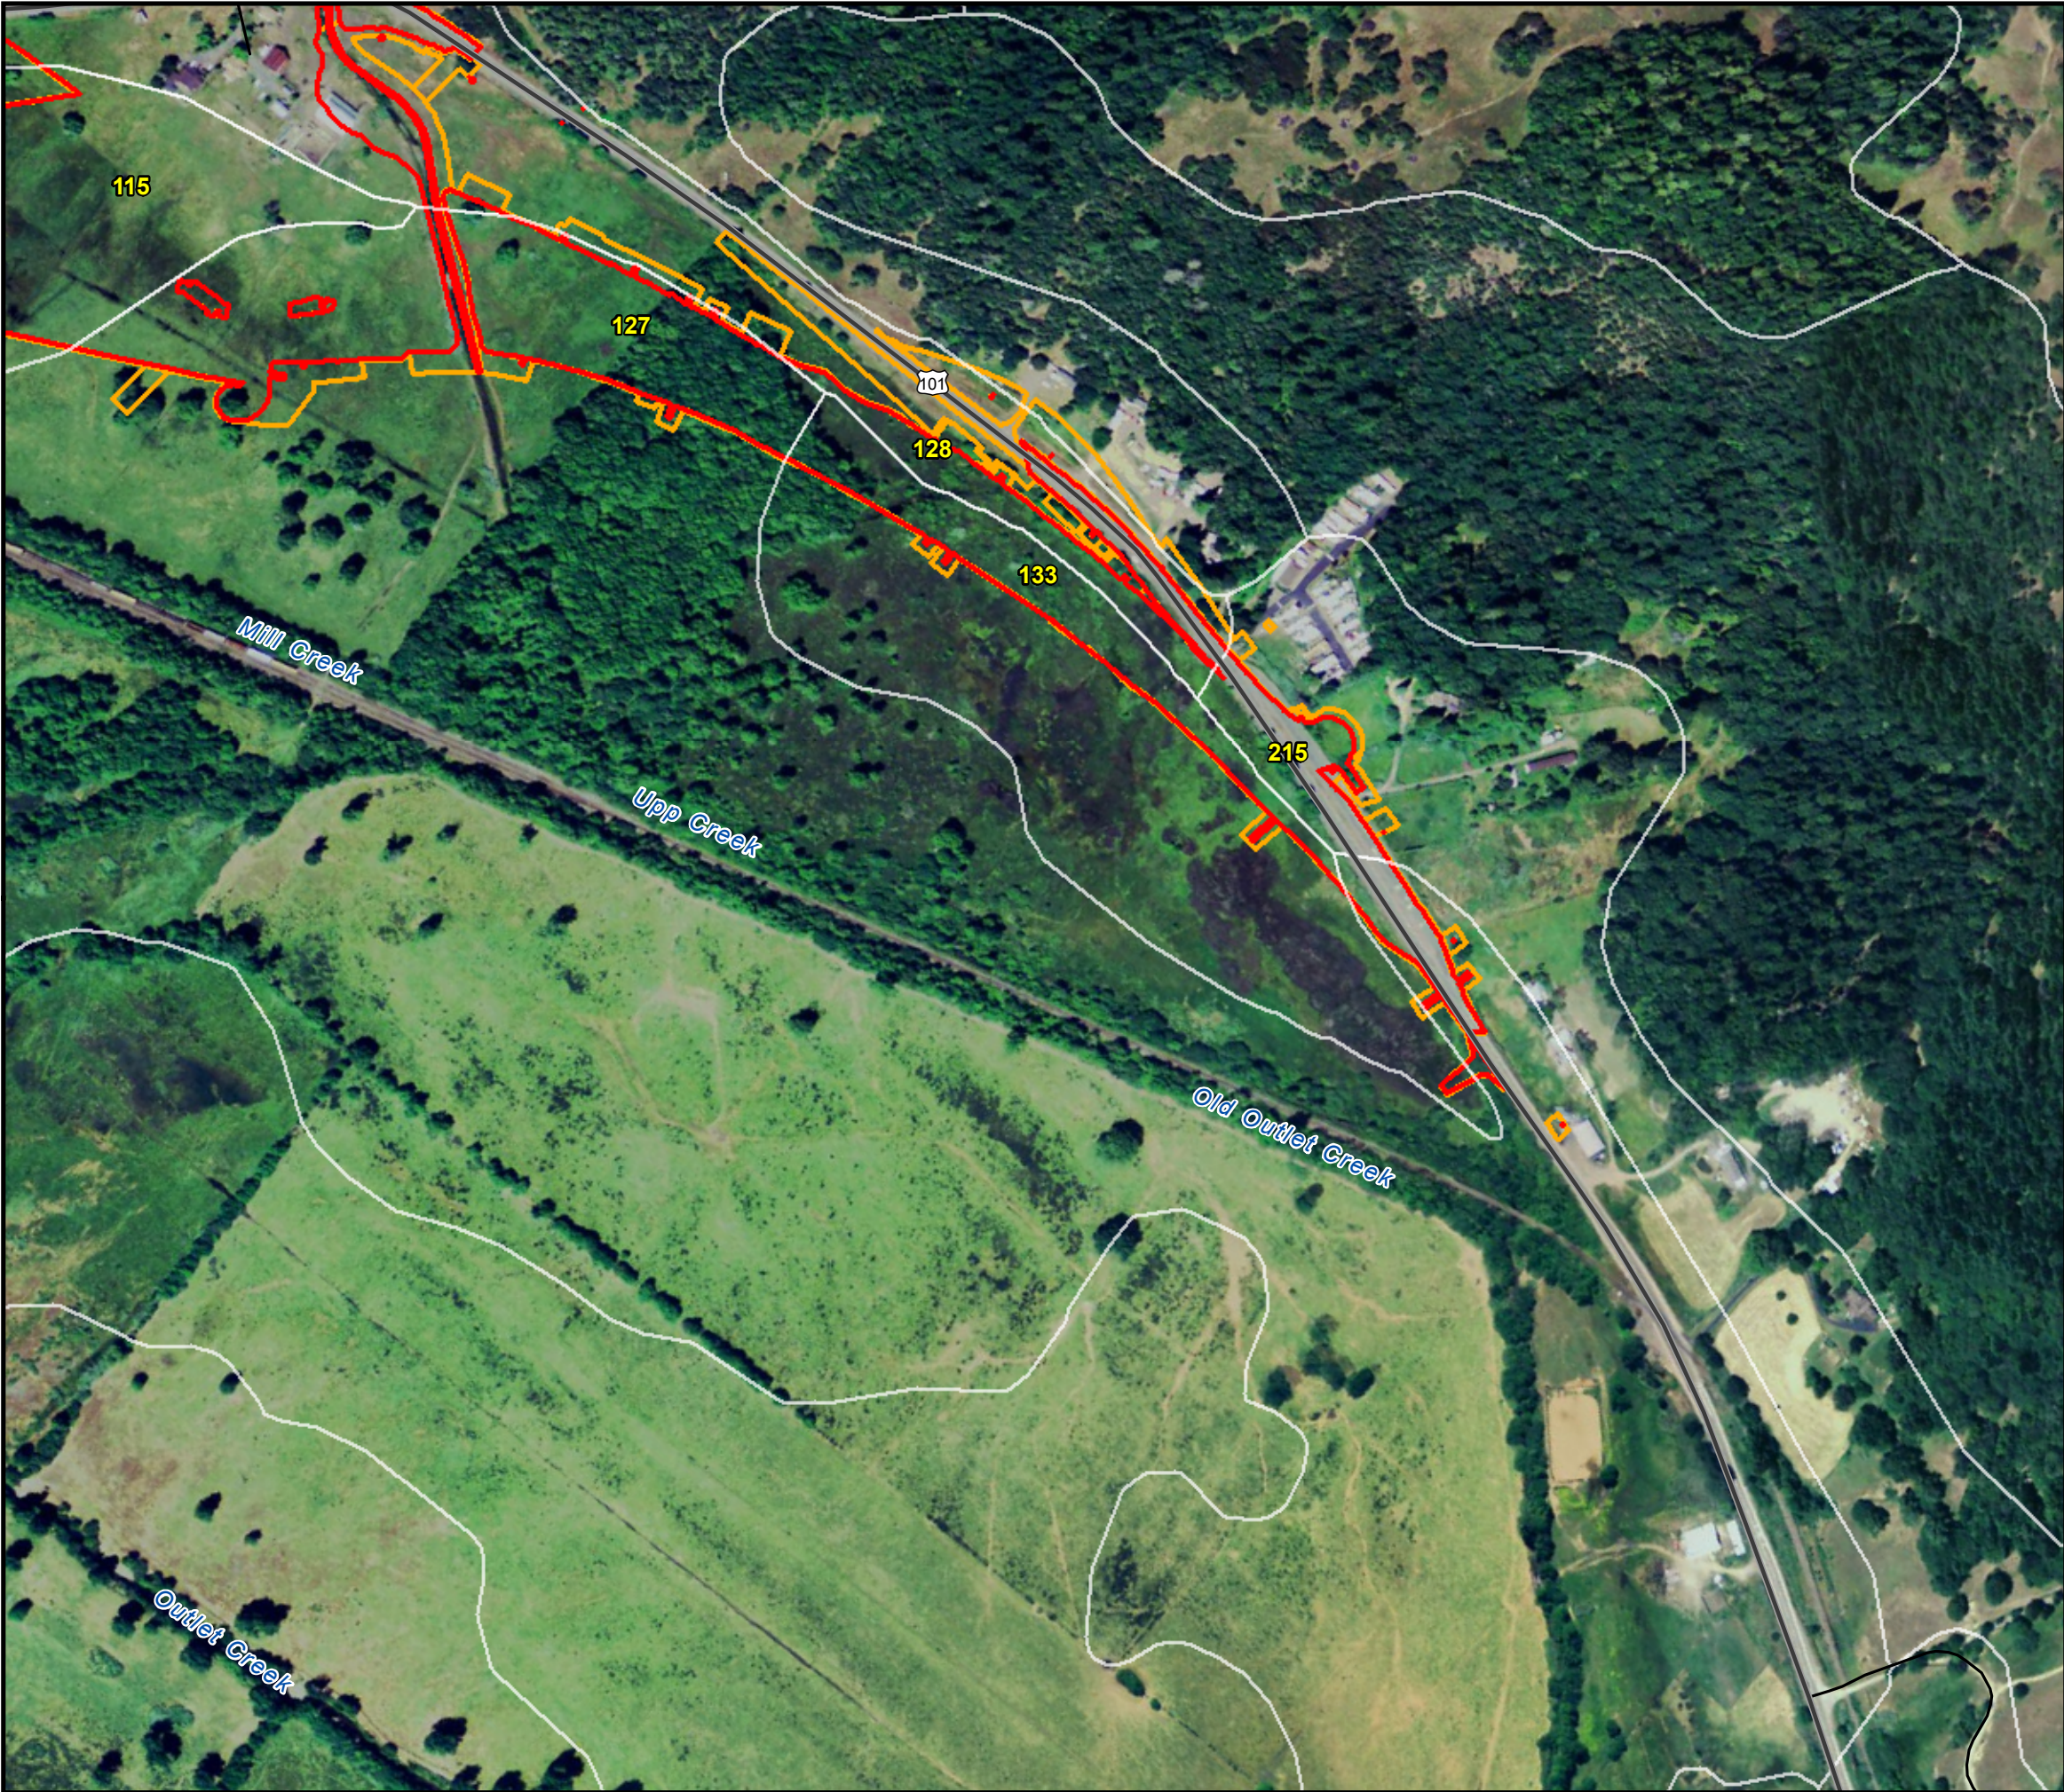
Figure 5-4f

SSURGO Map Unit

Permanent Impact Boundary

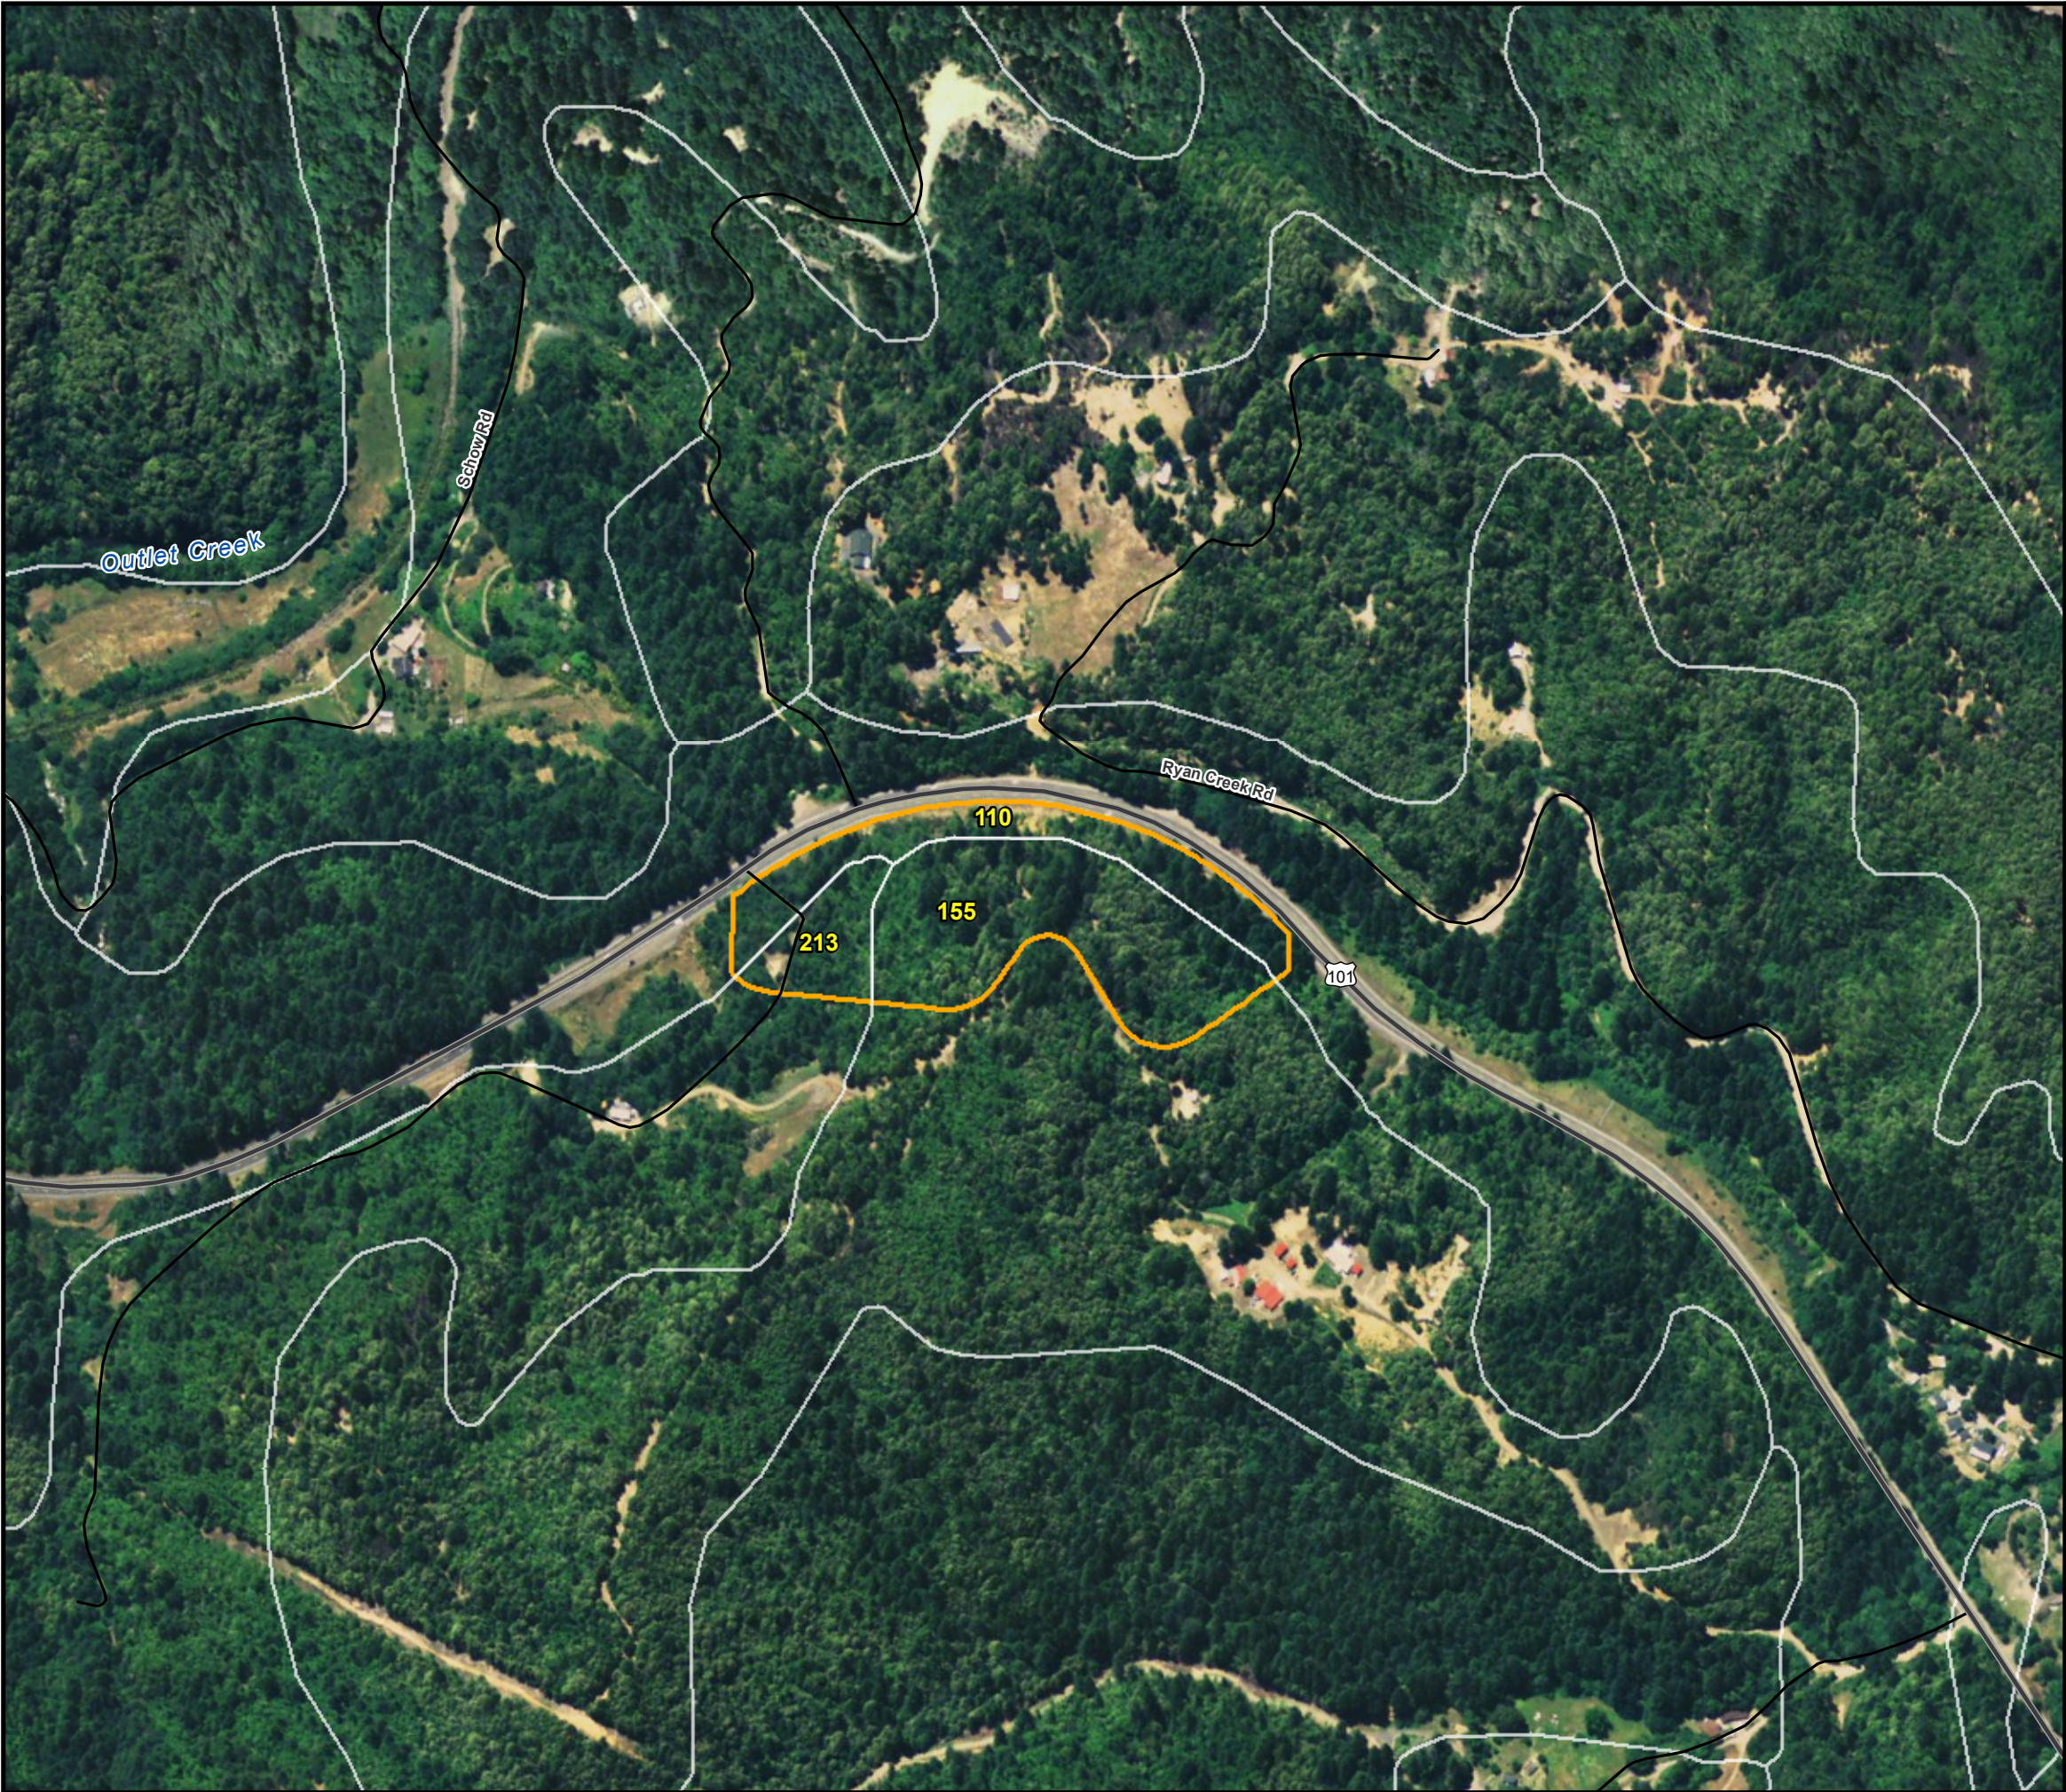
Figure 5-4g

SSURGO Map Unit

Permanent Impact Boundary

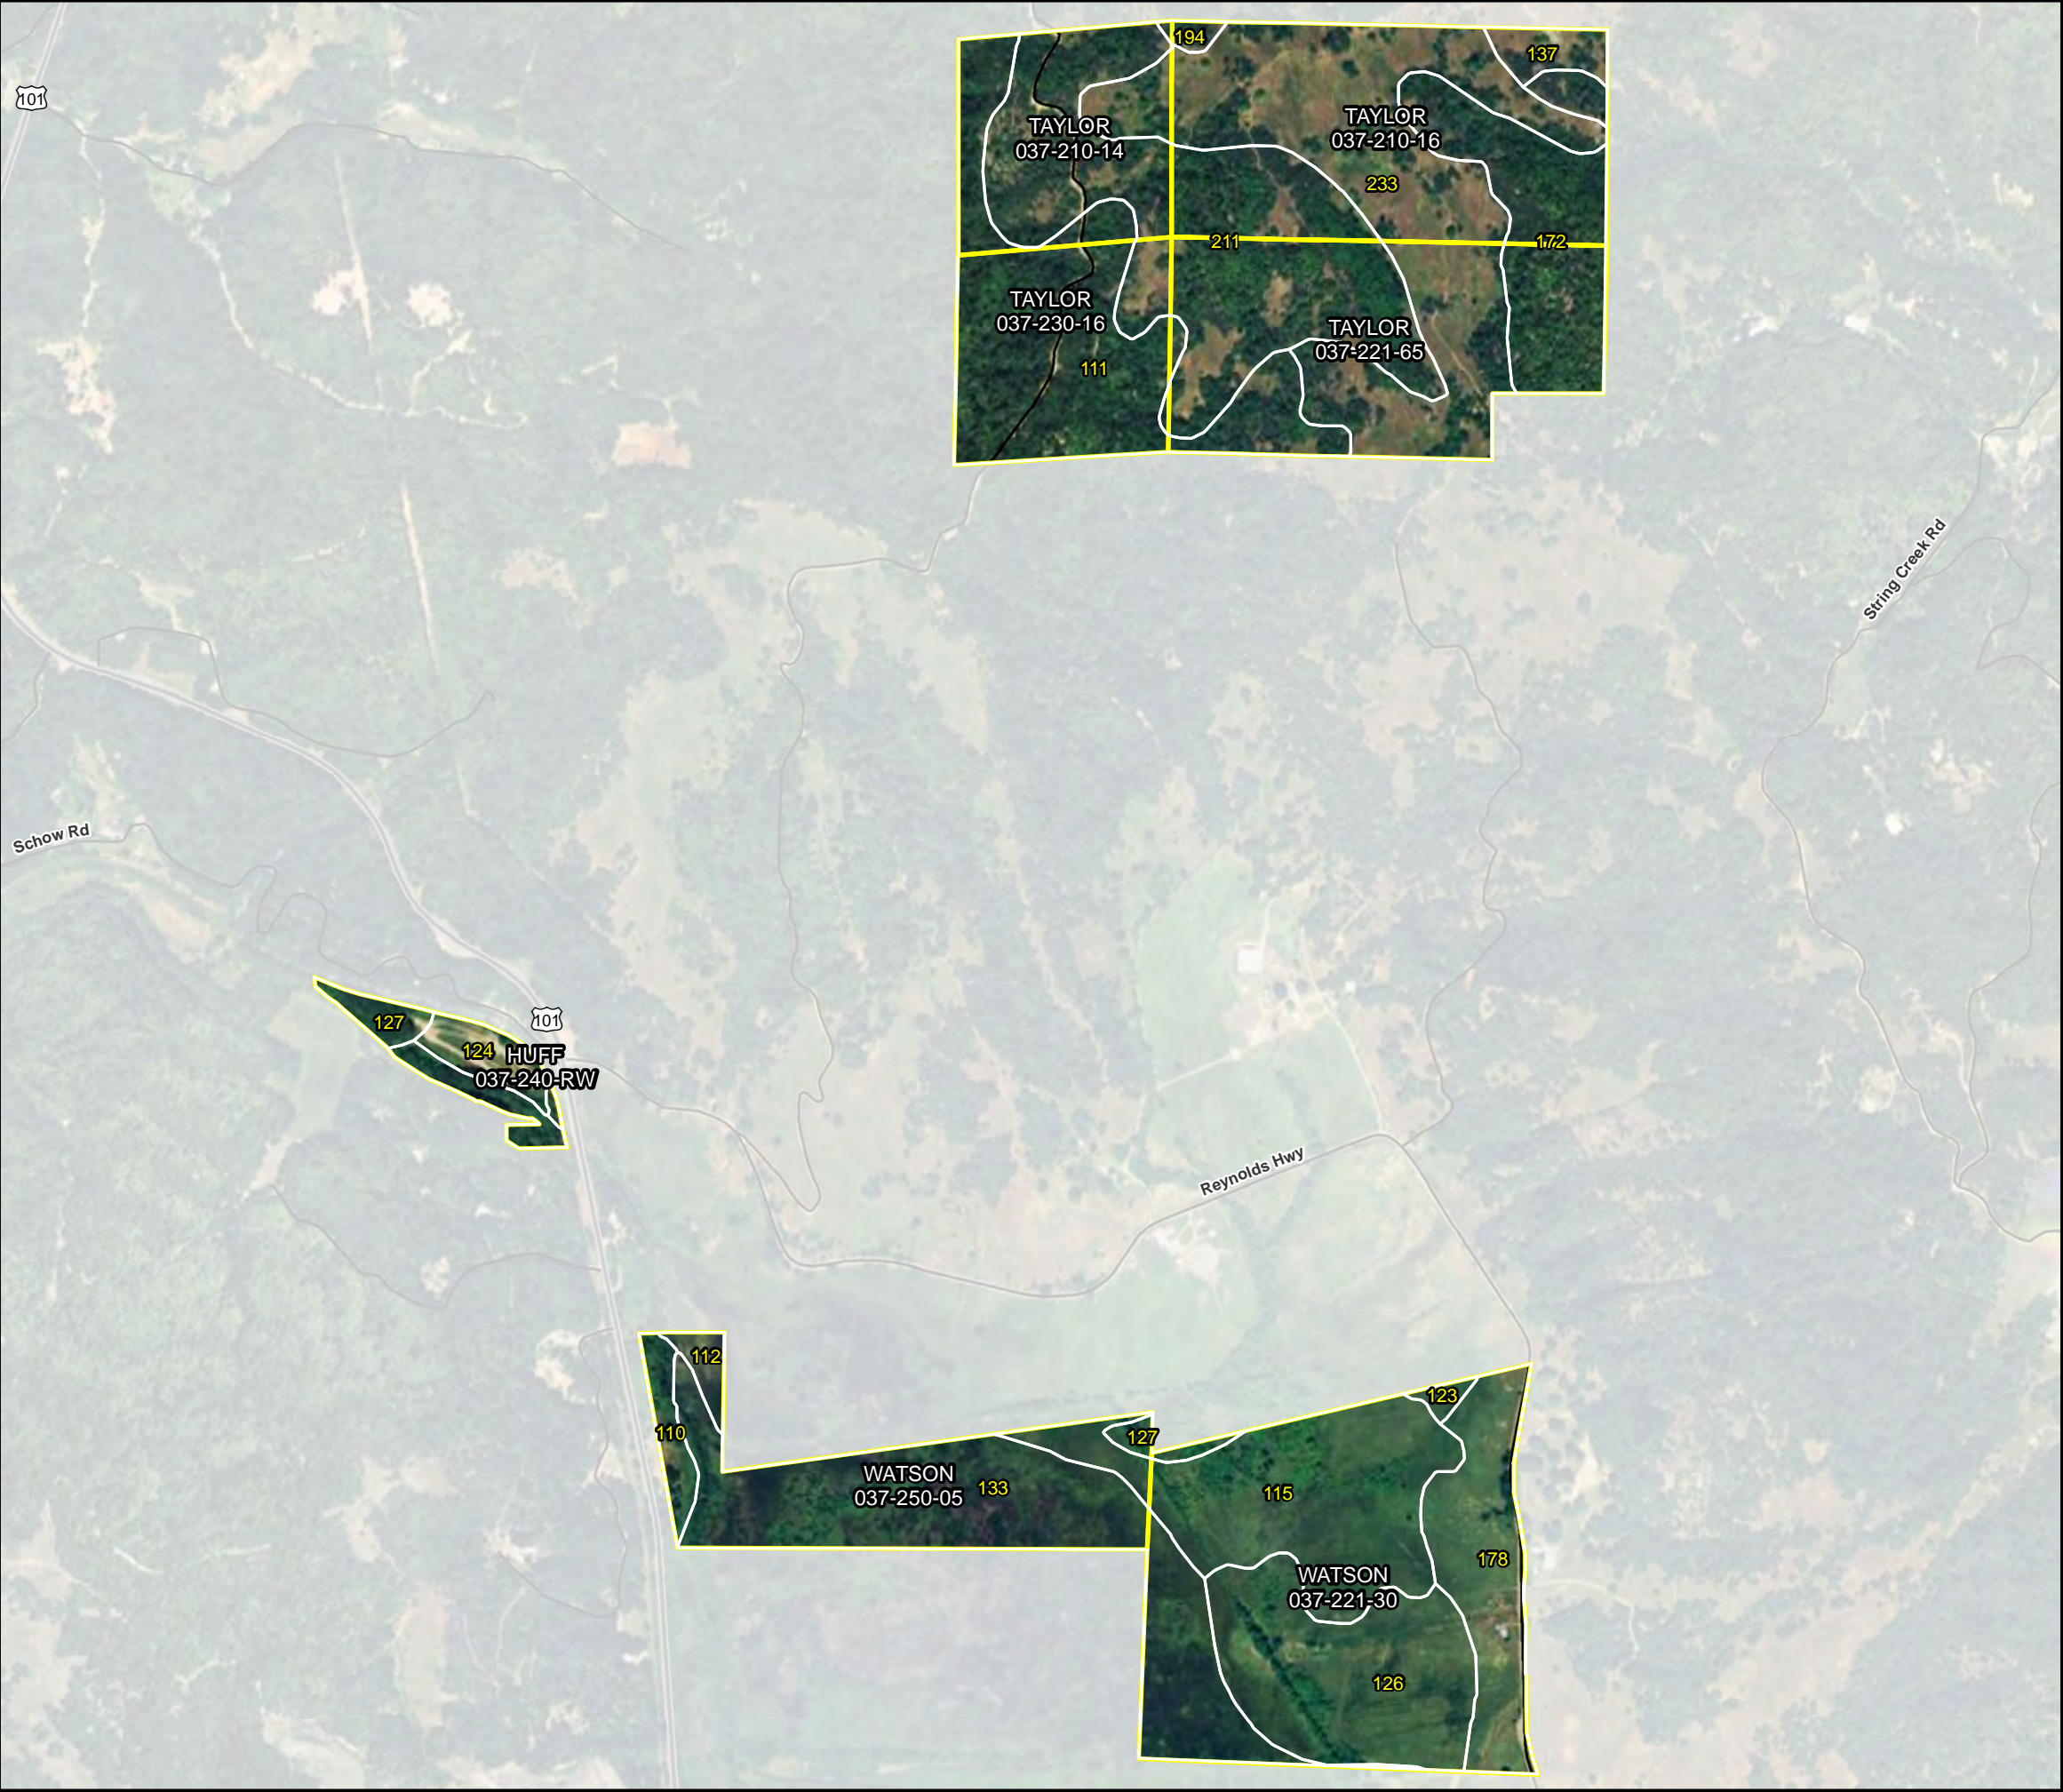
Figure 5-5a
Soil Types within the
Offsite Mitigation Parcels
Proposed Willits Bypass Project

Offsite Mitigation Parcels

SSURGO Map Unit

The offsite mitigation properties are east of the bypass alignment footprint or in some cases (Benbow, Brooke, Ford, Lusher, and Niesen) on parcels occupied by the bypass alignment footprint (Figure 3-2). Most of the offsite parcels currently are used for livestock grazing and/or hay production, and a few are fallow. The biological resources on the offsite mitigation properties are similar to those in the bypass alignment footprint in that they include North Coast semaphore grass, Baker's meadowfoam, anadromous fish habitat, jurisdictional wetlands and other waters of the United States, and riparian habitat. These biological resources are discussed in Sections 5.3.1 through 5.3.10 by parcel. Table 5-1 lists the offsite mitigation properties that provide jurisdictional wetland and other waters mitigation, their size, APN, and the acreage of sensitive biological resources present on each parcel. Figures 5-5a, 5-5b, and 5-5c show the soil types on each offsite mitigation property.

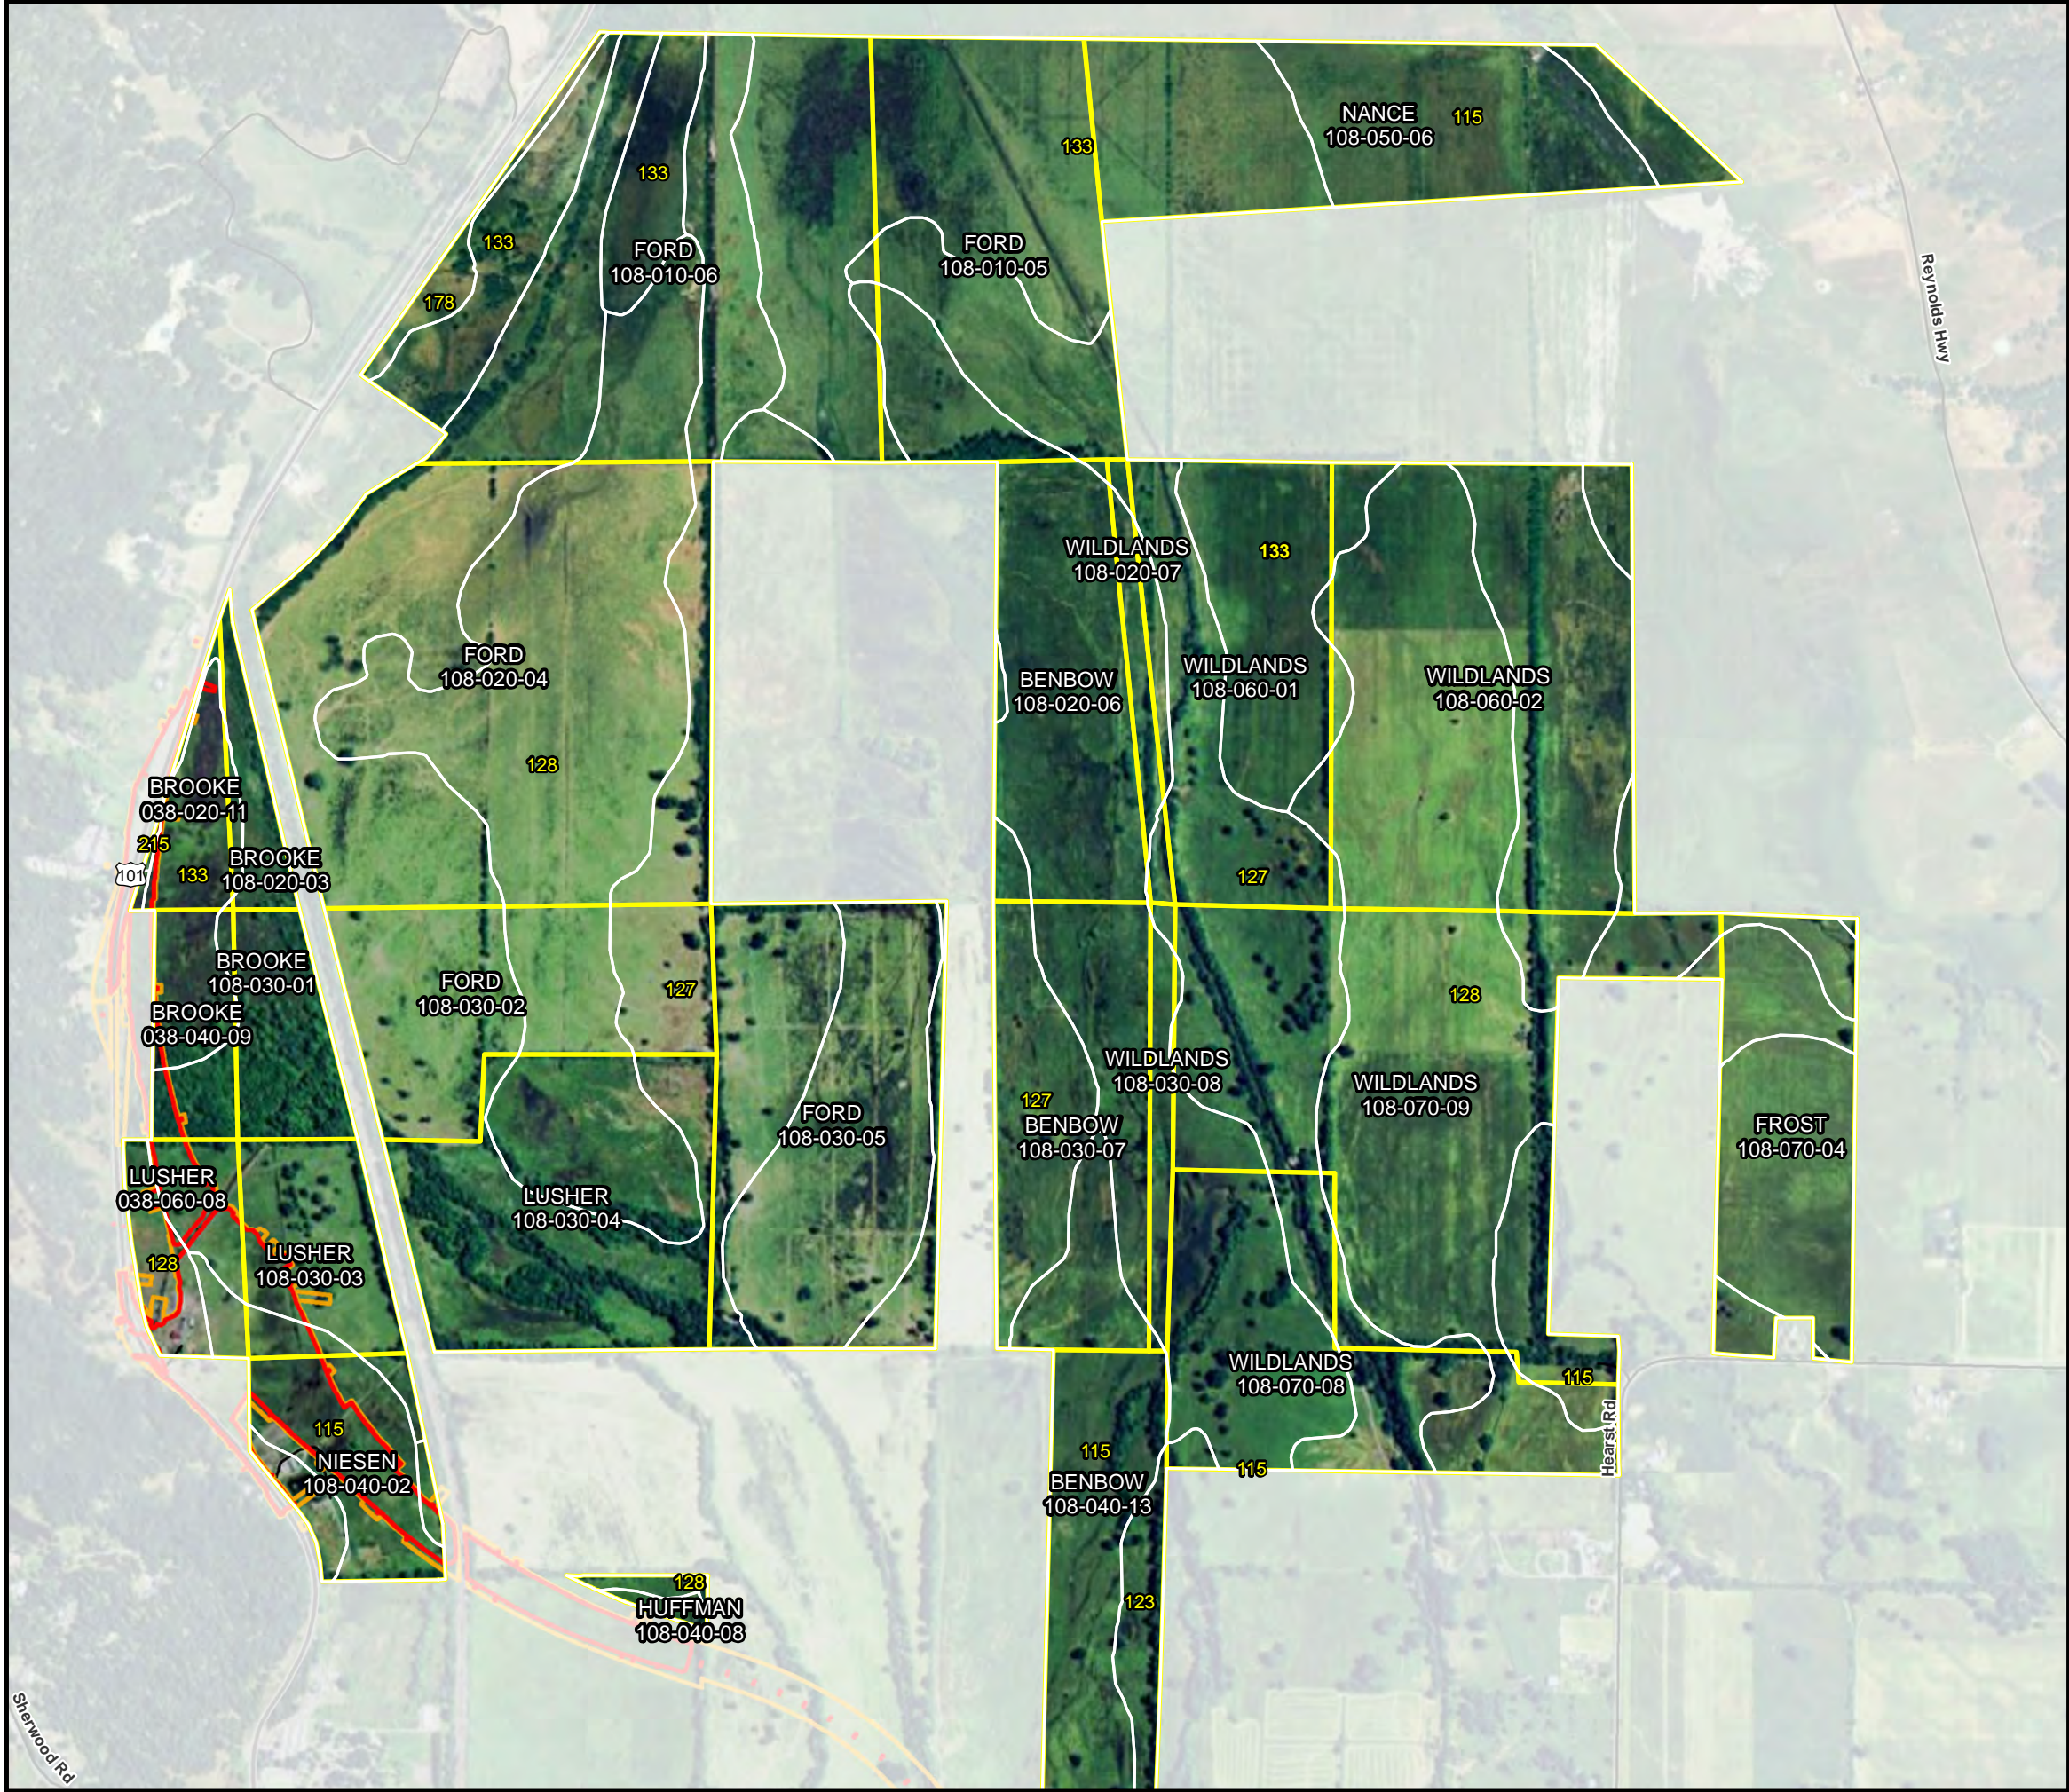
Figure 5-5b
Soil Types within the
Offsite Mitigation Parcels
Proposed Willits Bypass Project

- Offsite Mitigation Parcels
- SSURGO Map Unit
- Road
- Permanent Impact Boundary
- Temporary Impact Boundary
