Willits Bypass Project

Mitigation and Monitoring Proposal

U.S. Highway 101

January 2012

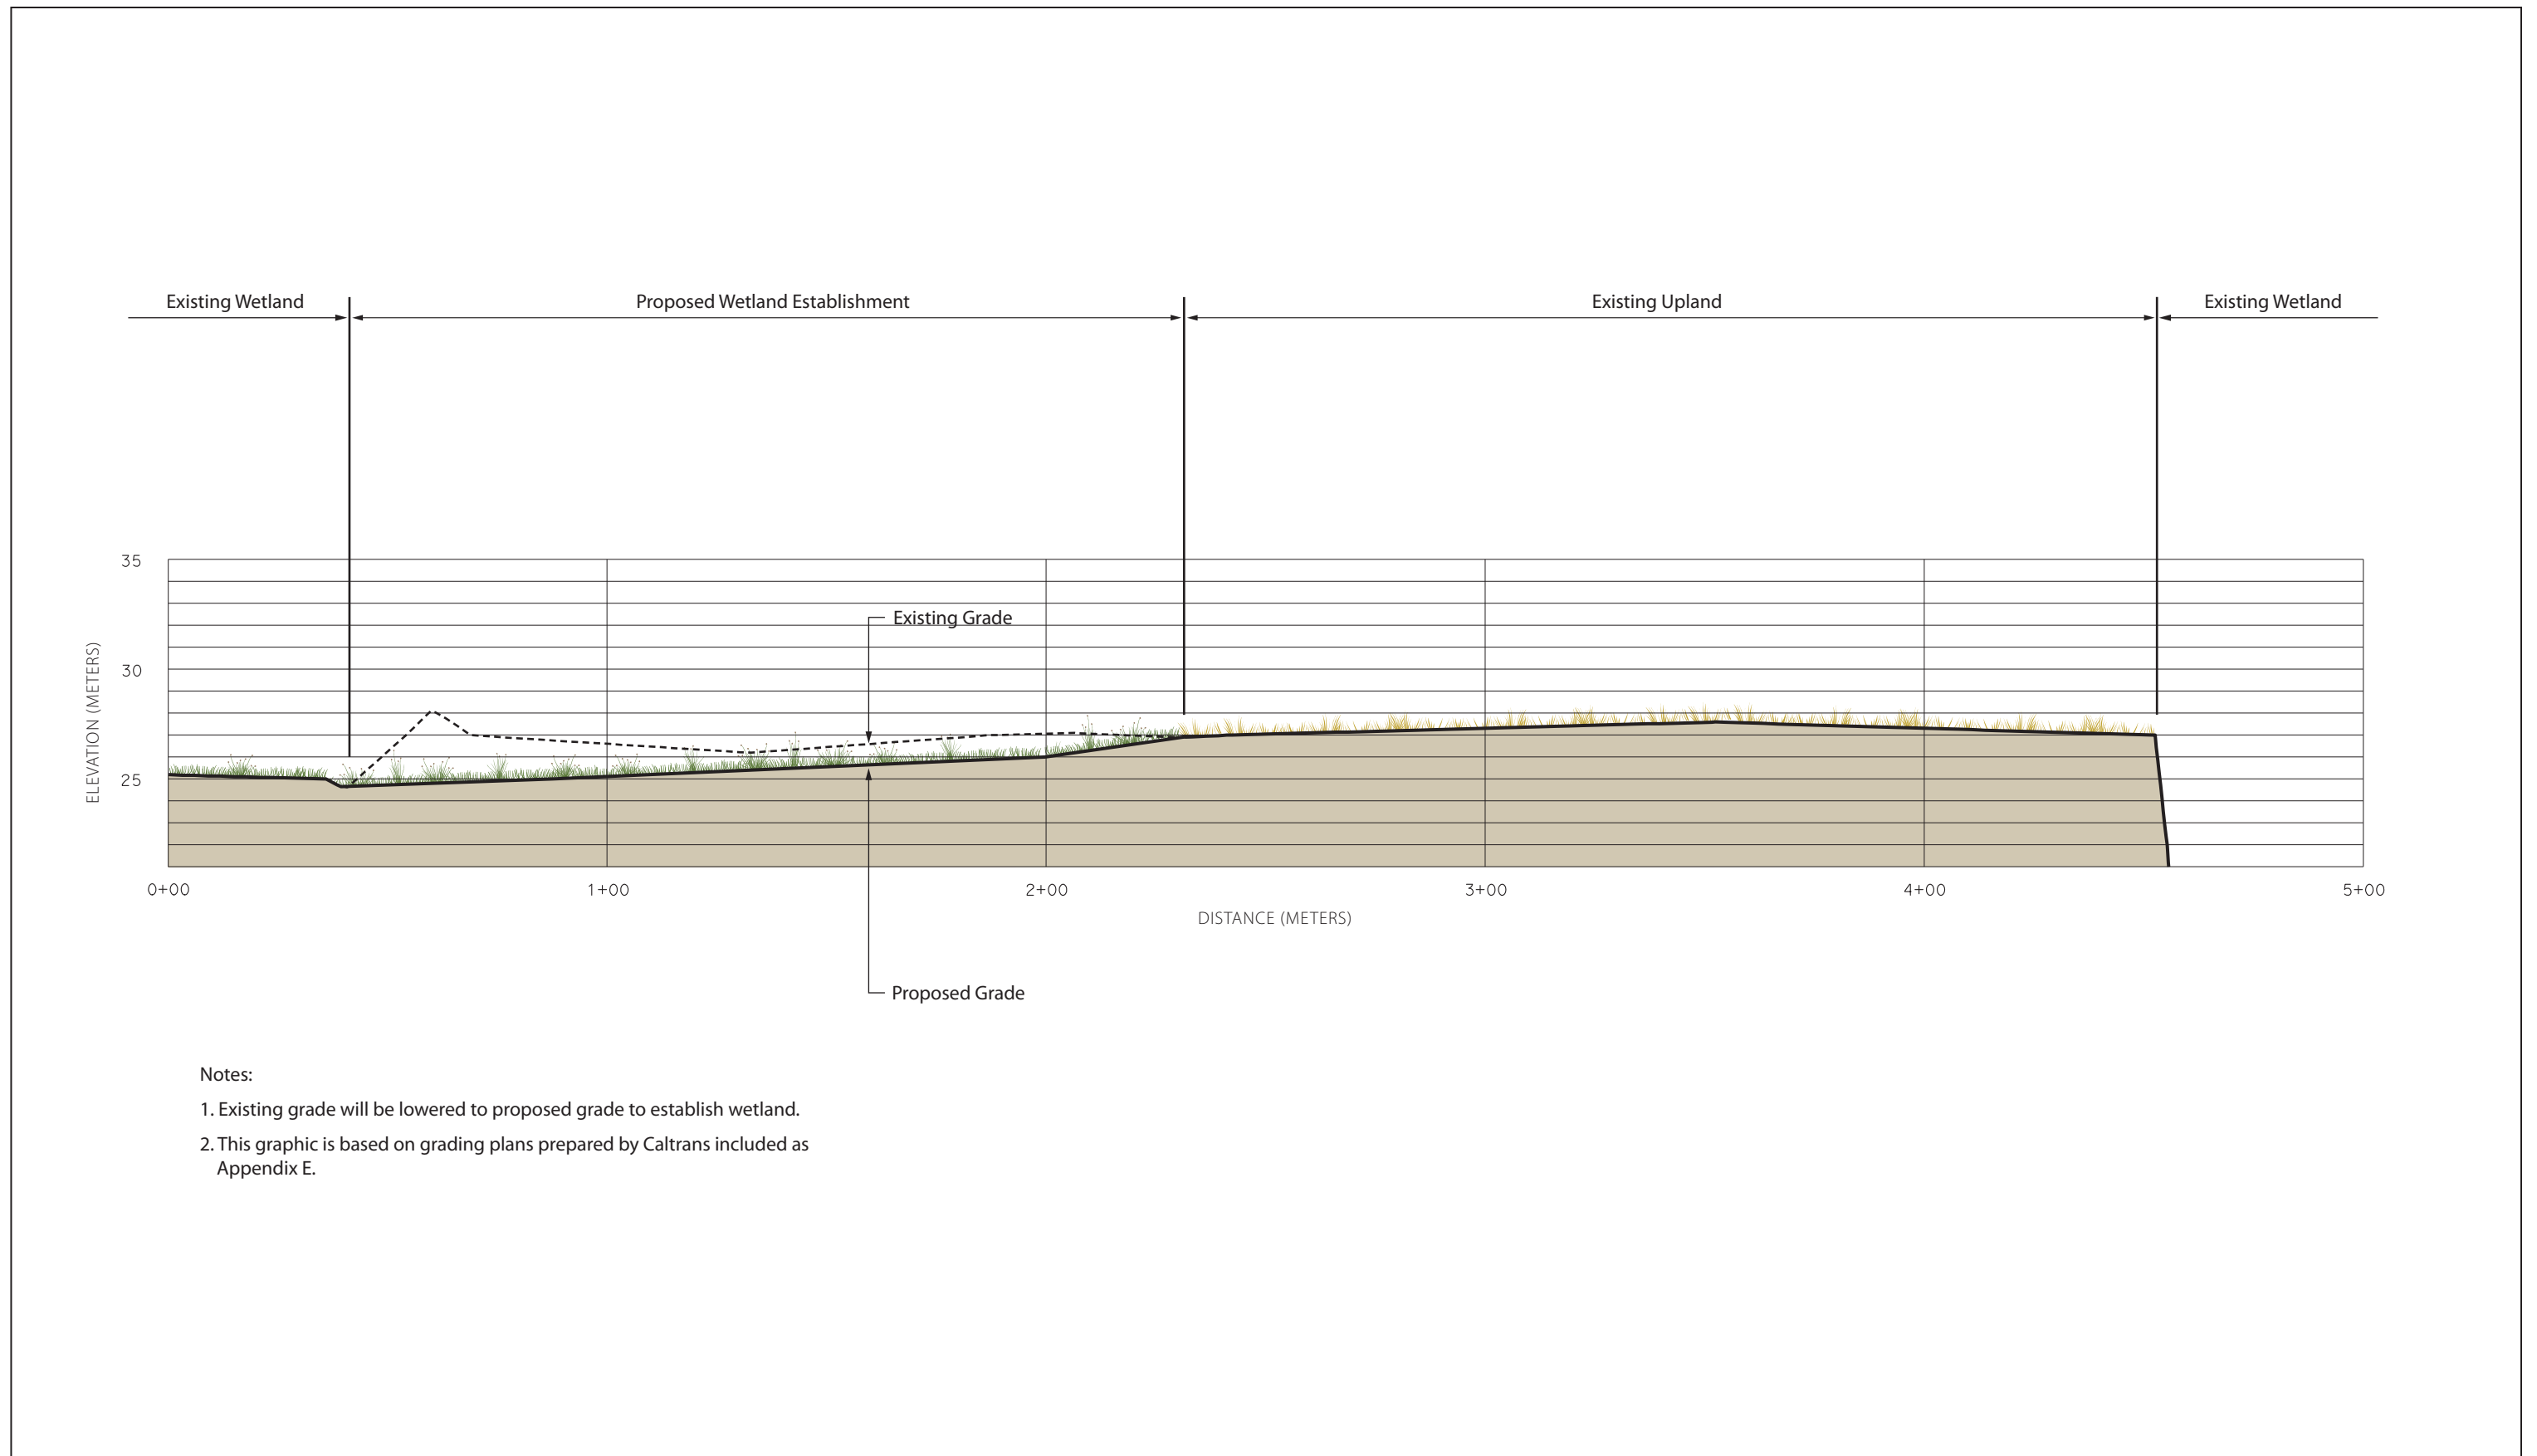
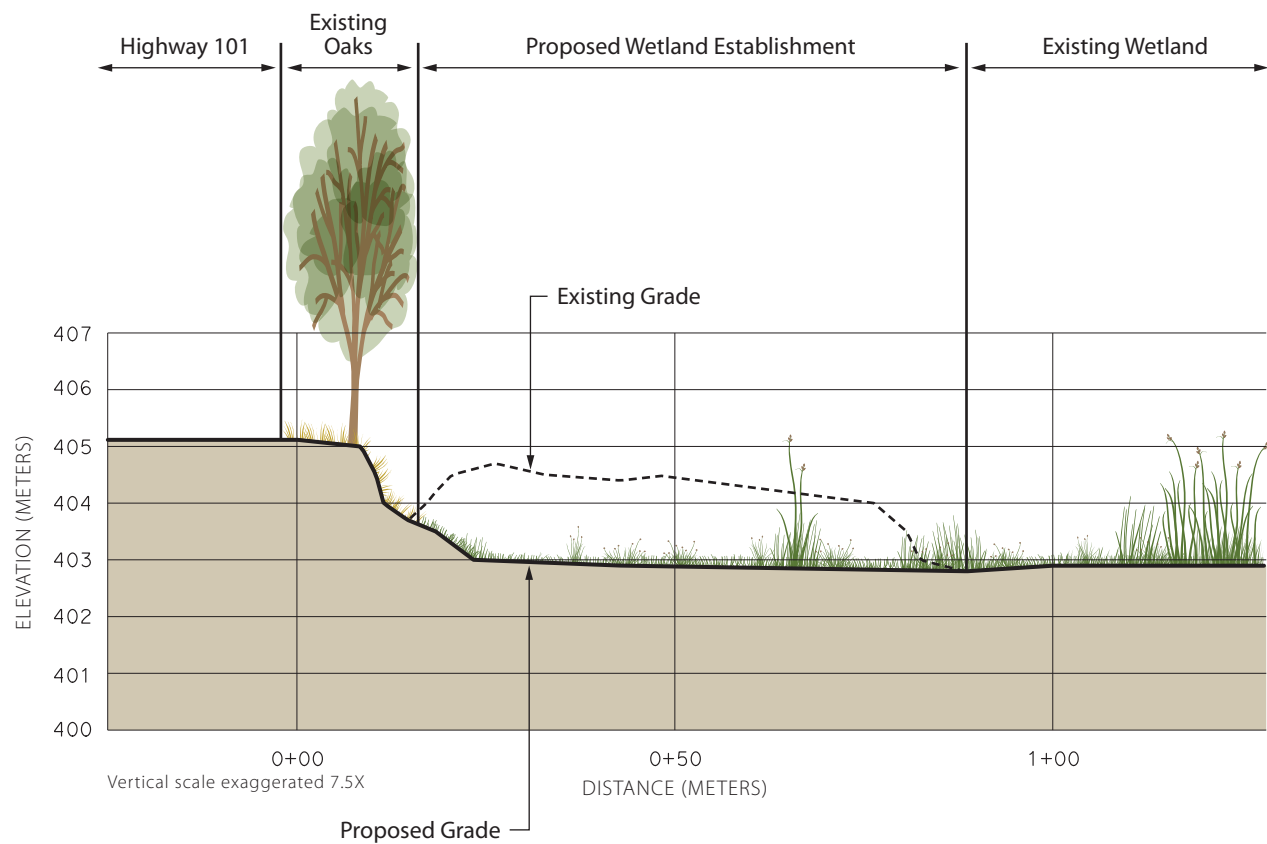
Figure 7-3
Wetland Establishment at Benbow (APN 108-020-06) and Wildlands Parcel (APNs 108-020-07 and 108-060-01)
 Willits Bypass Project

1. Existing grade will be lowered to proposed grade to establish wetland.
2. This graphic is based on grading plans prepared by Caltrans included as Appendix E.

Wetland establishment at this parcel will consist of Group 1 wetland establishment totaling 2.14 acres. The wet meadow unit will be established adjacent to US 101 (Appendix C, Table 6-2). Figure 7-4 provides a graphic representation of wetland establishment efforts at the Ford parcel. The grading and planting plans for offsite wetland establishment are presented in Appendix E.
