SUBMITTED:	PDT	INTELSUR Team Leader
DESIGNED BY:	CHECKED BY:	DRAWN BY:
DATE:	SHEET NO.	PDT
2/20/2013	1 OF 4	9 2
APPROVAL RECOMMENDED:		
CHIEF, Hydro Survey Section		
PREPARED UNDER THE DIRECTION OF:		
JOHN K. BAKER		
APPROVED:		
LT. COLONEL, C.E., DISTRICT ENGINEER

CALIFORNIA
CONTRA COSTA COUNTY
RICHMOND HARBOR
SOUTHAMPTON SHOALS
CONDITION SURVEY
20 FEBRUARY 2013

Sheet reference number
C1

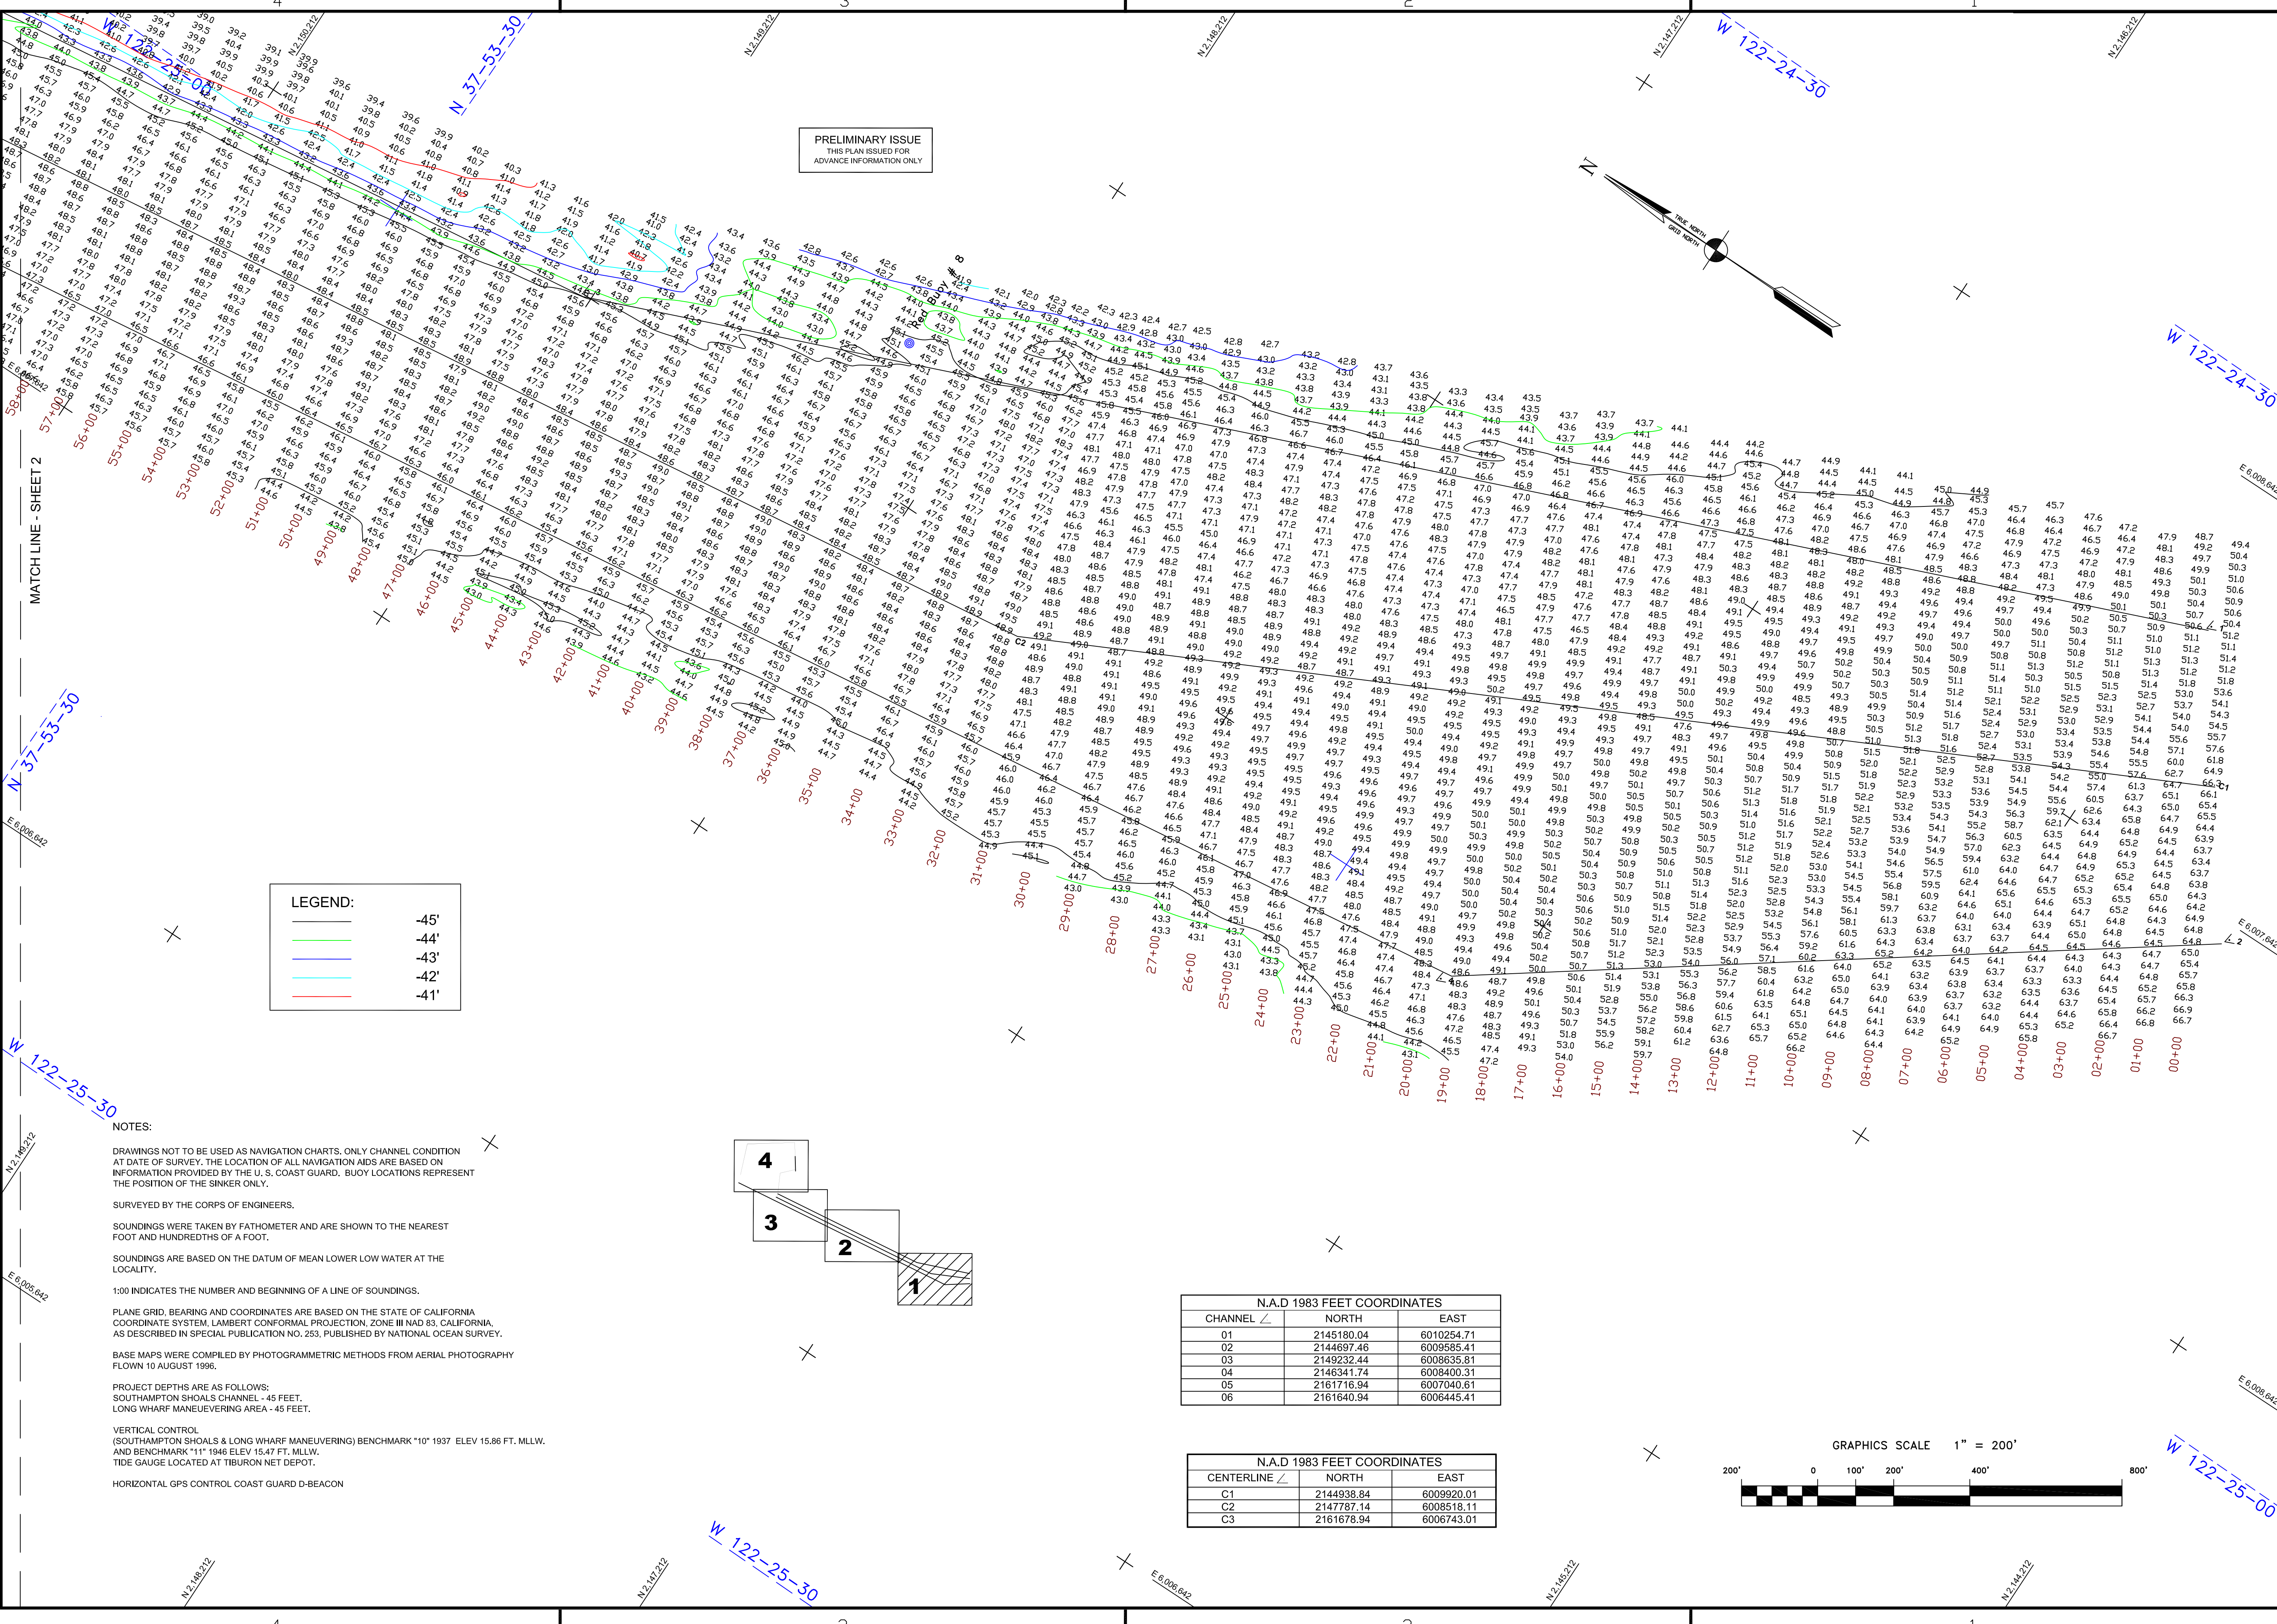
SURVEYED BY THE CORPS OF ENGINEERS.
SOUNDINGS WERE TAKEN BY FATHOMETER AND ARE SHOWN TO THE NEAREST FOOT AND HUNDRETHS OF A FOOT.

SOUNDINGS ARE BASED ON THE DATUM OF MEAN LOWER LOW WATER AT THE LOCALITY.

PROJECT DEPTHS ARE AS FOLLOWS:
SOUTHAMPTON SHOALS CHANNEL - 45 FEET.
LONG WHARF MANEUVERING AREA - 45 FEET.
