USACE File: 2013-00422N
Loch Lomond Marina
Maintenance Dredging

LOCH LOMOND MARINA 2014 MAINTENANCE DREDGING LOCATION MAP

LOCH LOMOND MARINA 2014 MAINTENANCE DREDGING
 SITE MAP

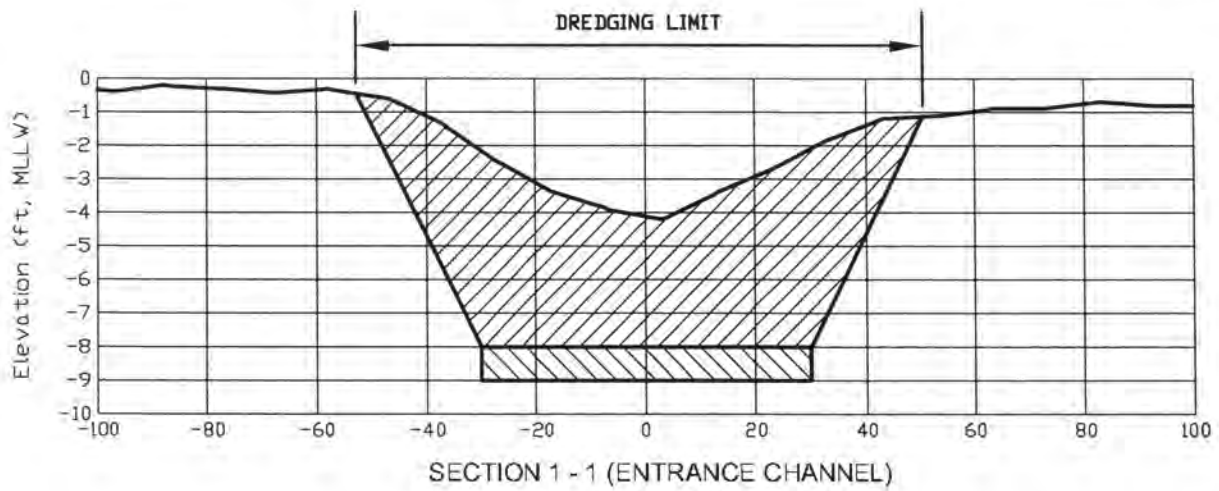
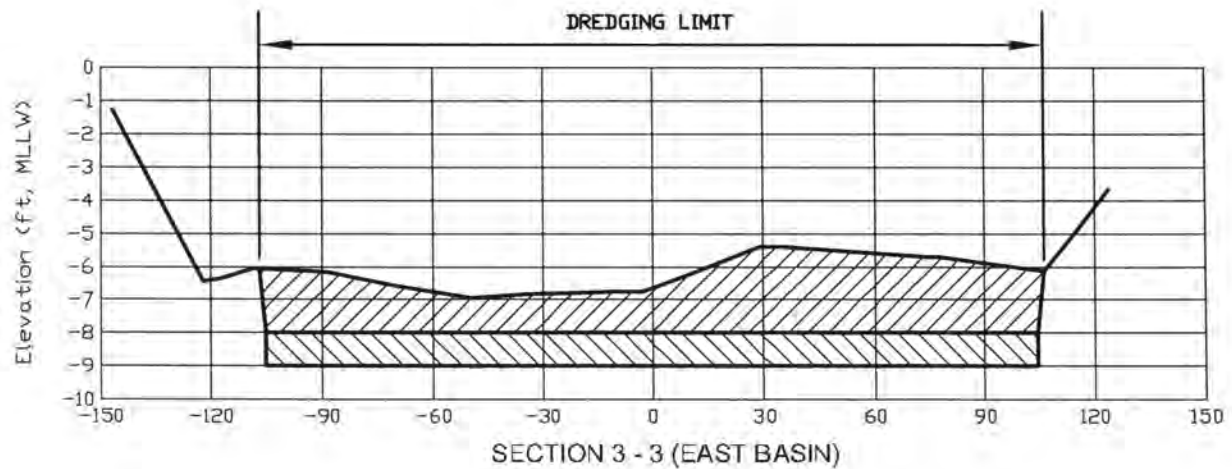
Sheet 6 of 6
April 2014

DESIGN DEPTH
-

1' OVER-DEPTH

LOCH LOMOND MARINA 2014 MAINTENANCE
TYPICAL SECTIONS
