Figure 1
Vicinity Map
 DMMO Application
 Westpoint Harbor 10-year Programmatic Maintenance Dredging

Figure 2
Dredge Footprint - 2017 Dredge Episode and 10-year Programmatic
 DMMO Application
 Westpoint Harbor 10-year Programmatic Maintenance Dredging

Figure 3
Typical Cross-sections - 2017 Dredge Episode
 DMMO Application
 Westpoint Harbor 10-year Programmatic Maintenance Dredging

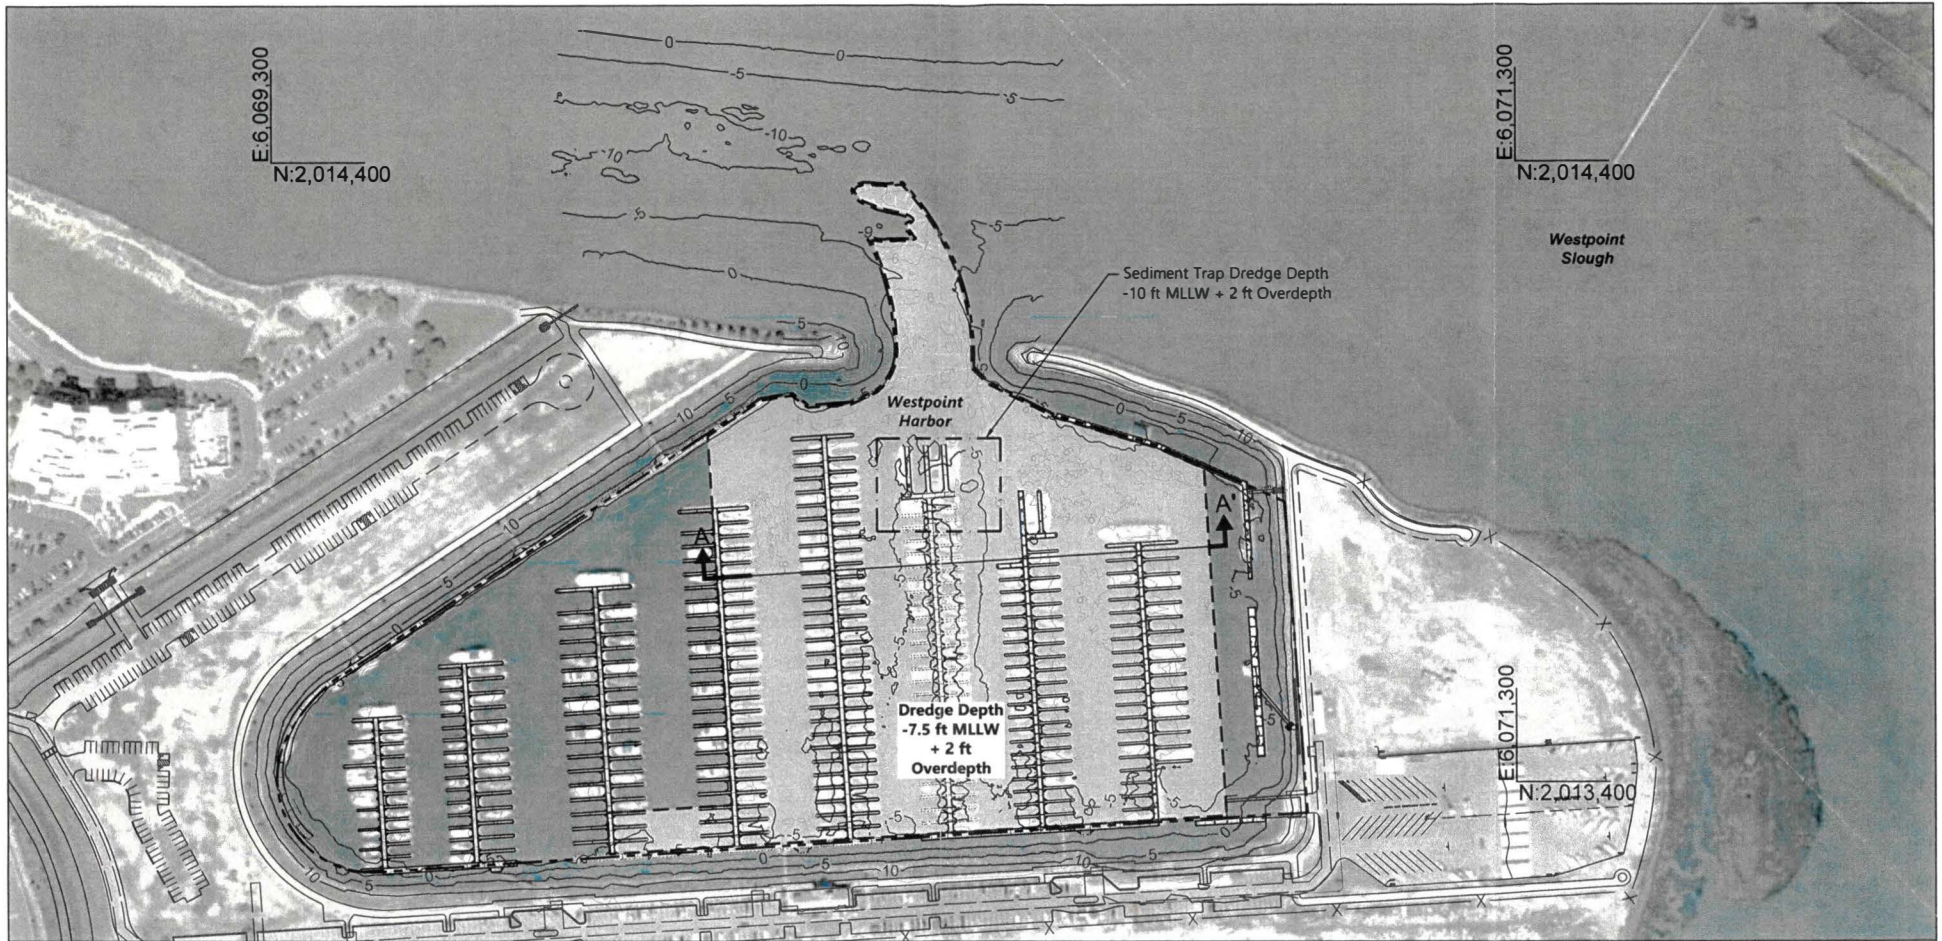
SOURCE: Aerial Google Earth Pro, 2016. Bathymetry from eTrac Inc., survey dated August 4, 2016.
 HORIZONTAL DATUM: California State Plane, Zone 3, NAD83, U.S. Feet.
 VERTICAL DATUM: Mean Lower Low Water (MLLW).

| — 5 — | Existing Contour | - - - - - | 2017 Dredging Boundary |
| - - - - - | Sediment Trap Dredging Footprint | - - - - - | 10-year Programmatic Maintenance Dredging Footprint |

Episode 1 Dredging Footprint

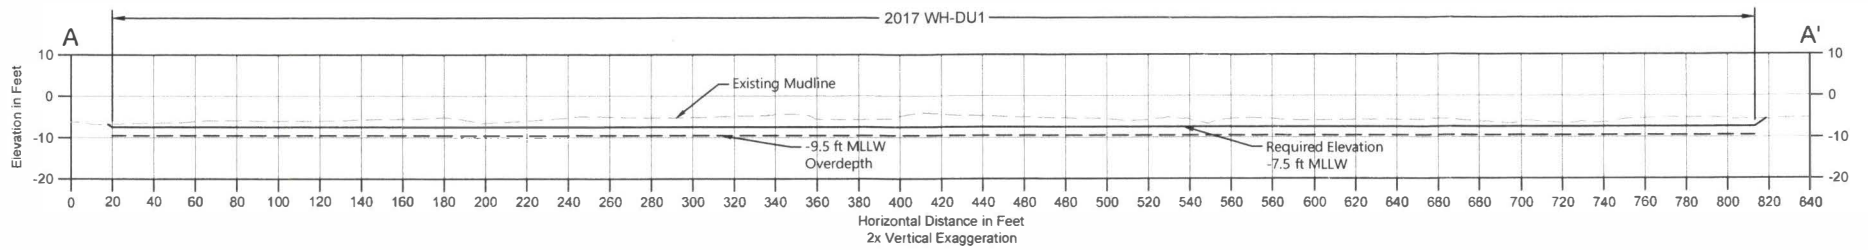
SOURCE: Aerial Google Earth Pro, 2016. Bathymetry from eTrac Inc., survey dated August 4, 2016.
HORIZONTAL DATUM: California State Plane, Zone 3, NAD83, U.S. Feet.
VERTICAL DATUM: Mean Lower Low Water (MLLW).
